**2020 BUILDING
CONDITION SURVEY
REPORT**

CORNWALL CENTRAL
SCHOOL DISTRICT

Elementary School
(Lee Road)

CSArch Project #204-1901

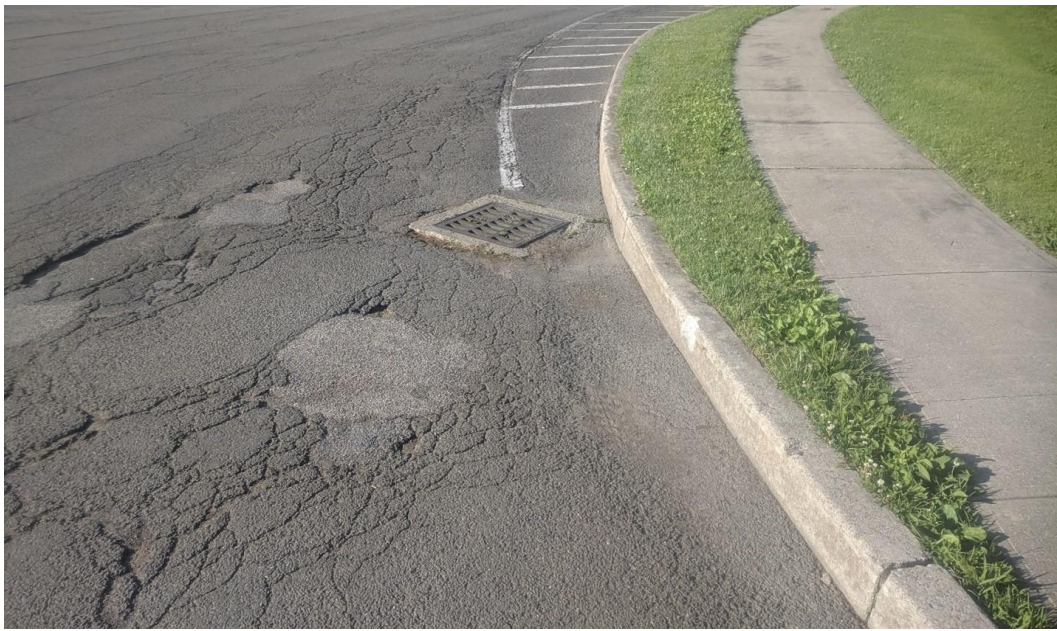
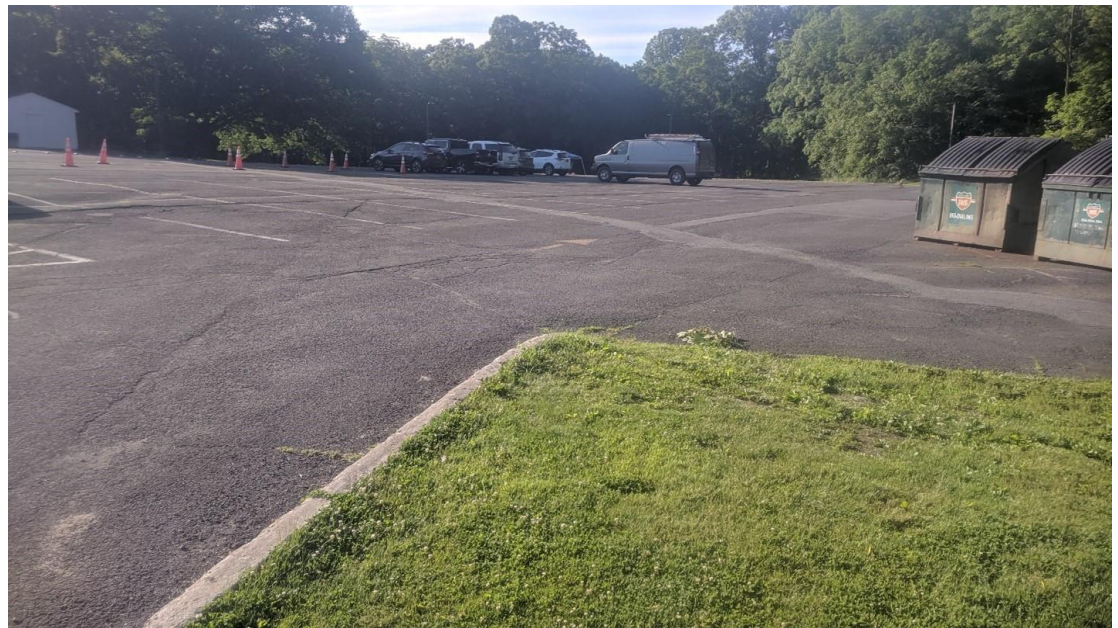
Category 44: Closed Drainage Pipe Stormwater Management System
Need additional catch basins in parking lot and in driveways in front of the building.

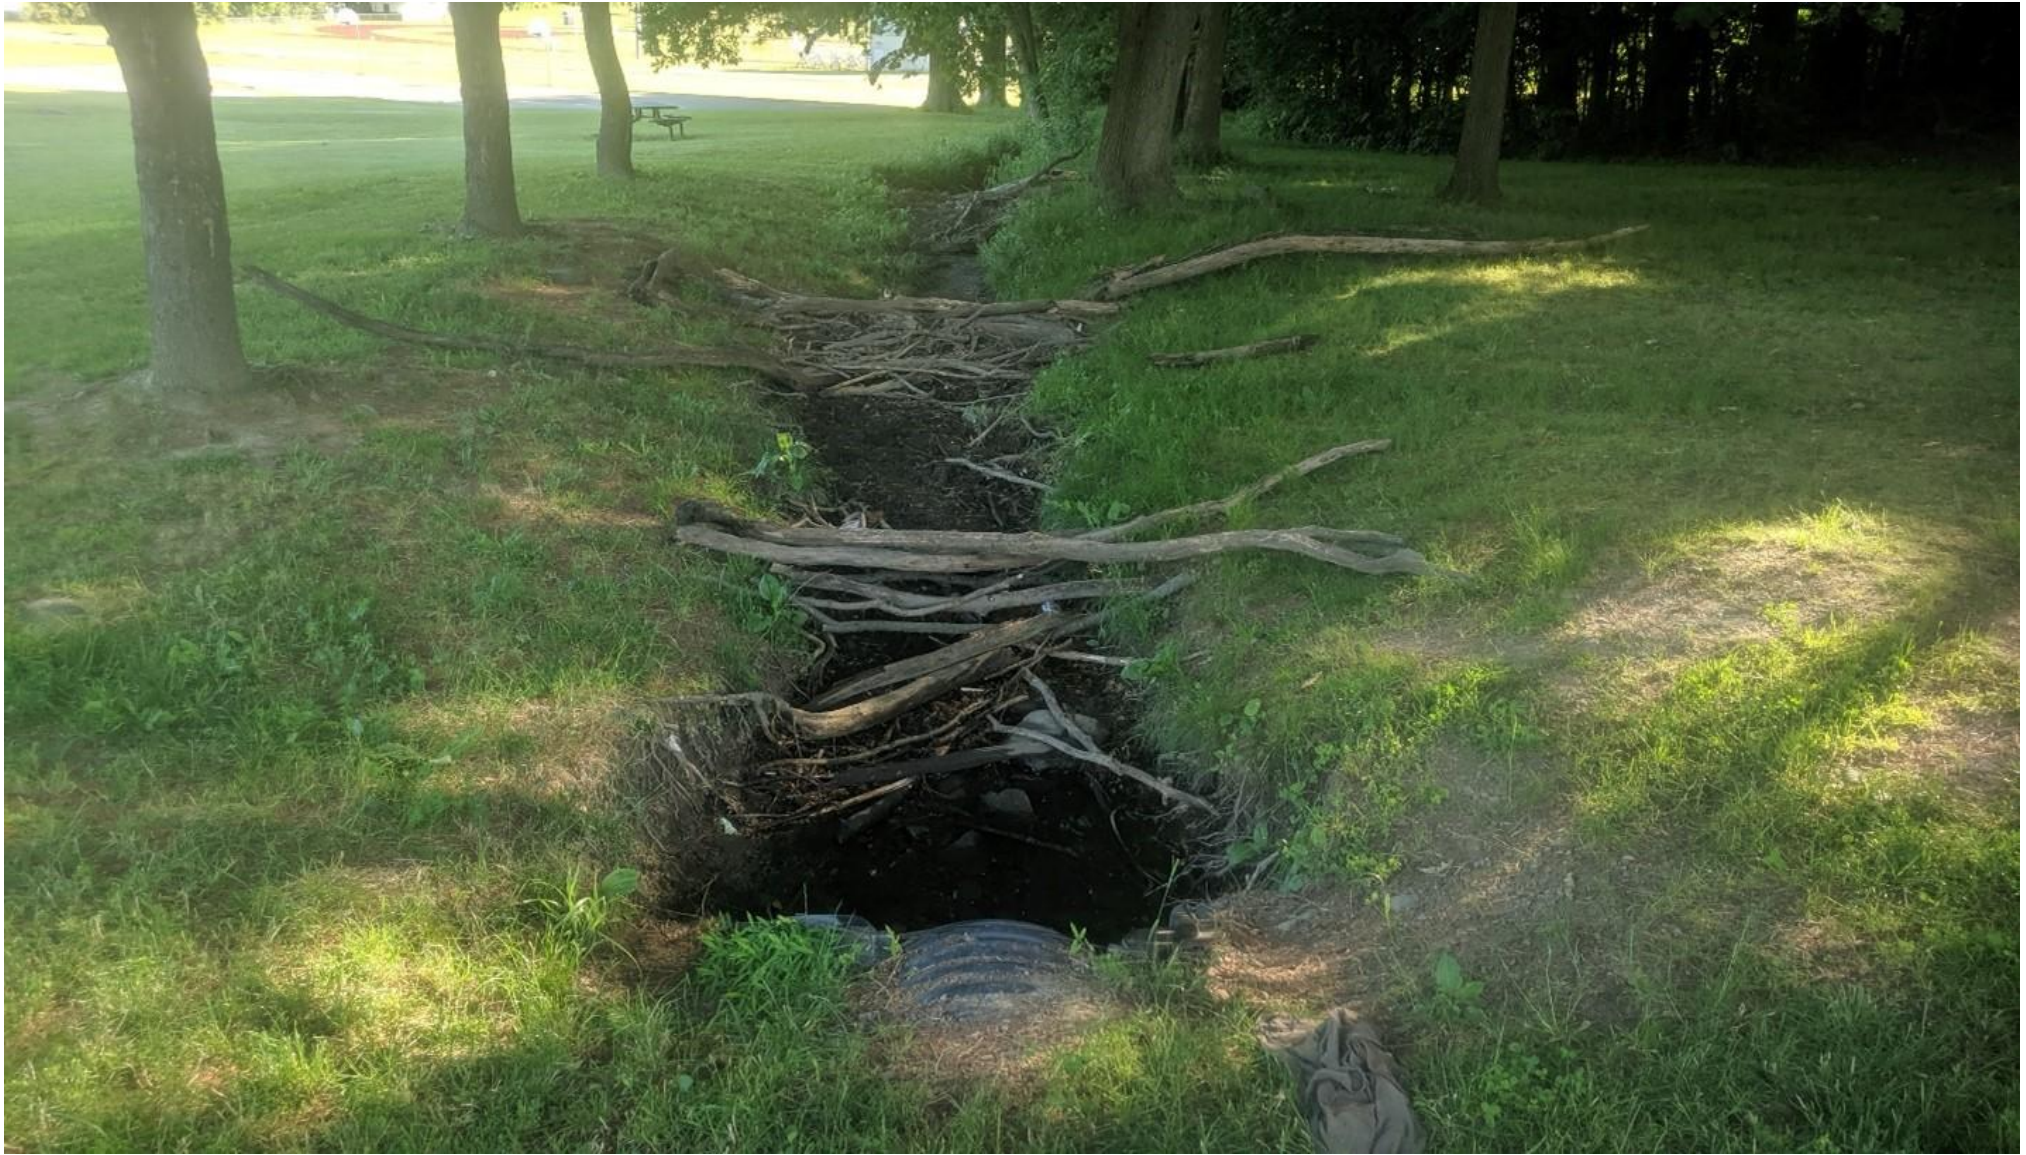
CES-03

Category 53: Point of Outfall Discharge
Clean discharge point/swale.

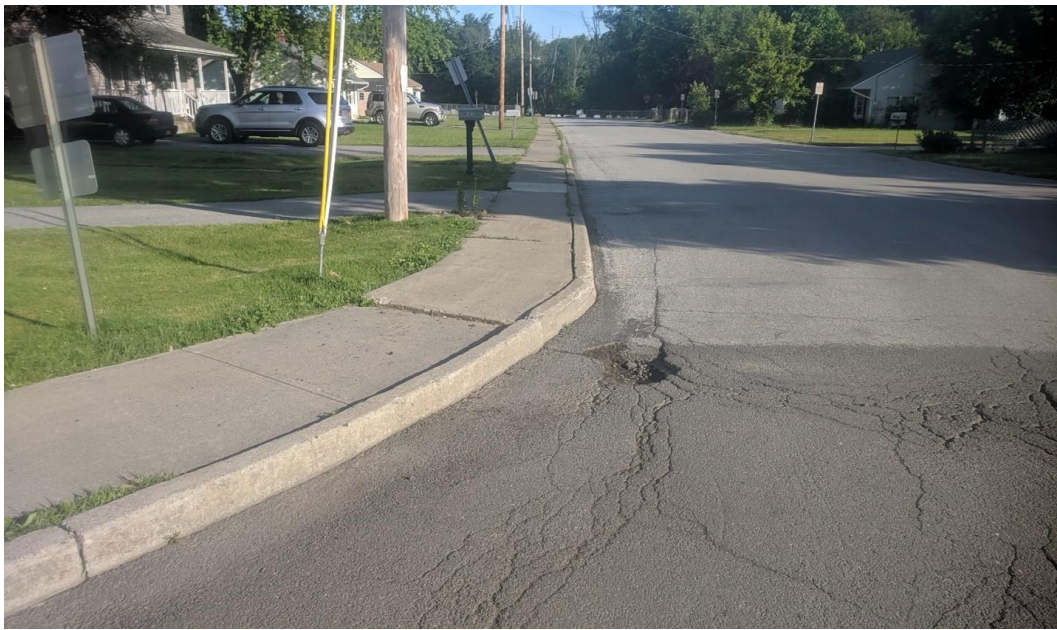
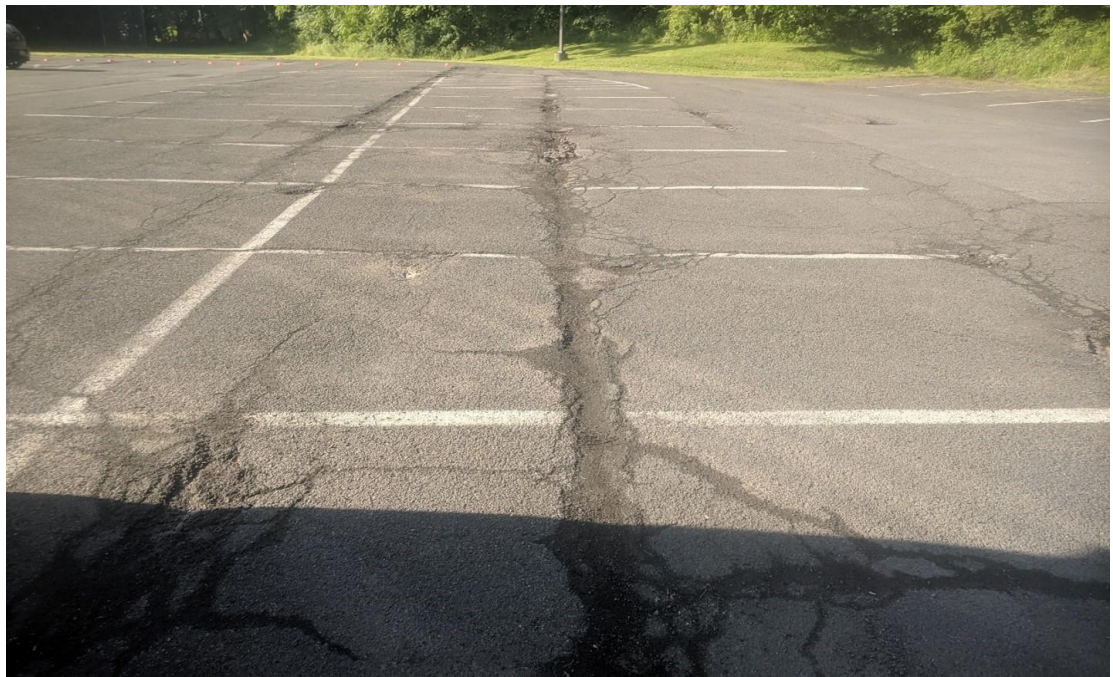
Category 55: Pavement (Roadways and Parking Lots)
Replace driveway and parking lot pavement. Pavement in poor condition and at end of useful life.

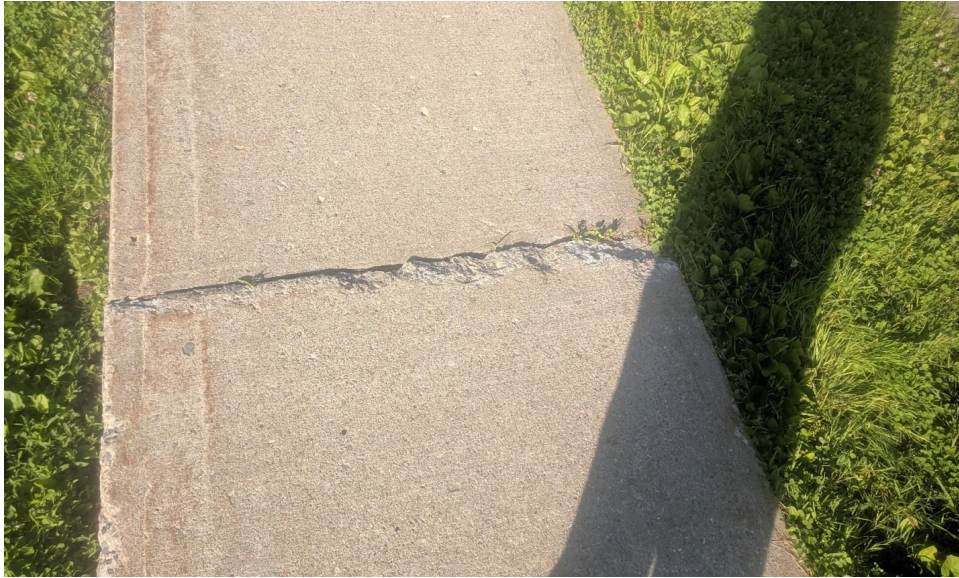
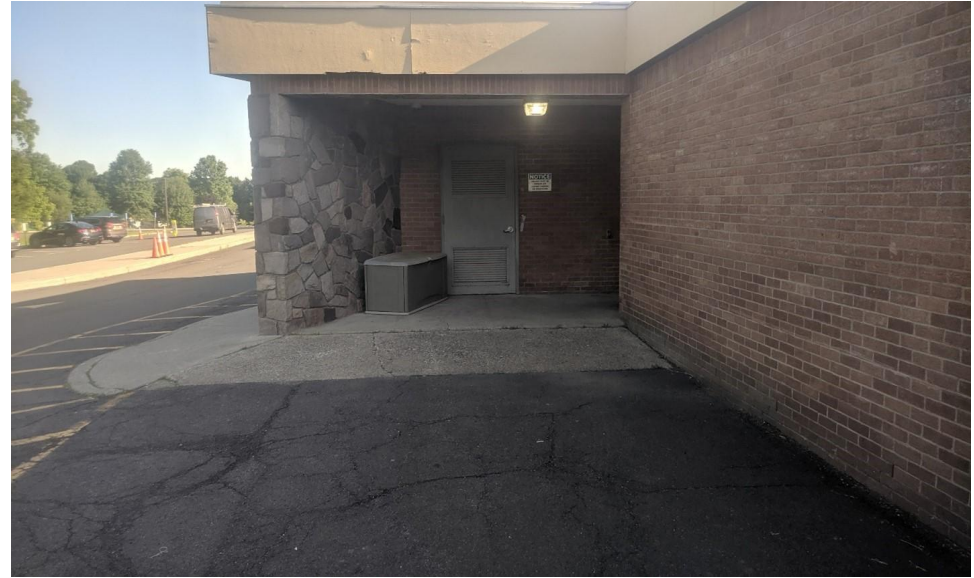
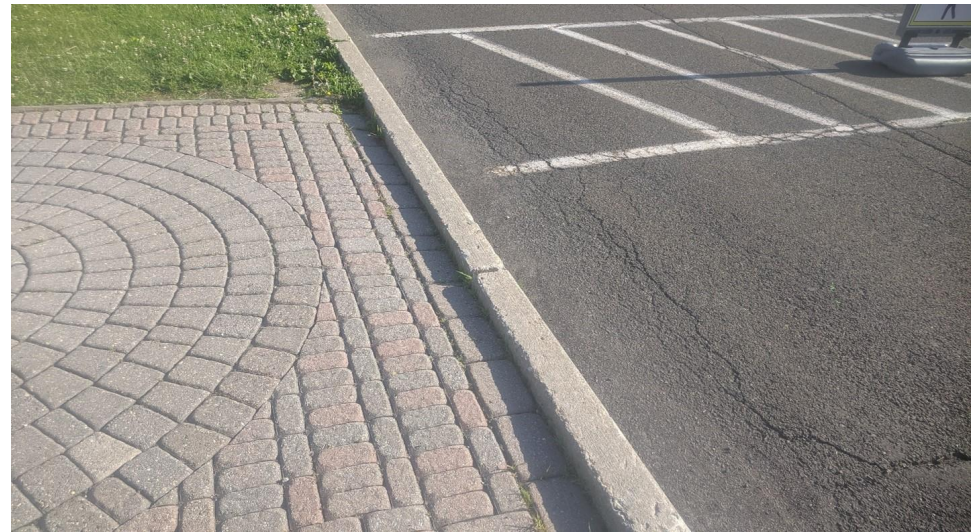
Replace concrete sidewalk. Sidewalk in poor condition. Surface heaves in winter creating an unsafe surface. Replace concrete pad at door. Concrete pad has settled and there is greater than 1/2" rise to finished floor elevation (not code compliant). Replace/install ADA curb ramps at crosswalks.

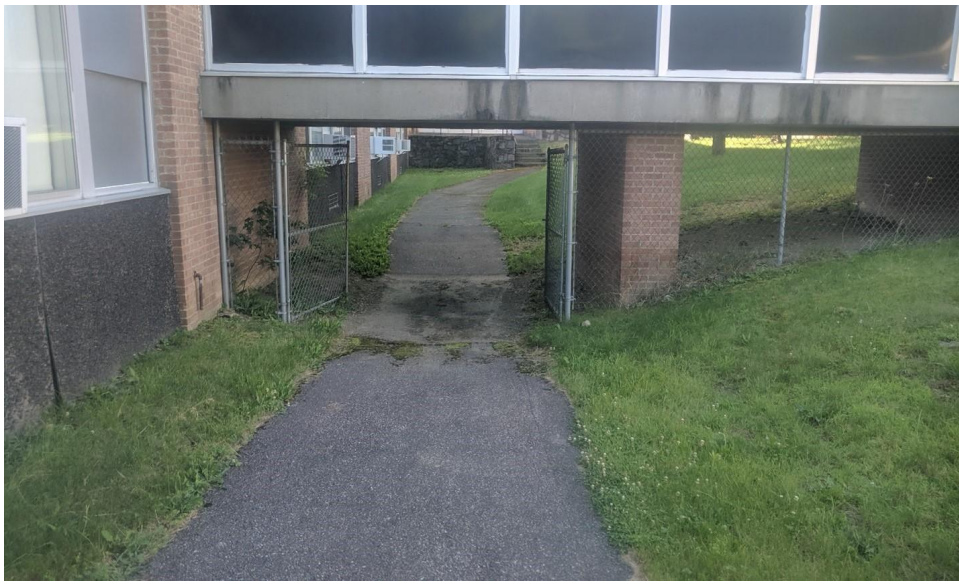
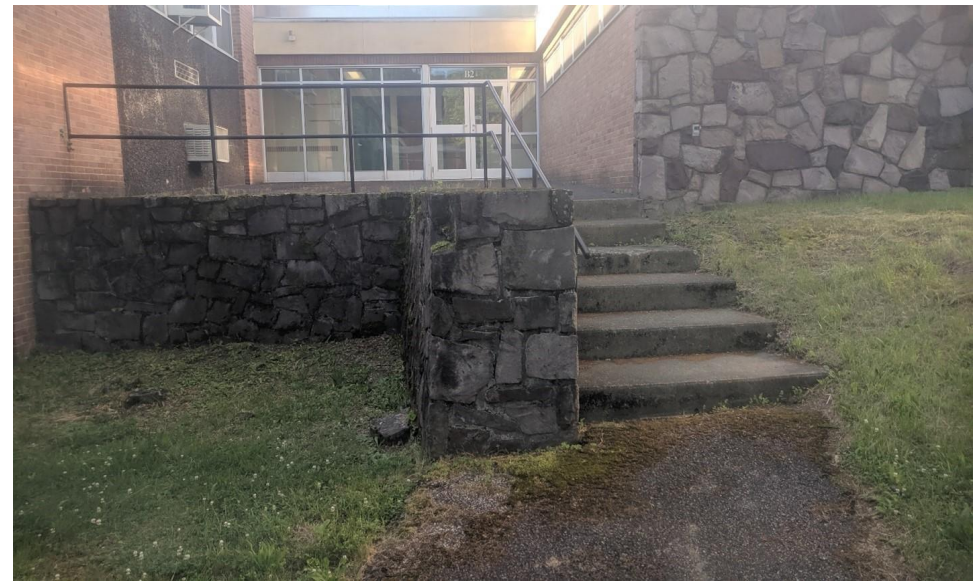
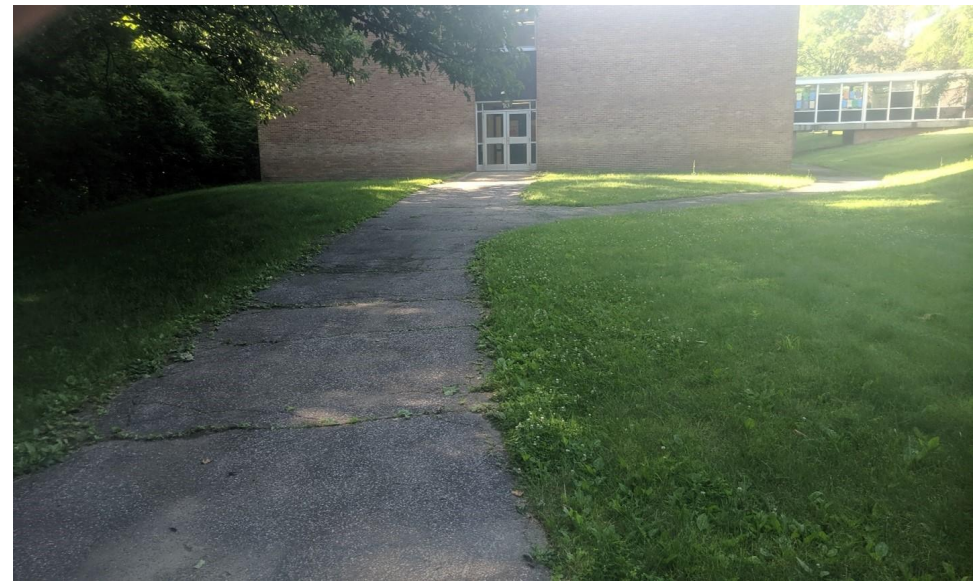
Replace asphalt walks with concrete. Asphalt walks nearing end of useful life. Install drainage. Replace concrete site stair. Stair treads worn/spalling, and landing cross-slope not code compliant.

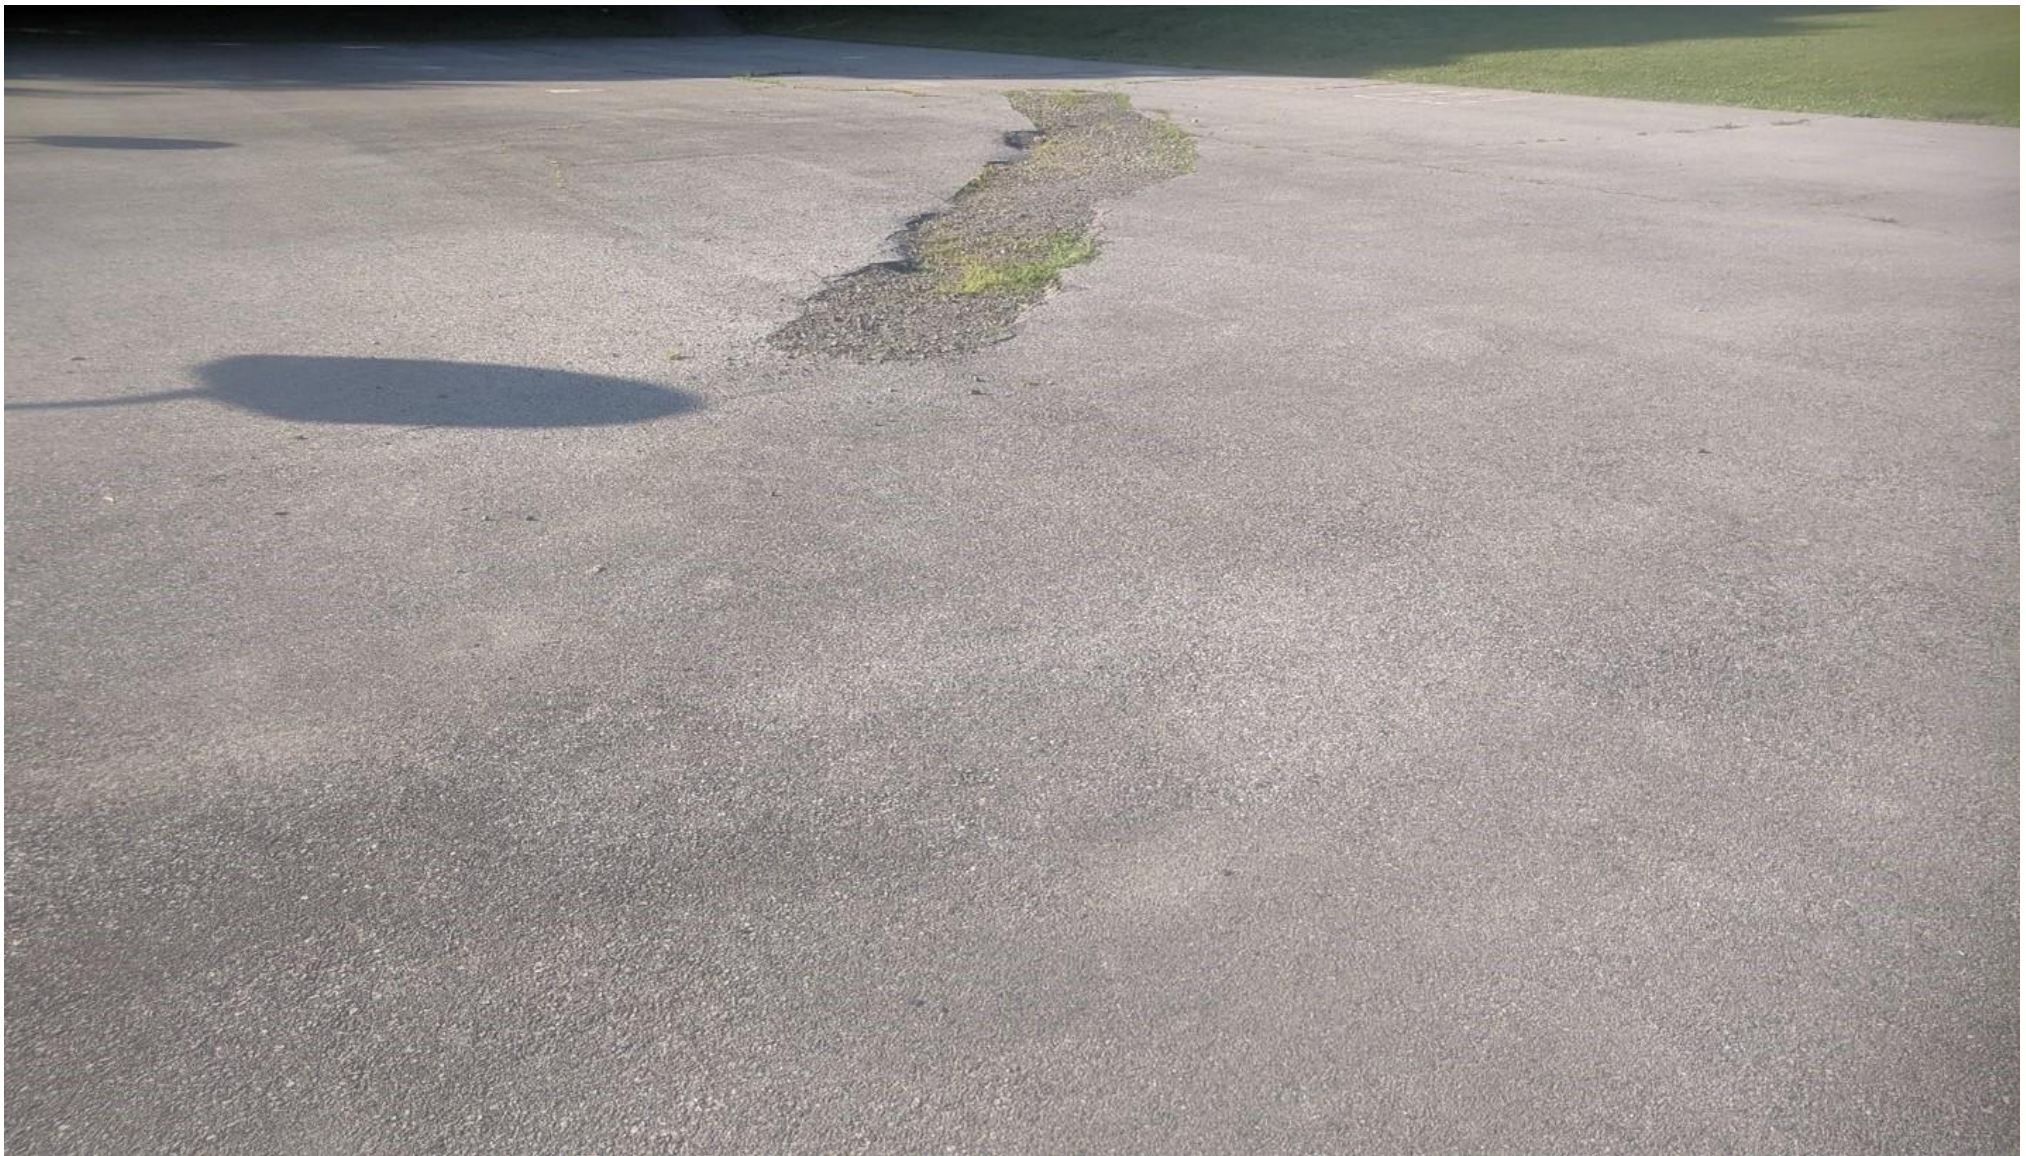
CES-12

Replace basketball court pavement. Large section of asphalt missing in center of surface, and the sub-base is exposed and eroding.

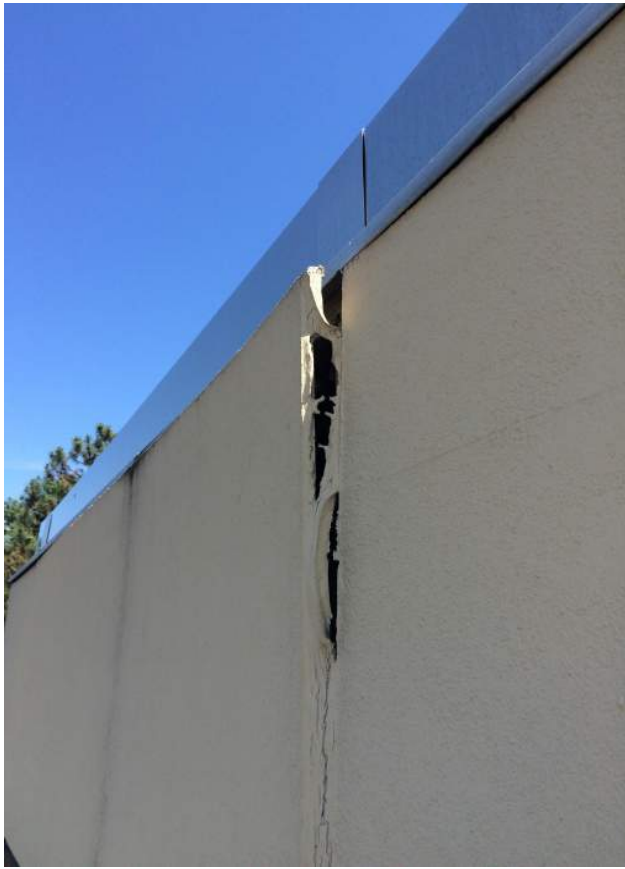
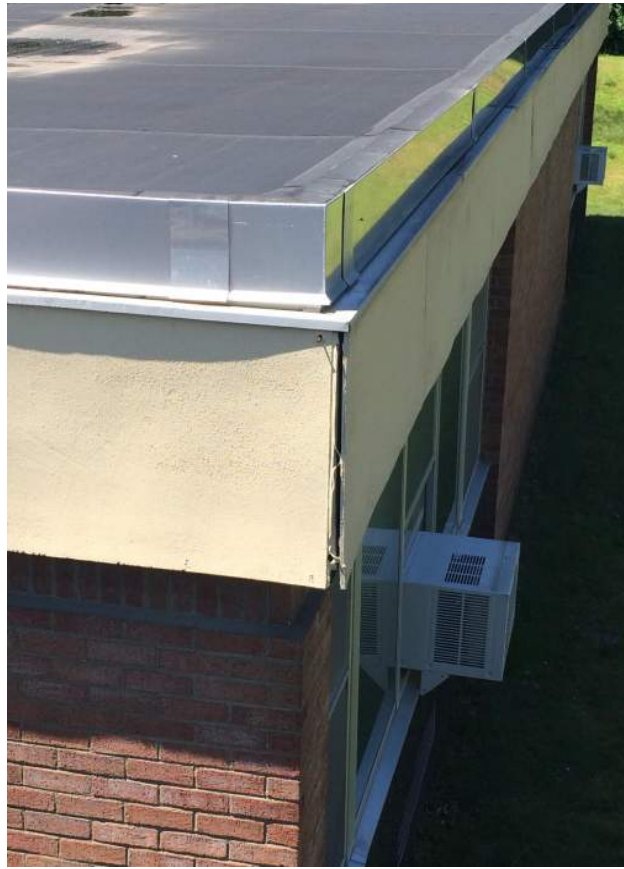
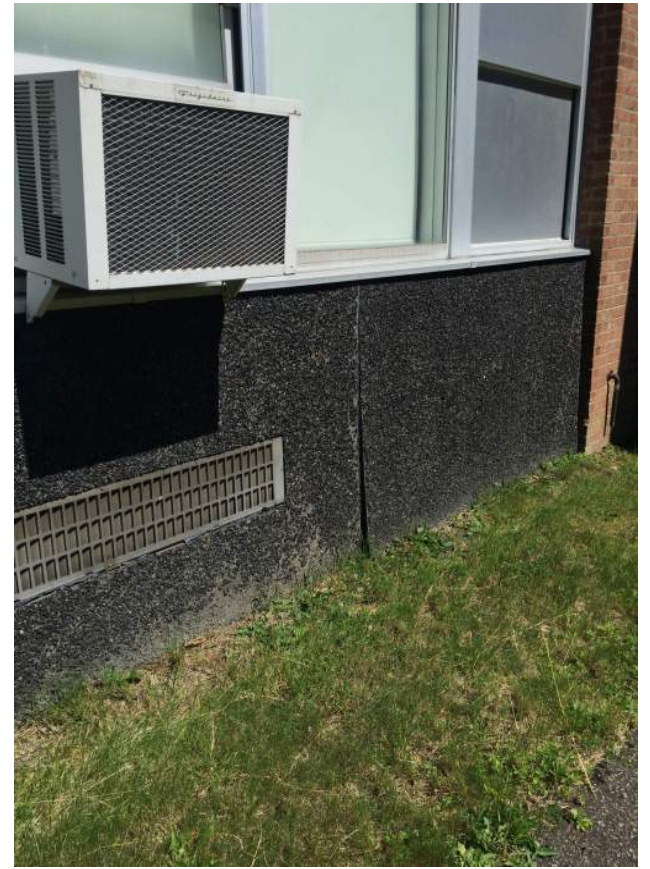
Repair/replace architectural band detail. Seal vertical joints at panels below window system. Repoint brick at various locations and clean masonry.

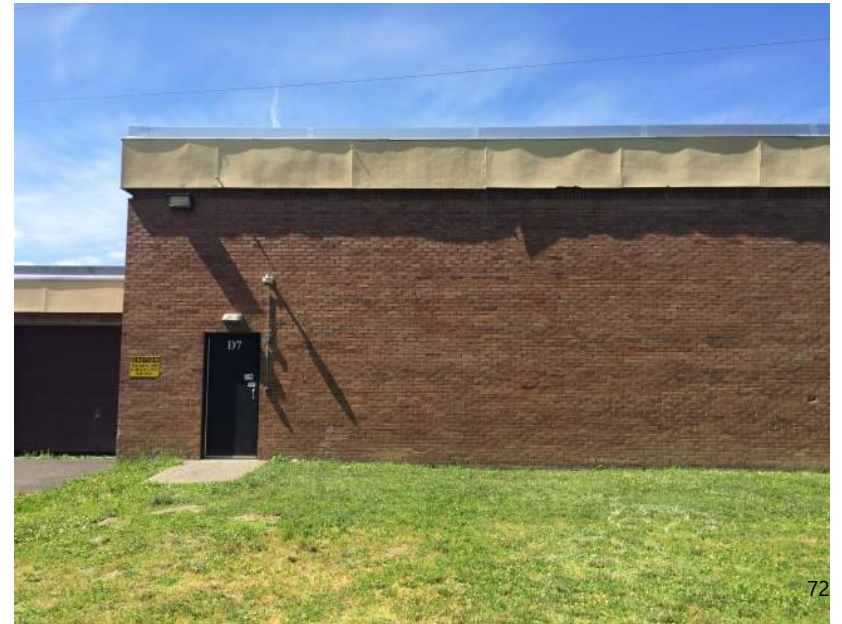
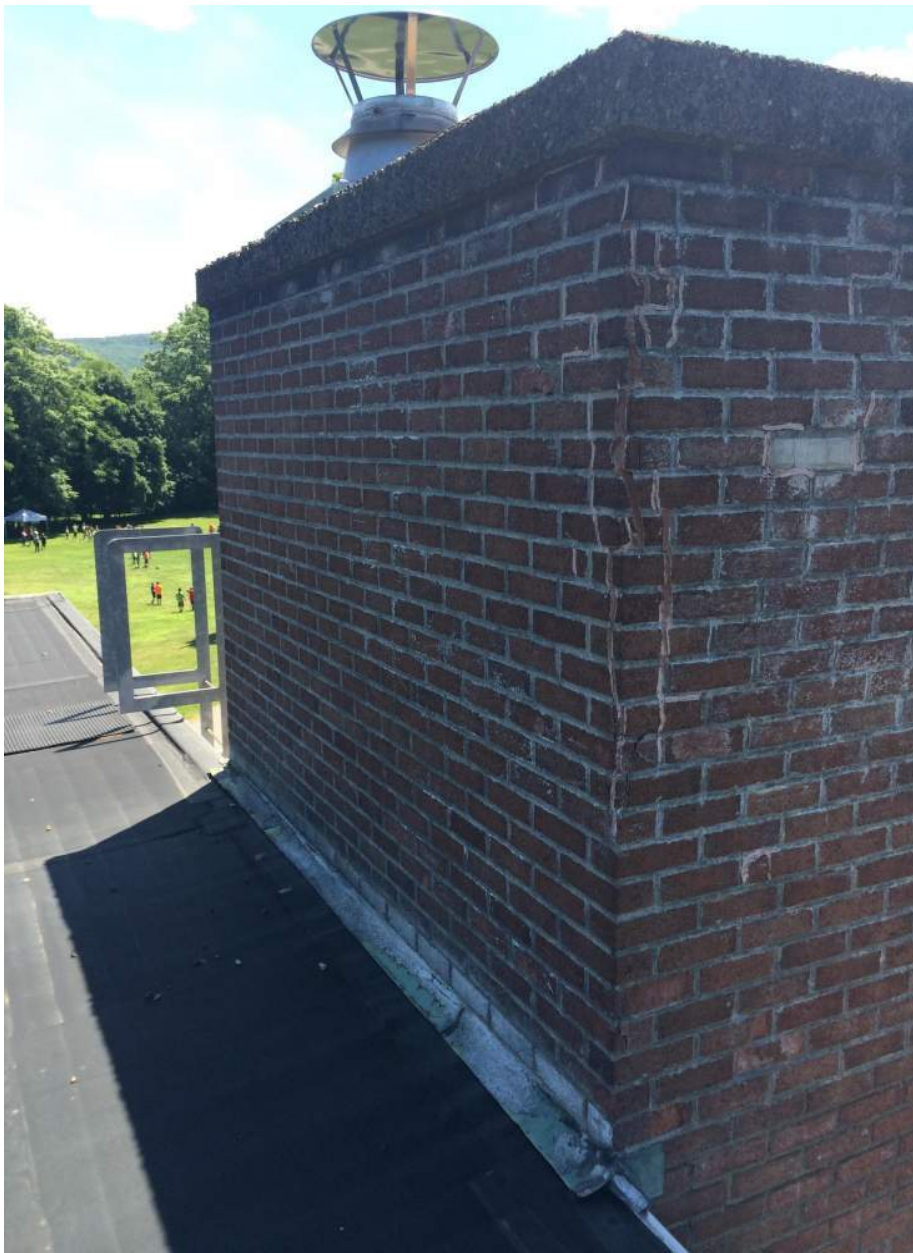
Repoint, repair, and clean masonry.

- Repoint / reconstruct unit masonry (brick) at the chimney above the roof.
- At the raised plaza, replace the handrail system, add guardrails to meet the current code requirement for elevation changes above 30".

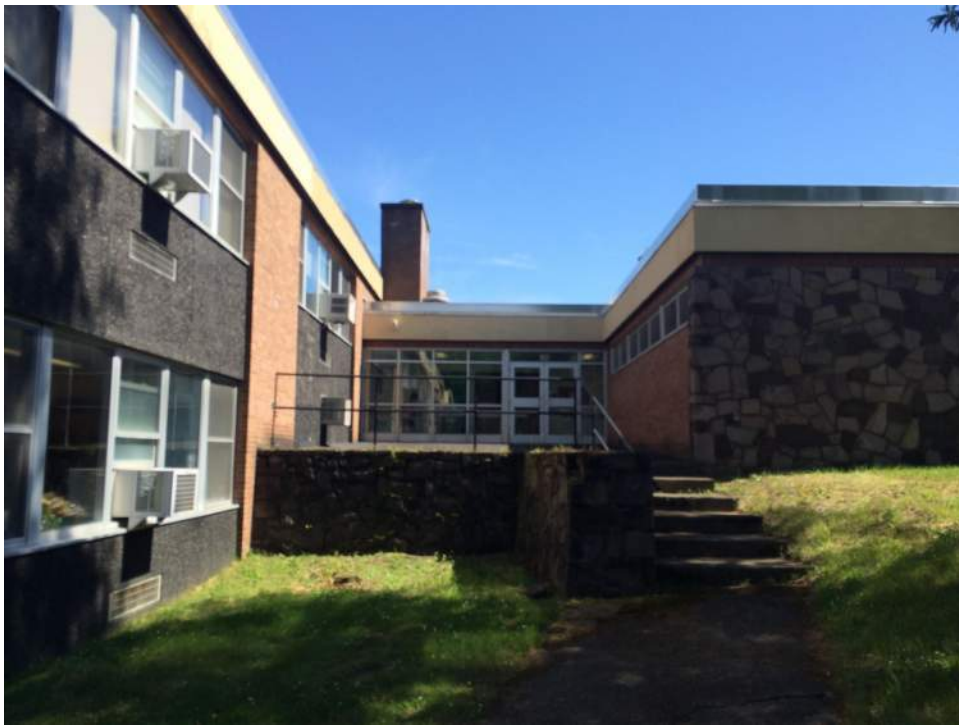
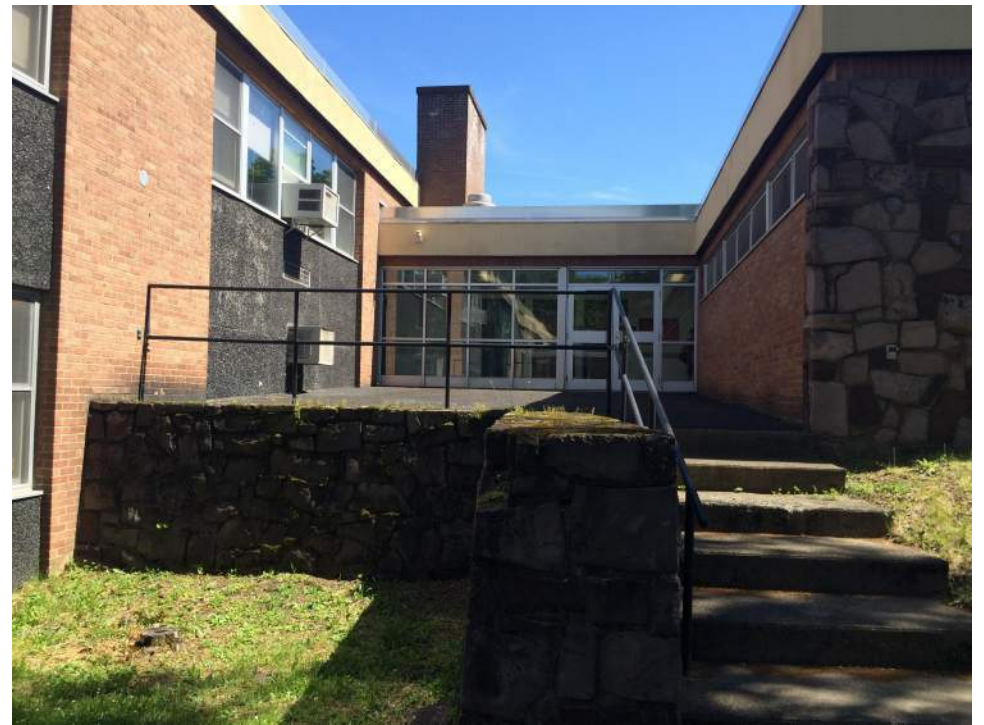
Category 70: Exterior Steps, Stairs, and Ramps
Replace courtyard handrail system. Existing system does not meet current code parameters.

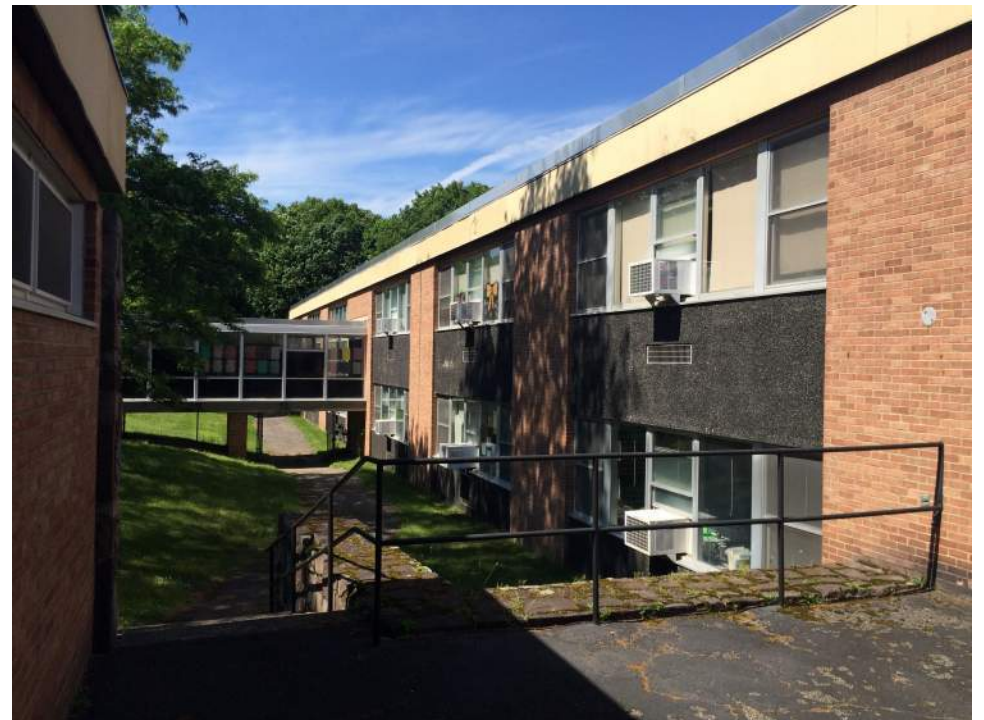
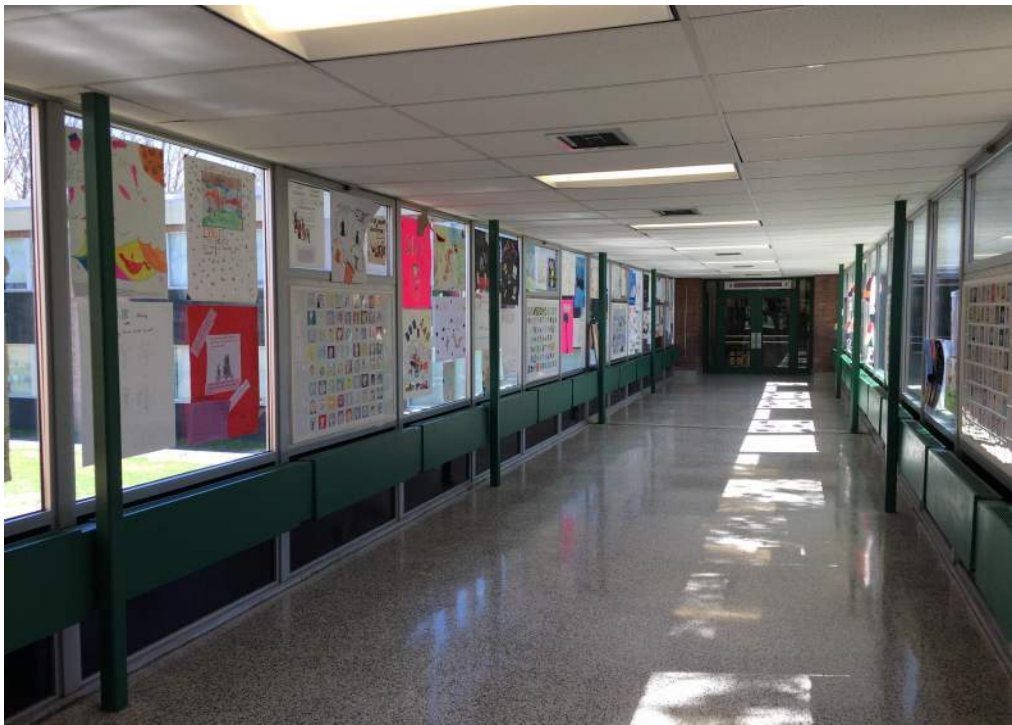
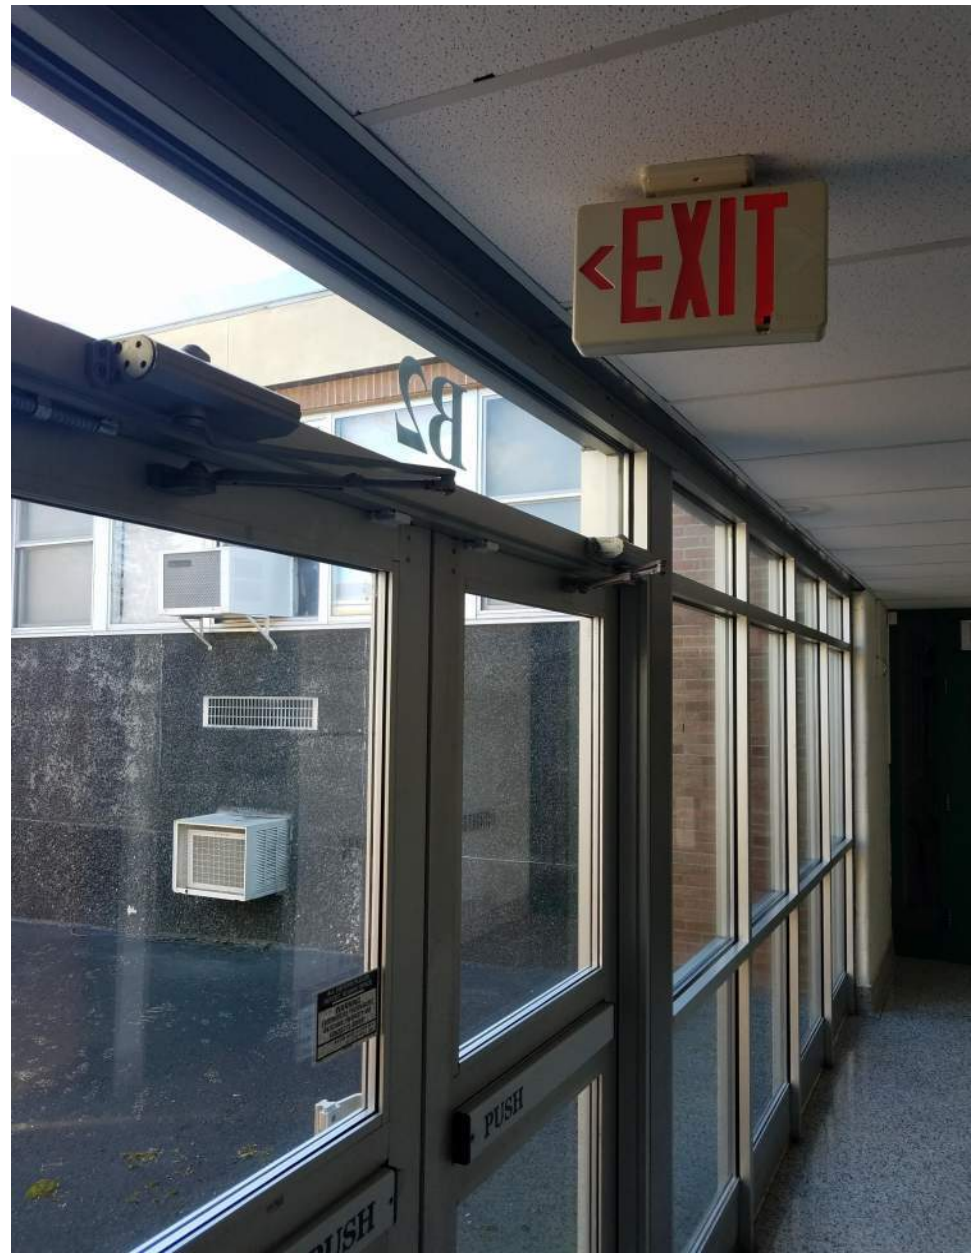
Replace building storefront system at corridor bridge and multi-purpose room.

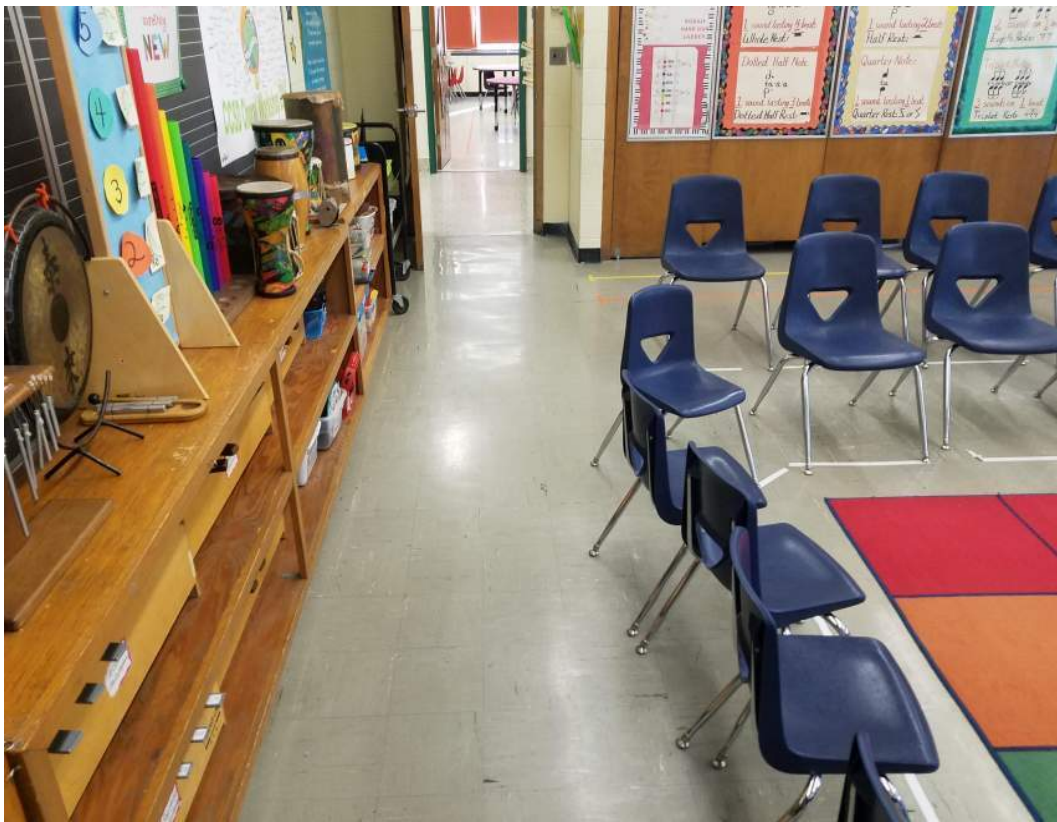
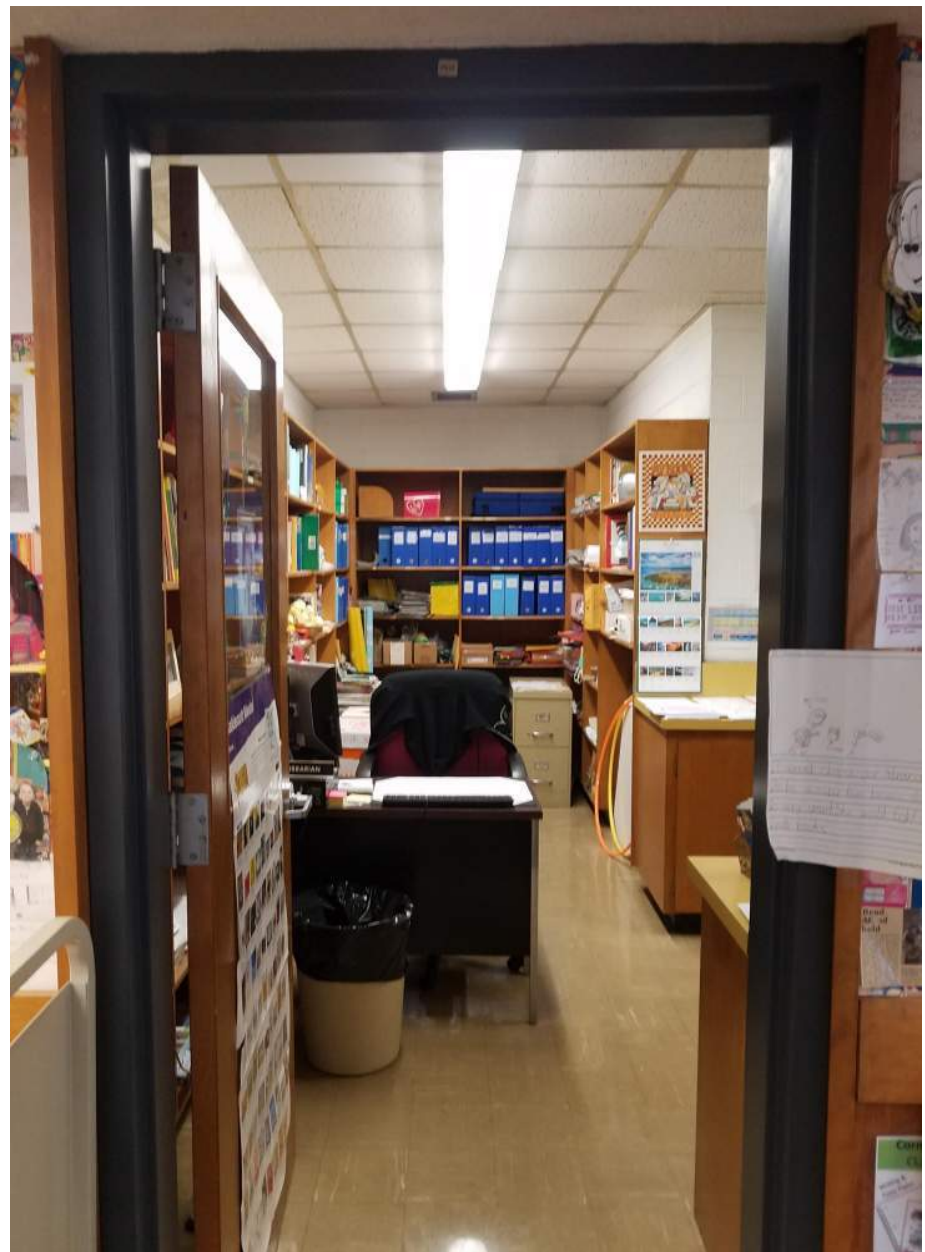
Category 77: Resilient Tiles or Sheet Flooring
Remove 9x9 floor tiles. Replace resilient flooring in 9 classrooms, the library work room, and storage.

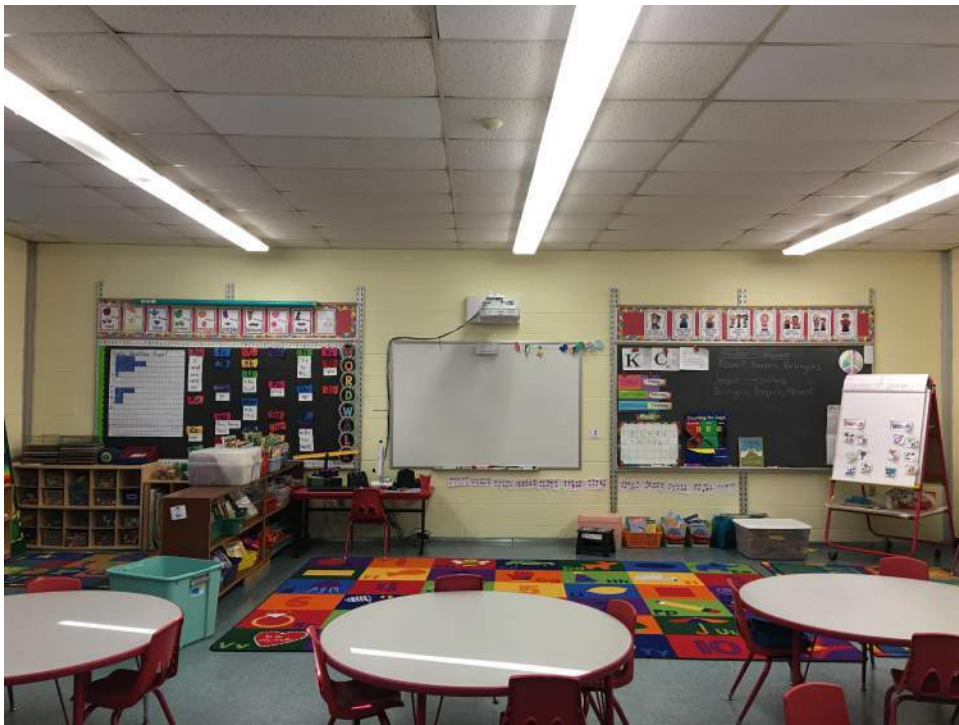
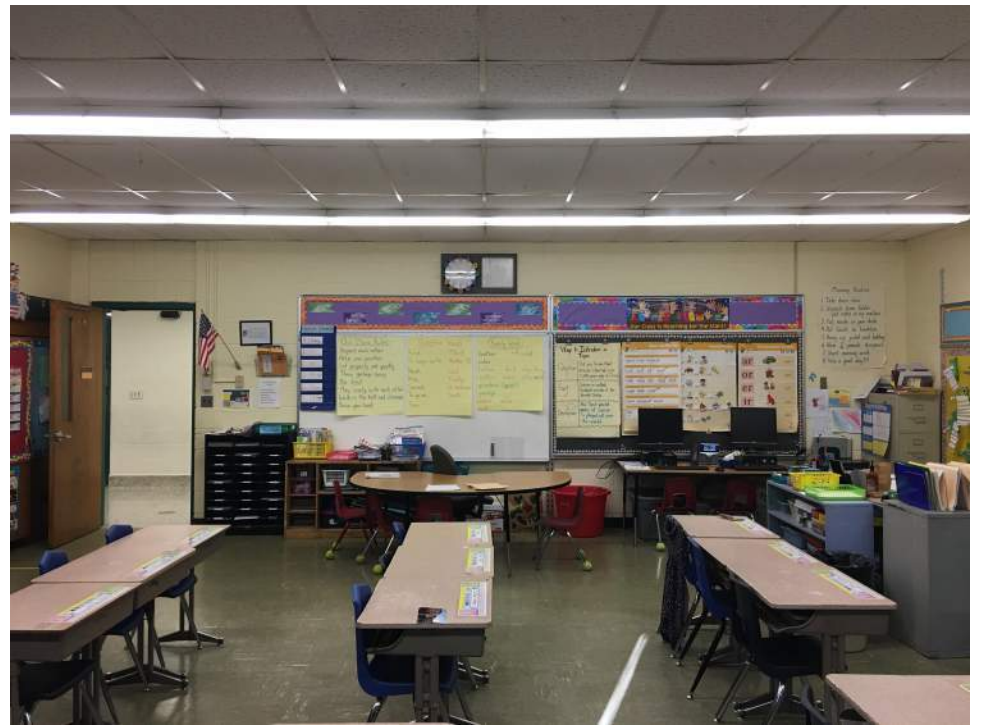
Category 80: Ceilings
Replace classroom ceilings in 40 classrooms and other instructional areas.

- Due to the poor system condition, replace the lay-in ceiling tiles in forty (40) classrooms and other instructional spaces, the corridor ceilings are in good condition. Staining observed in the Library.
- Replace classroom interior doors and hardware, including closet bi-fold door systems; doors and frames are not rated as required by authority having jurisdiction, the classroom doors are considered an integral component to the fire-rated assembly between the corridor system and classrooms.
- For the classrooms, replace all casework, counters, and surrounding cabinetry due to the poor condition of the units, including, the sinks, fixtures, and associated plumbing.
- Renovate the toilet rooms throughout the building, including the upper, lower floor, toilet serving the Gymnasium, Staff and Nursing Suite and enlarge the Kindergarten toilet to include ADA requirements.
