**2020 BUILDING
CONDITION SURVEY
REPORT**

CORNWALL CENTRAL
SCHOOL DISTRICT

Elementary School
(Lee Road)

CSArch Project #204-1901

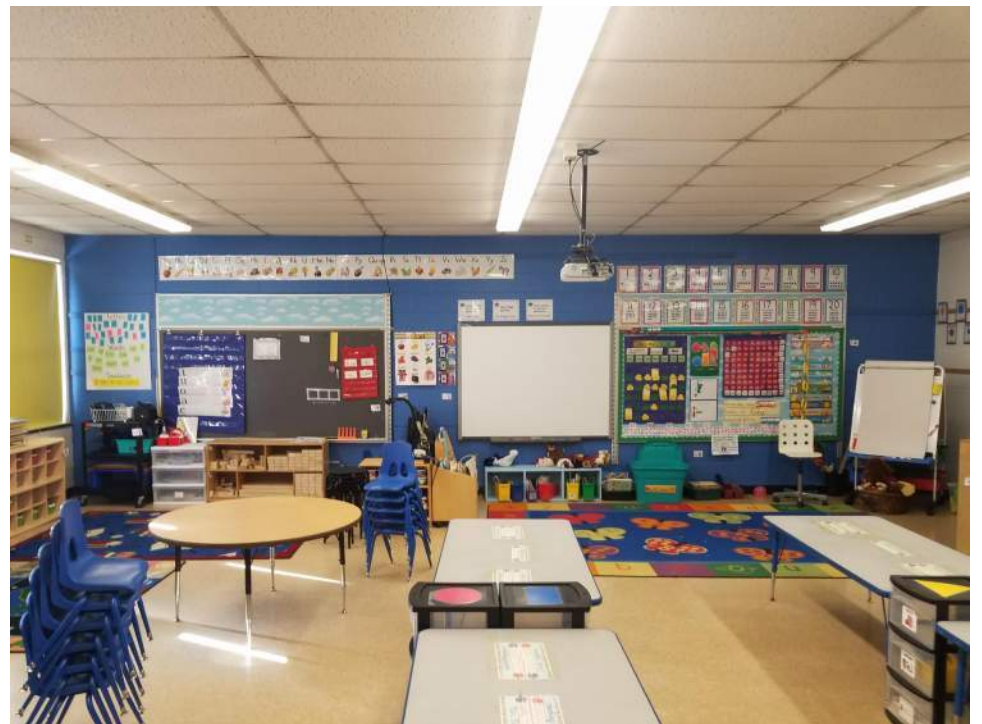
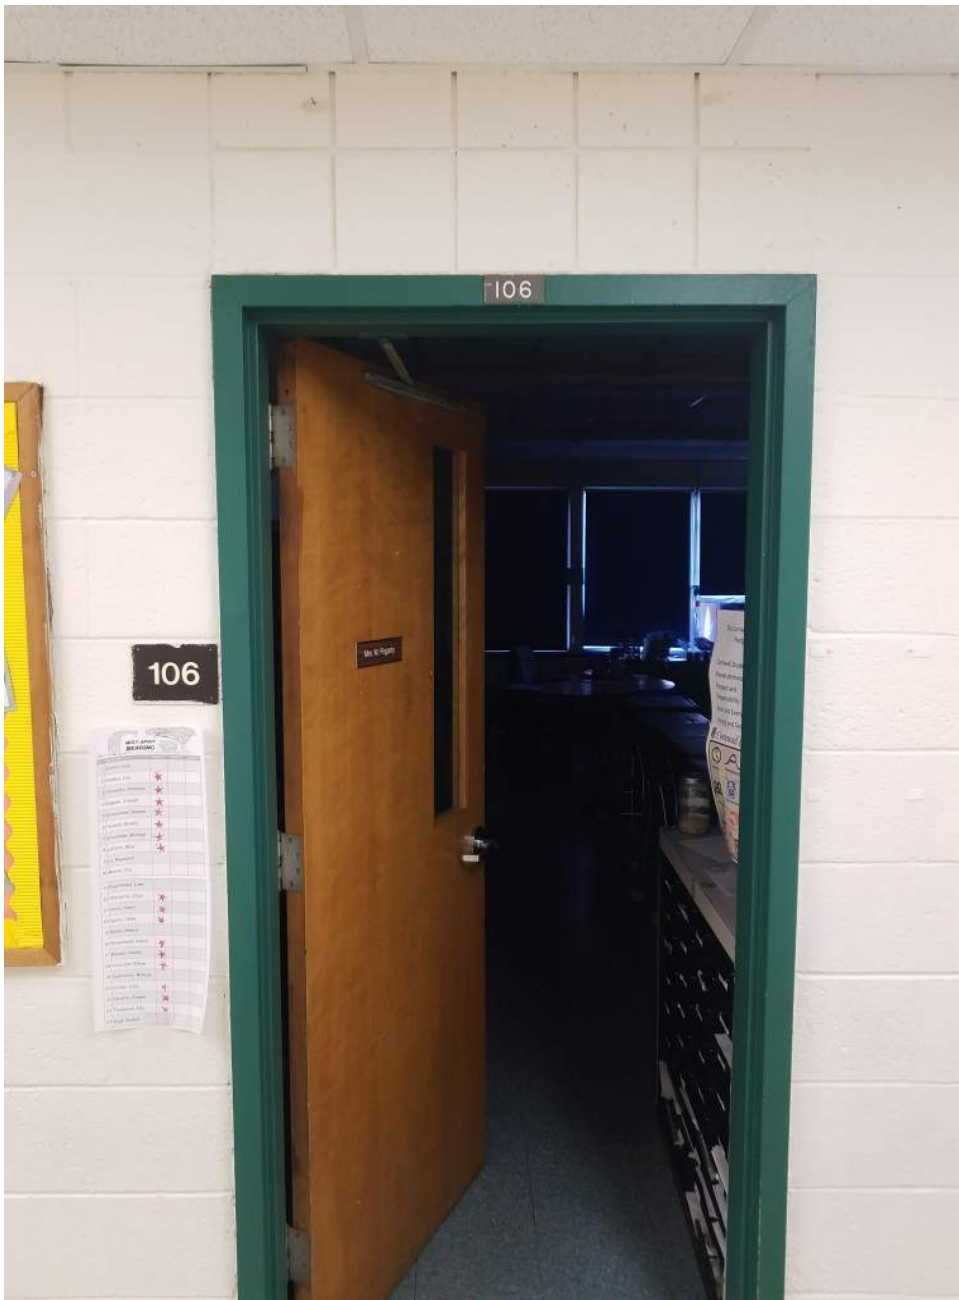
Replace interior doors and hardware, including bi-fold door systems. Existing doors and frames are not rated as required.

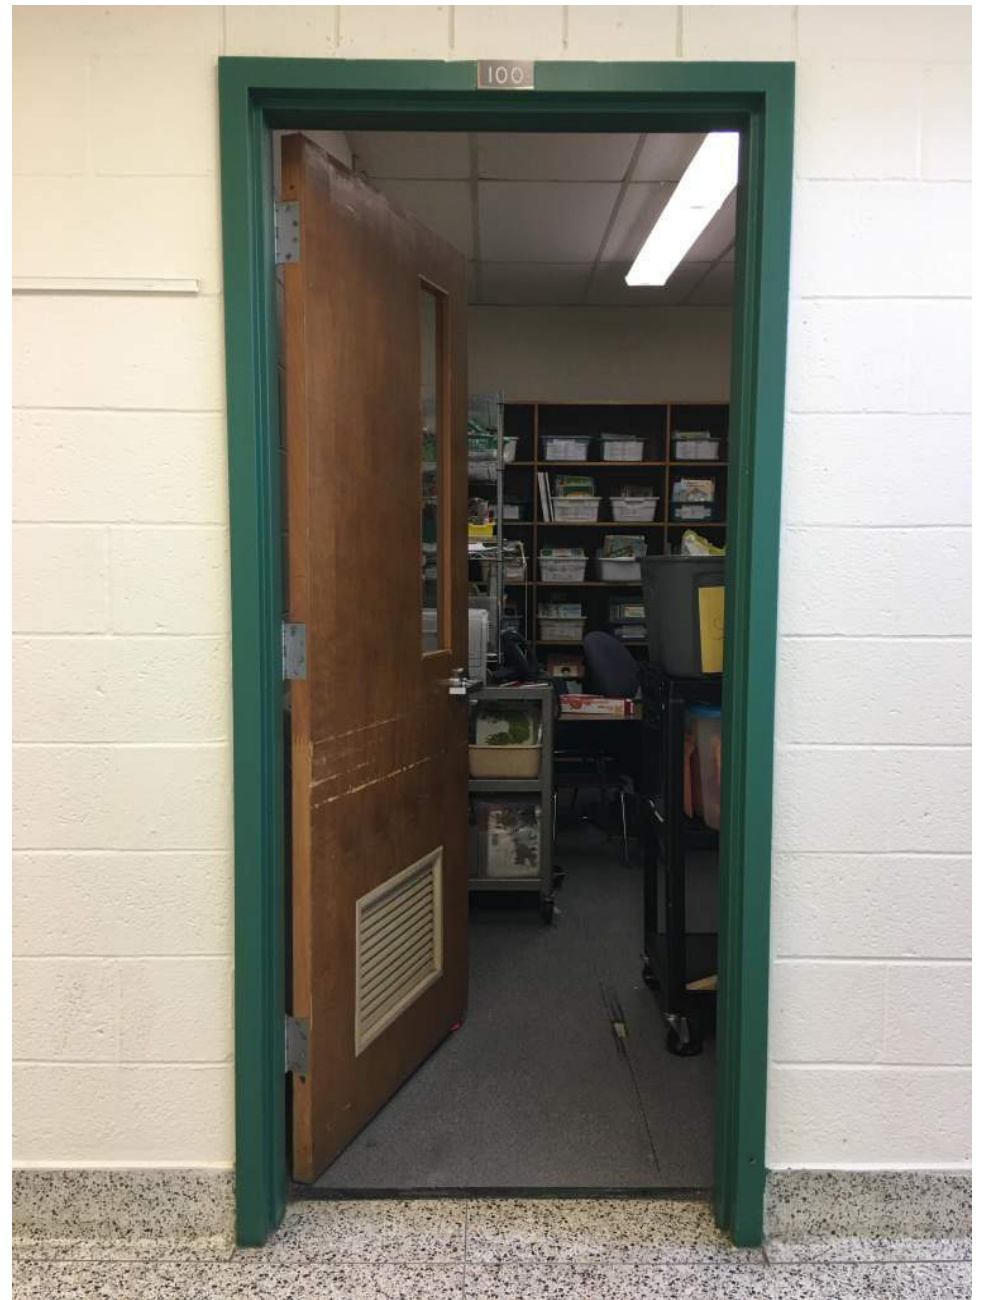
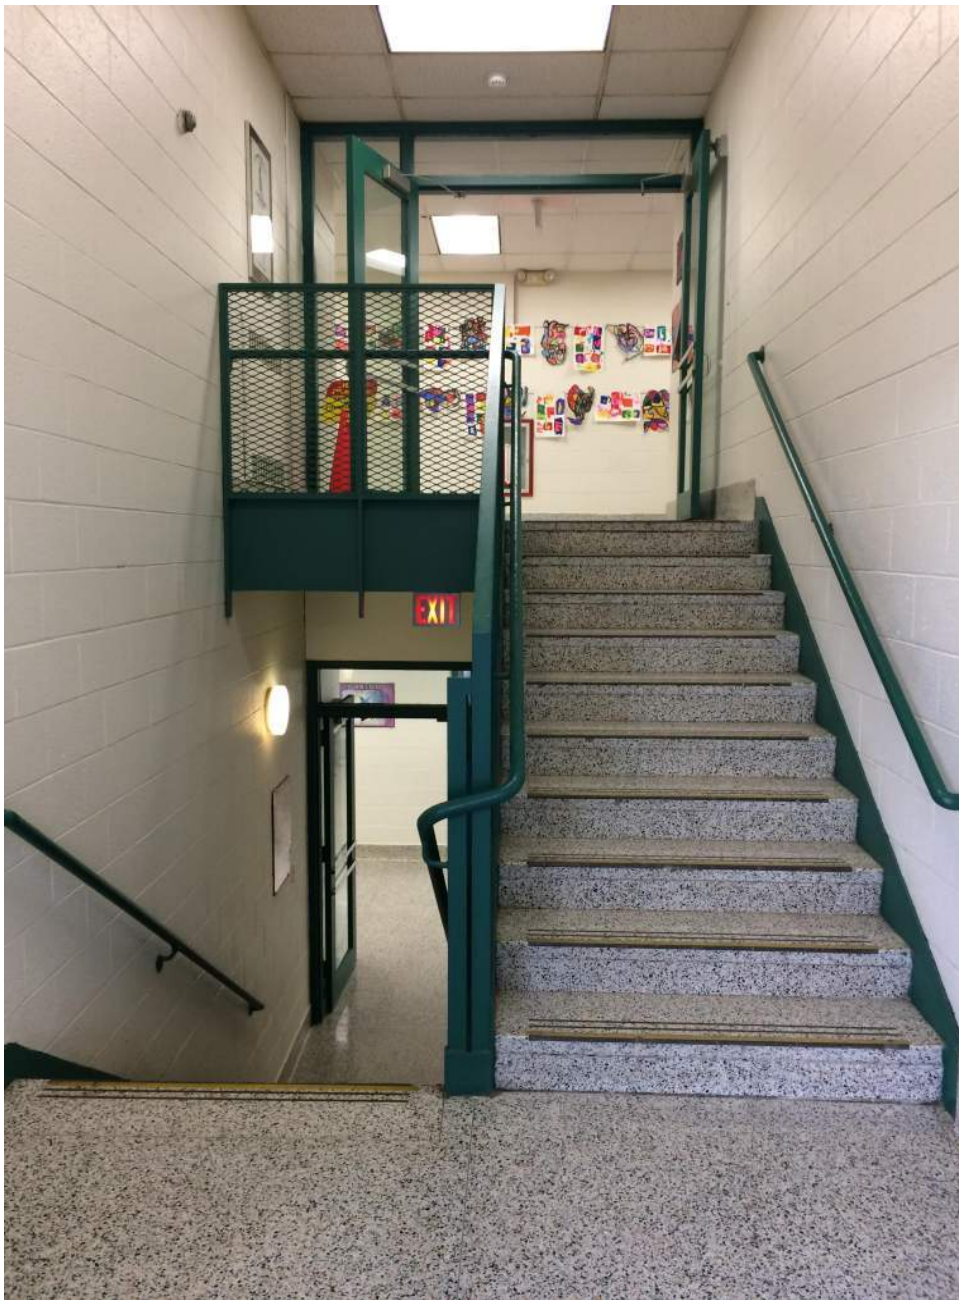
Category 83: Interior Stairs
Handrails are not ADA compliant. No handrail extensions observed.

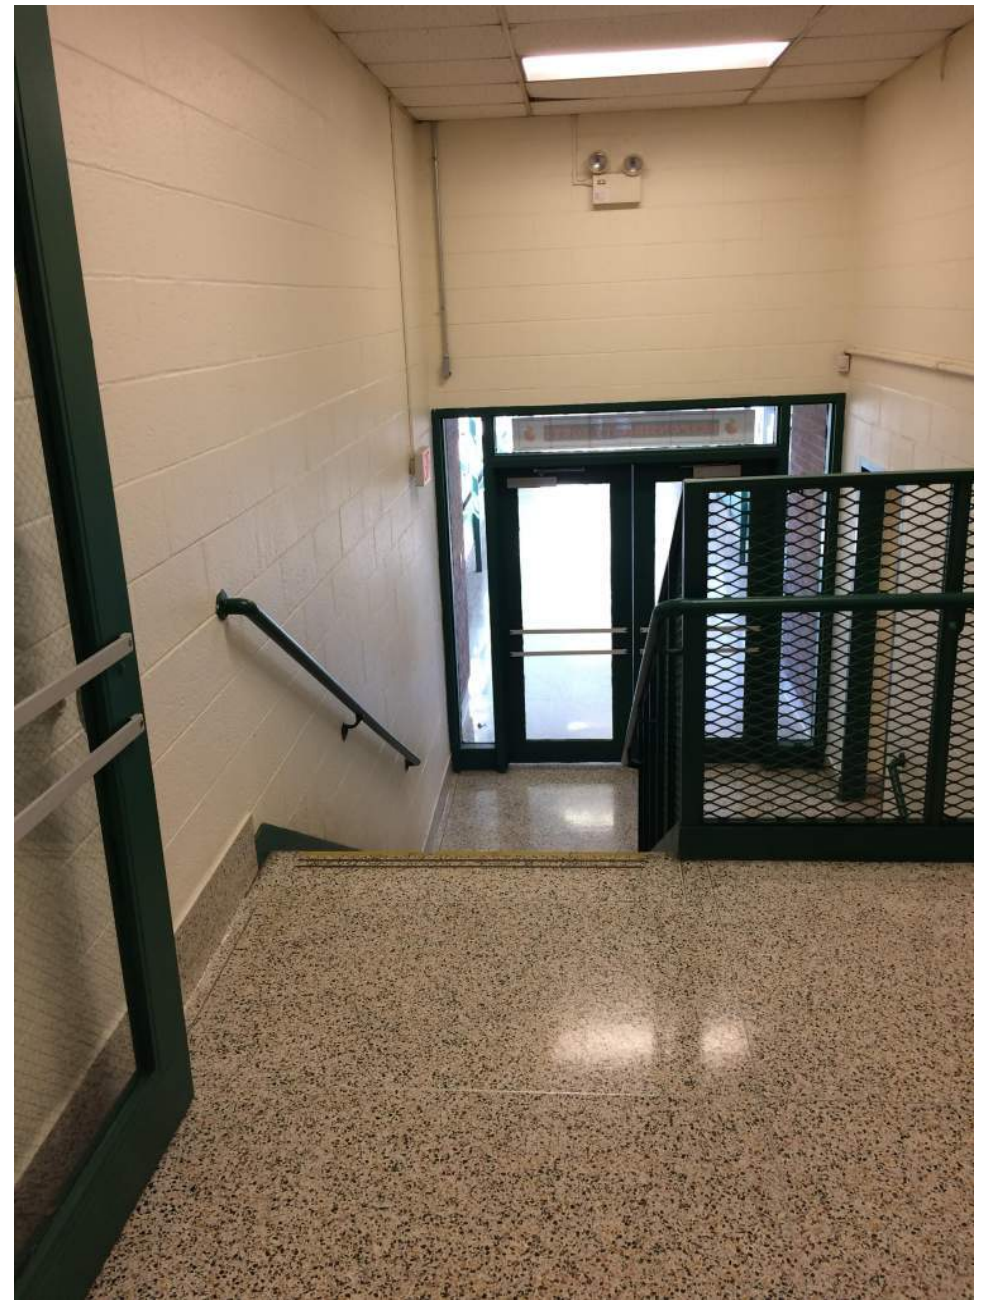
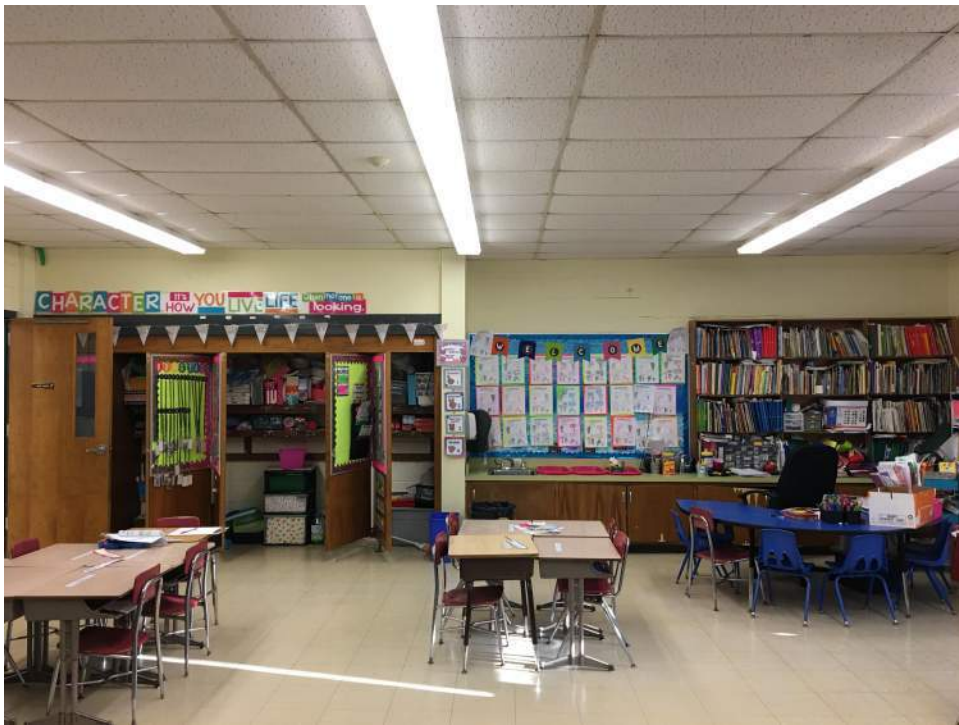
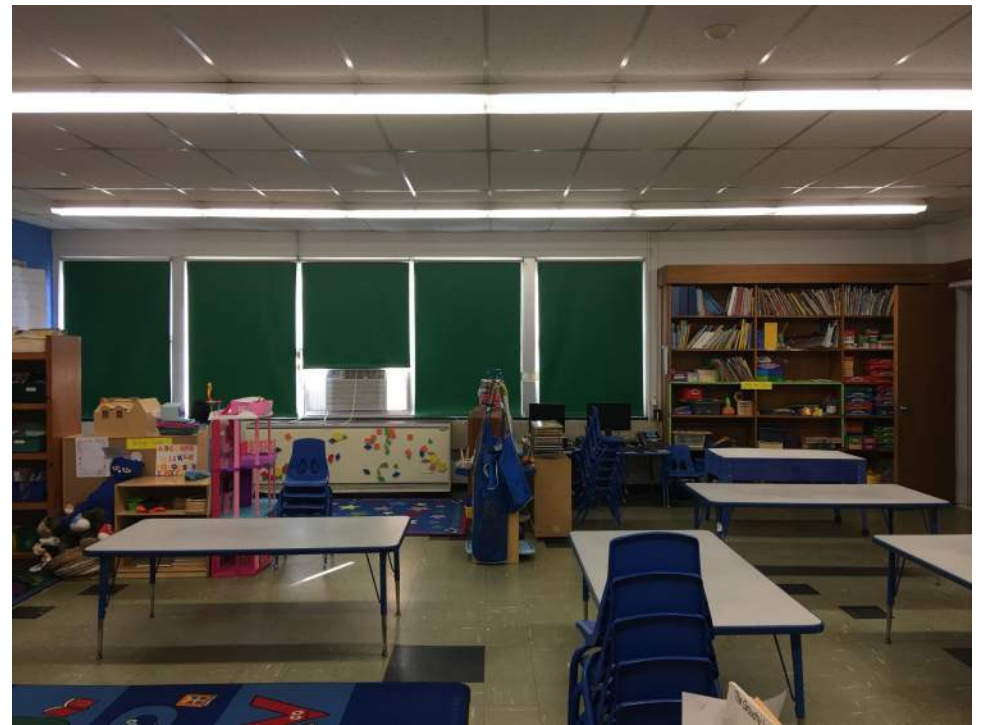
Replace lighting in classrooms throughout building and associated controls.

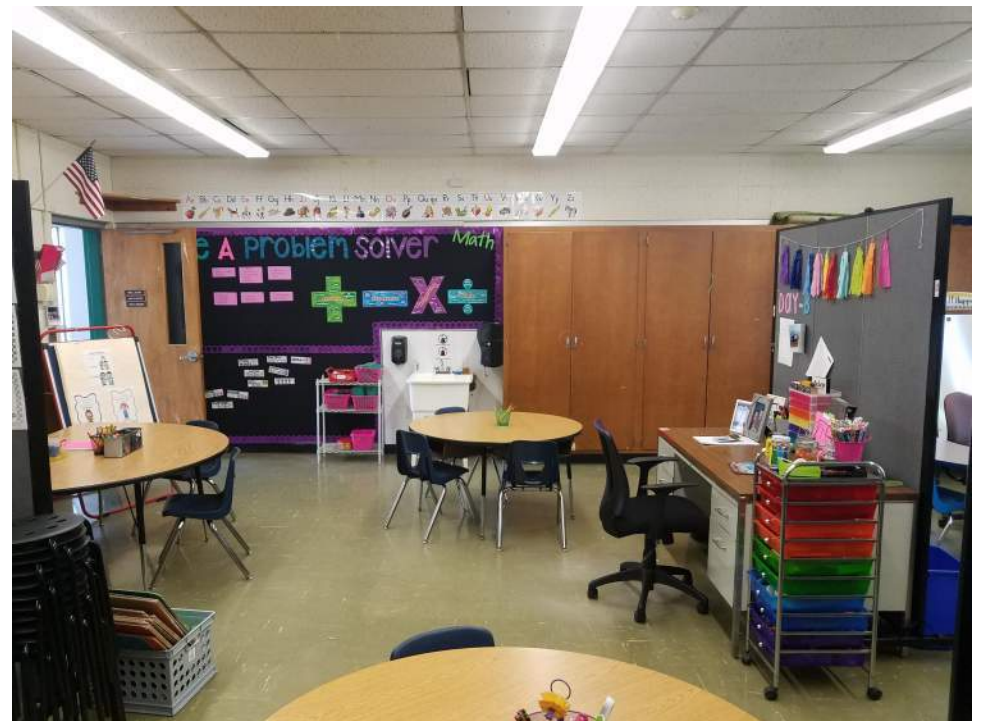
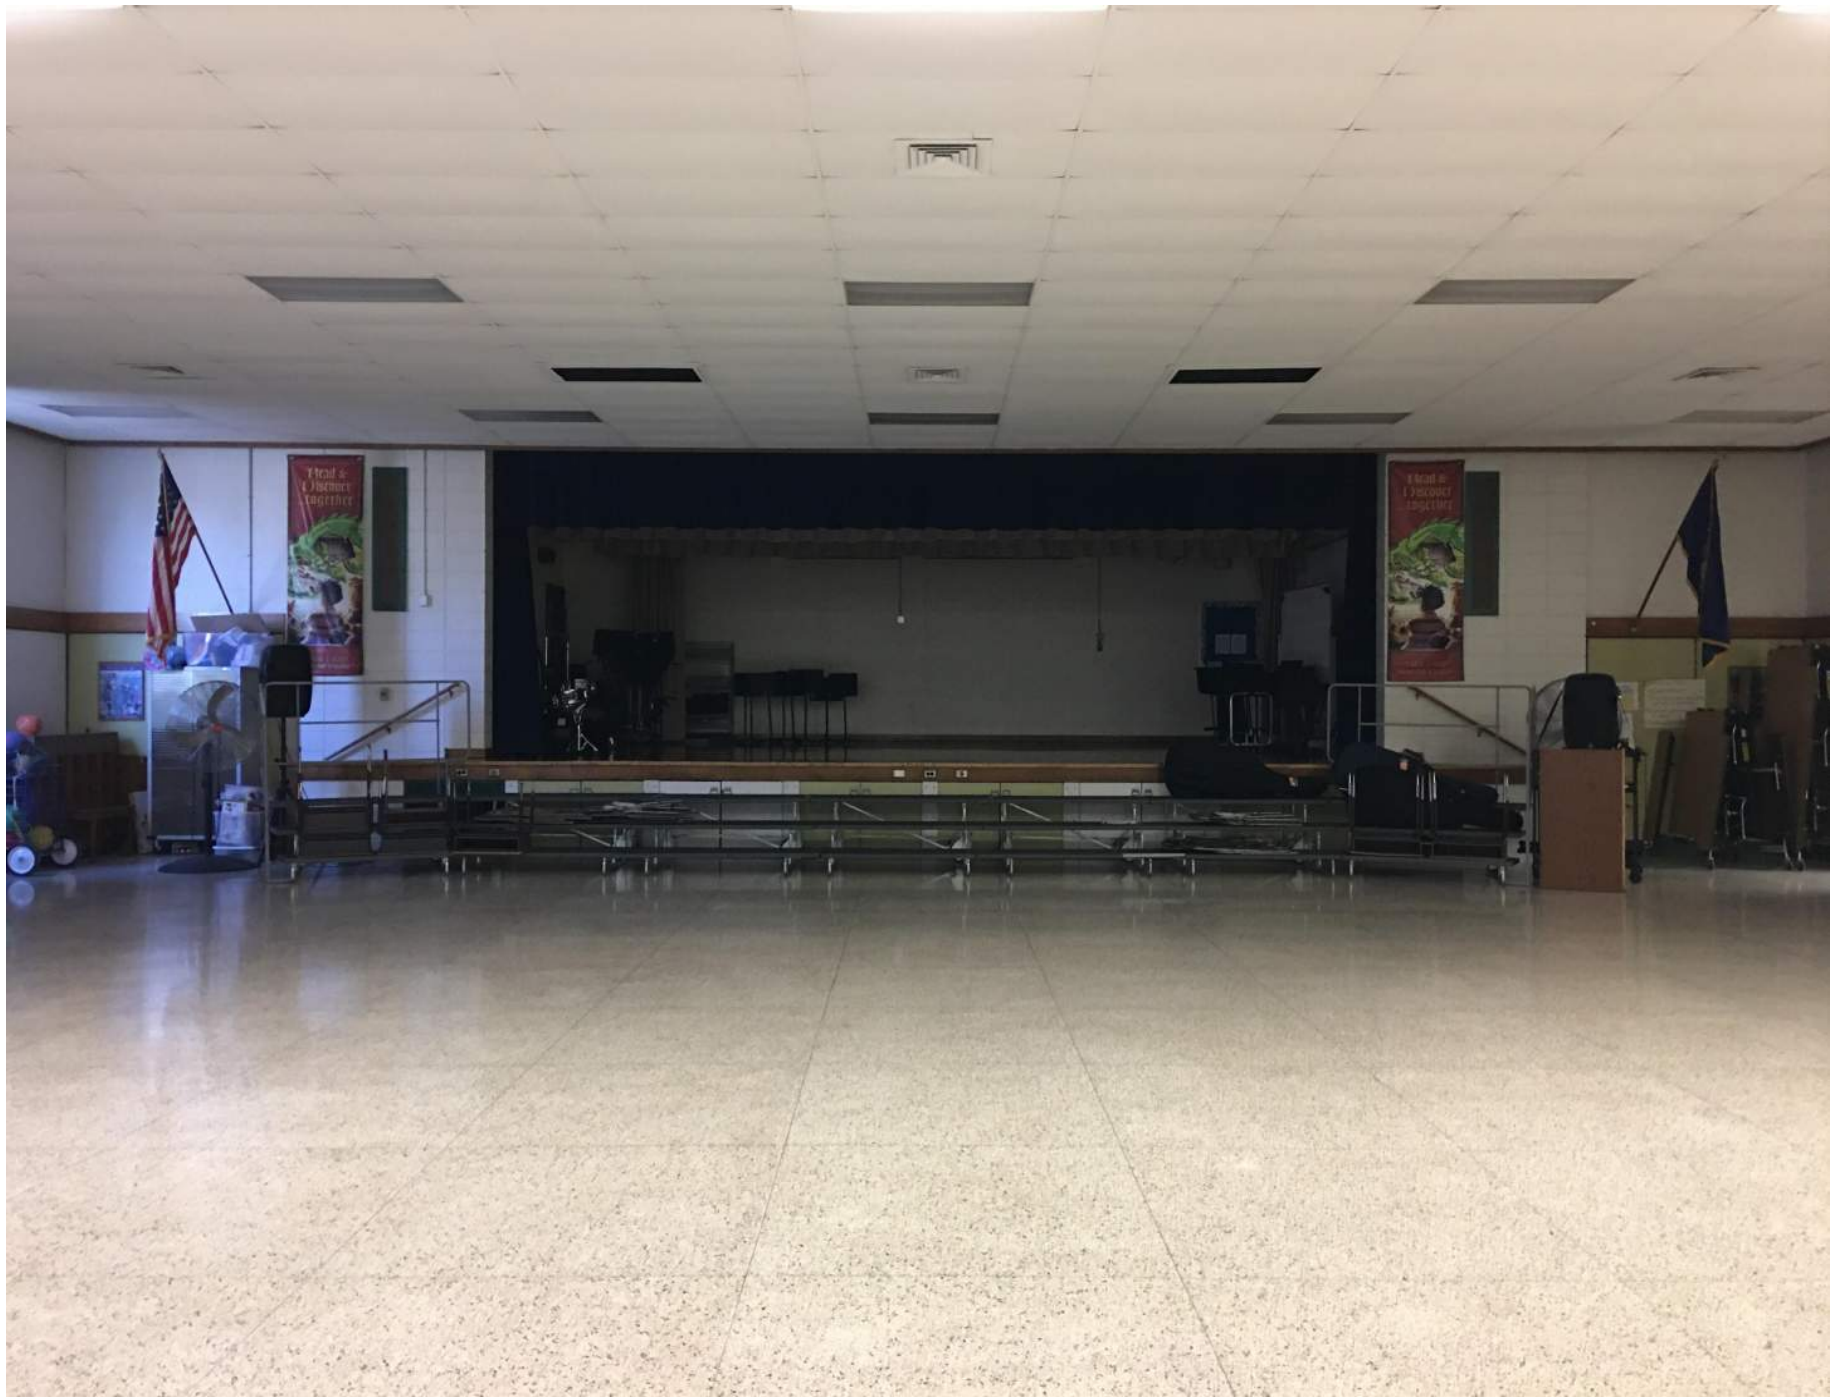
Category 115 & 116: Int. Accessible Route, Access to Goods and Services, and Restroom Facilities
Cafetorium stage is not accessible. Consider installing a lift.

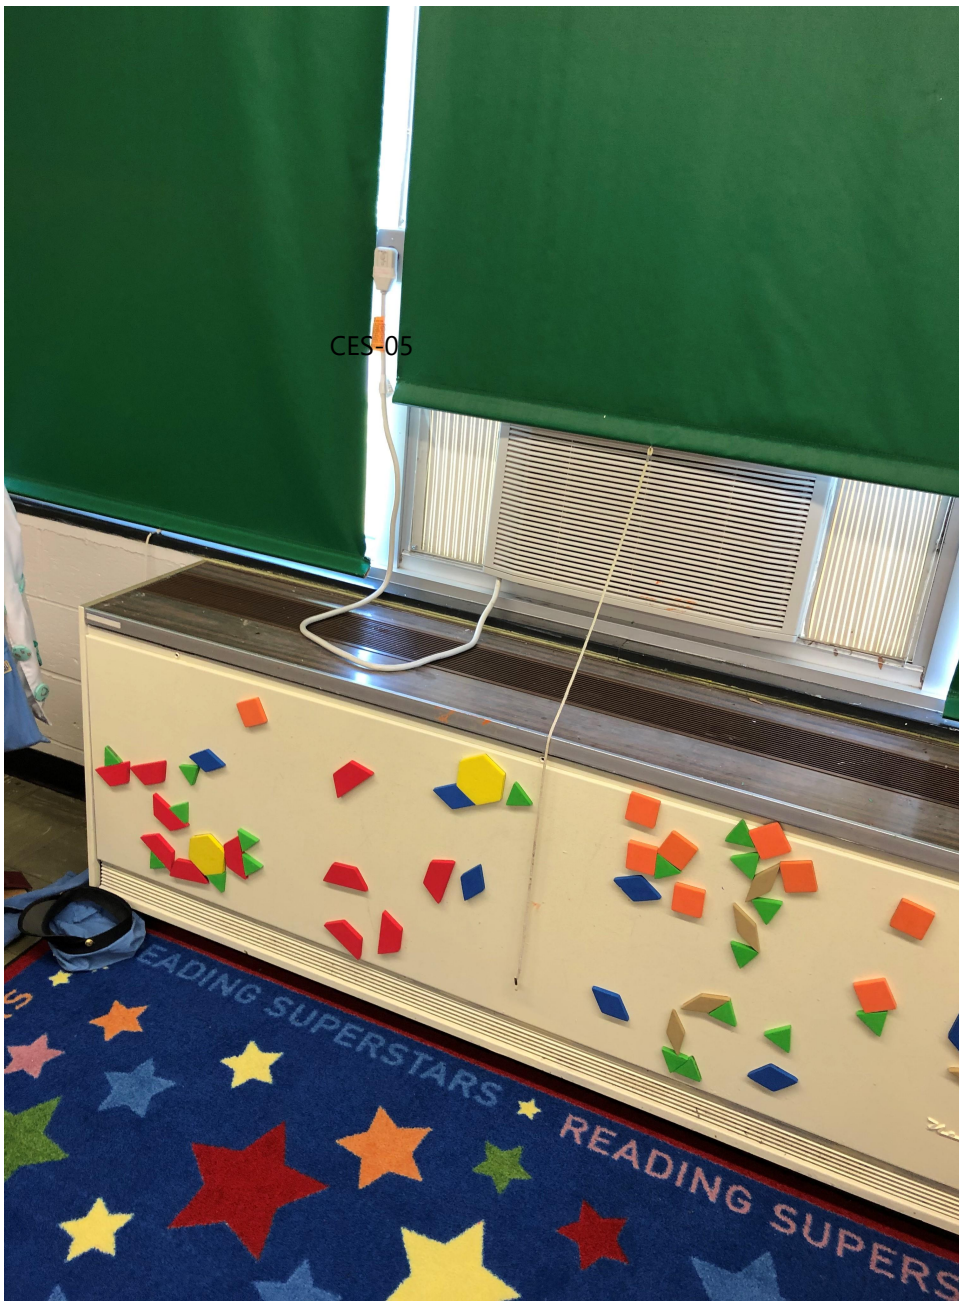
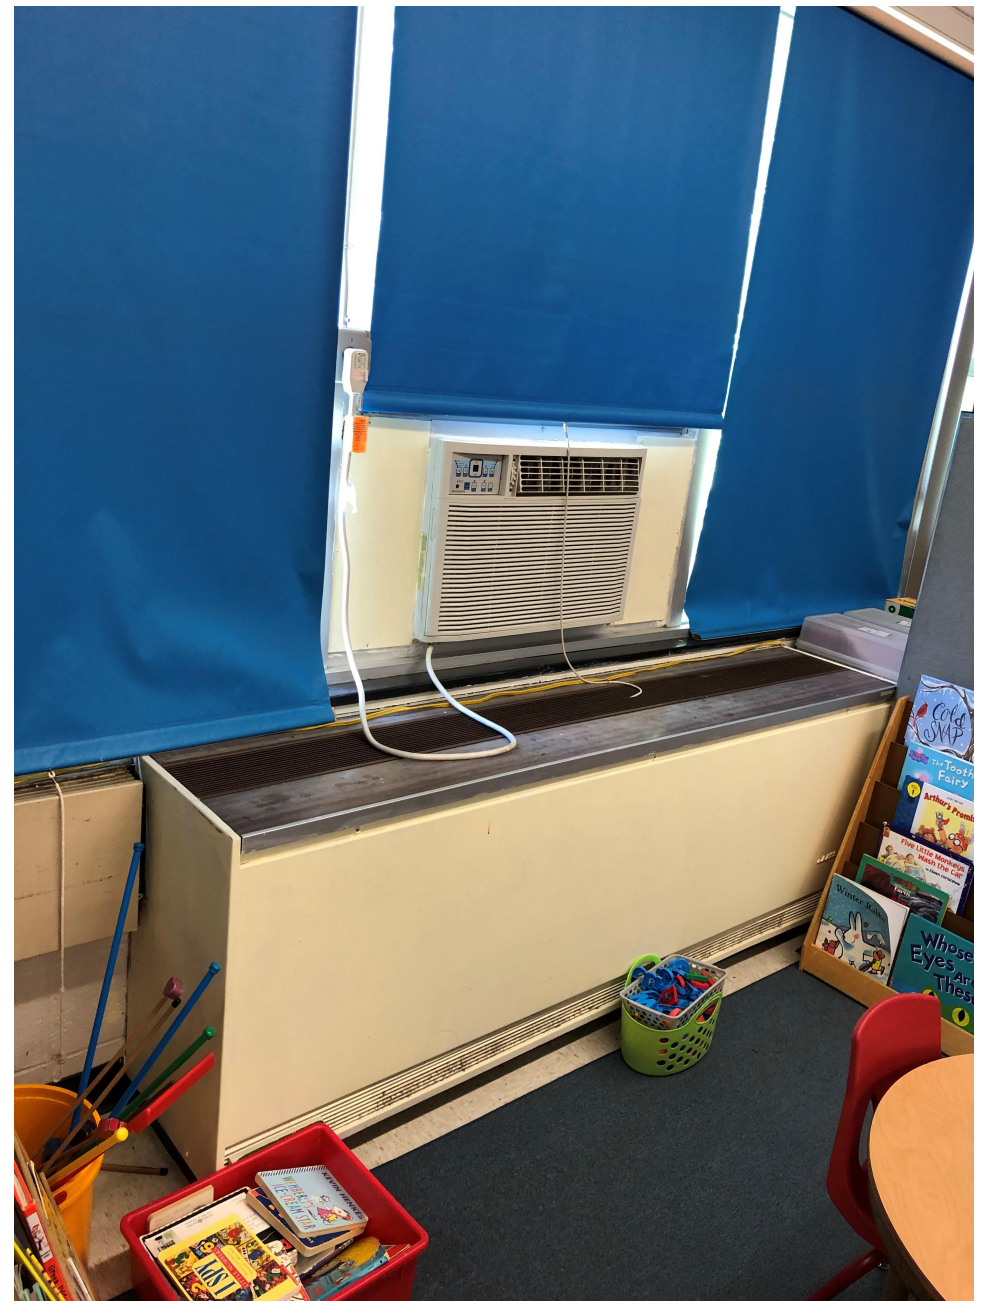
The unit ventilators do not provide enough heating in the three (3) Kindergarten classrooms.

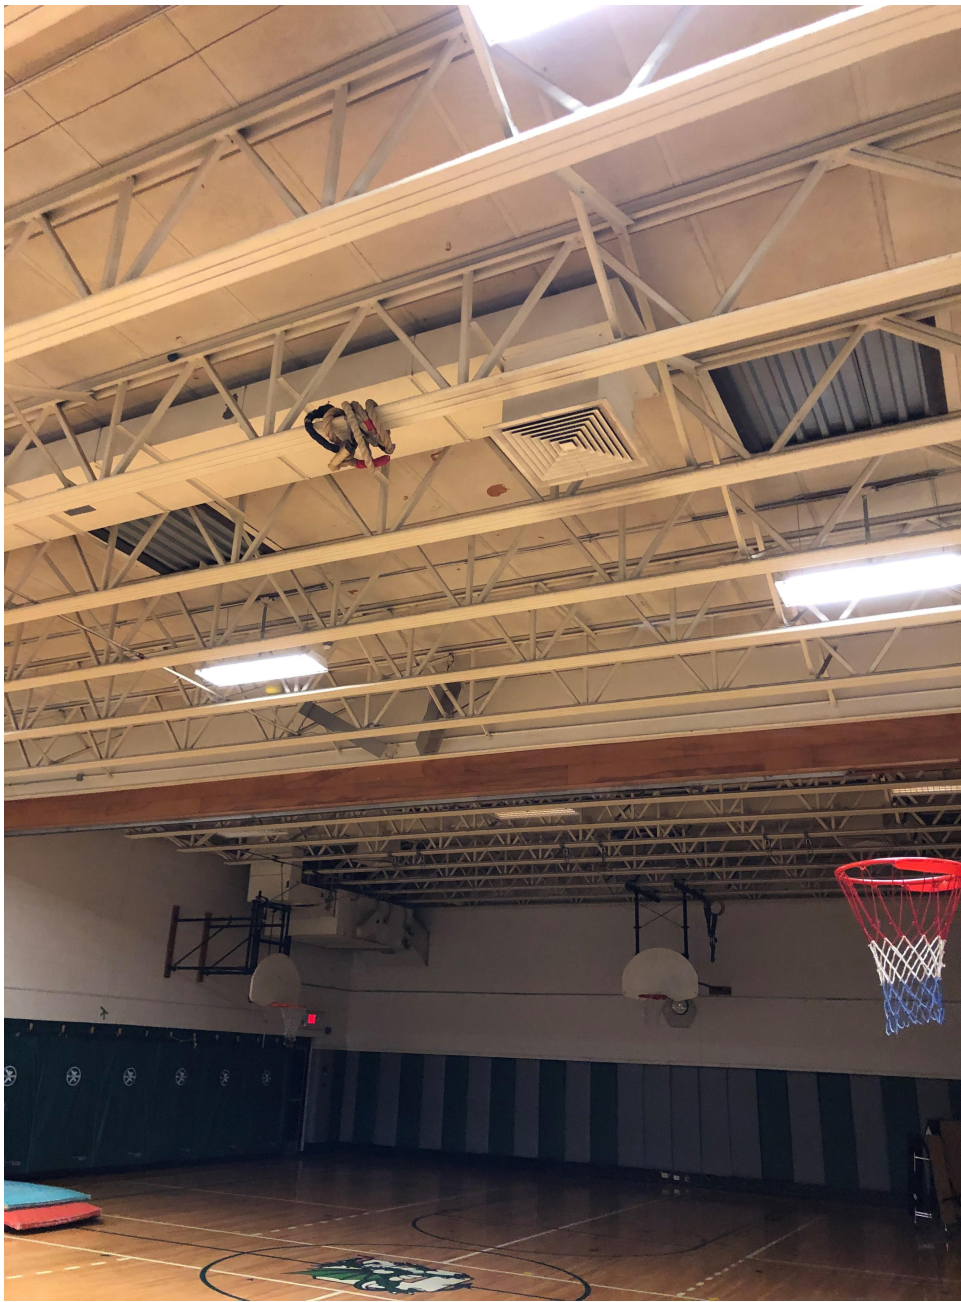
CES-43

Category 89: Mechanical Cooling / Air-Conditioning Systems
Install exhaust system for the gymnasium.

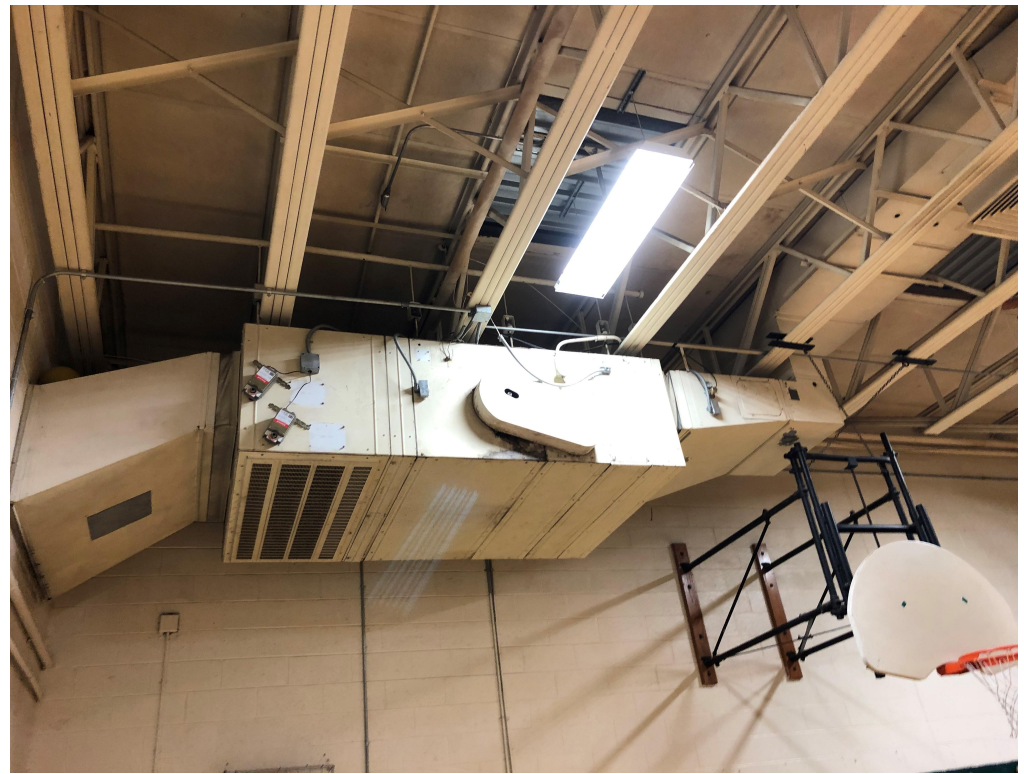
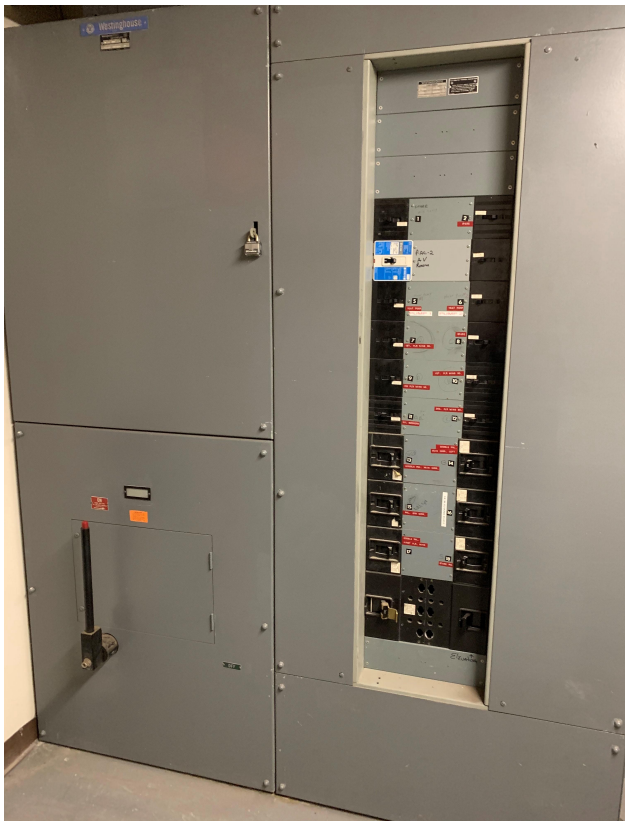
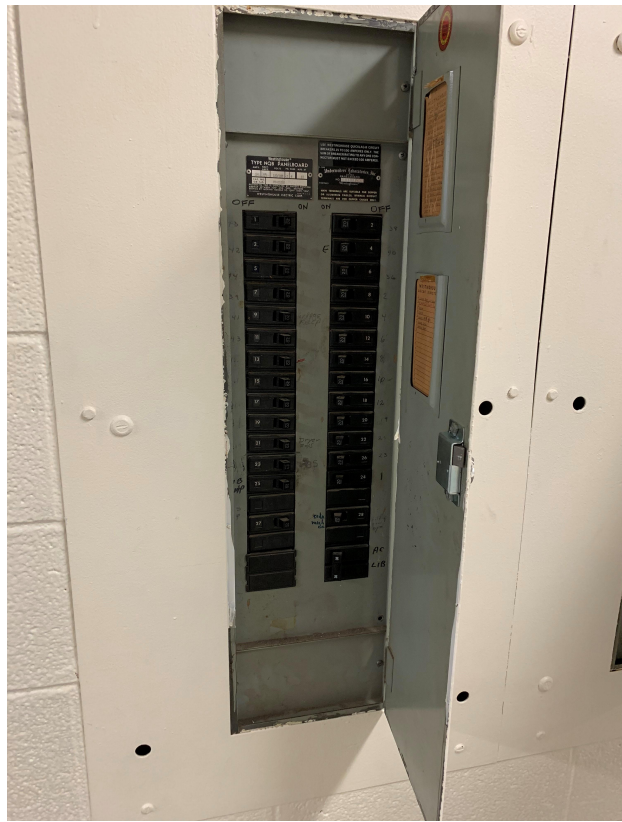
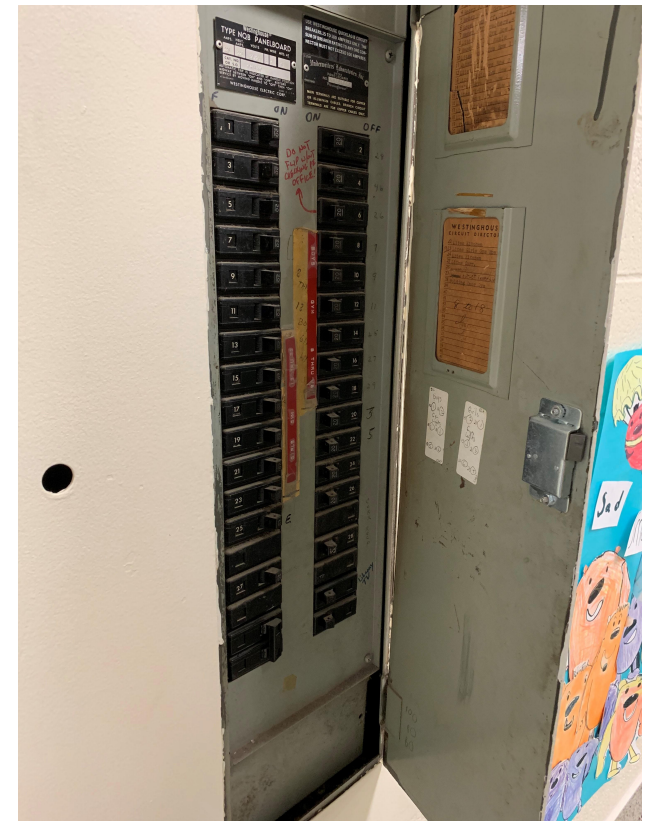
The existing main power distribution switchboard requires maintenance: Cleaning, exercise/lubrication of existing switches and circuit breakers, tightening of all internal connections and a complete thermal imaging scan. An existing service cable pullbox was found to be severely corroded and requires replacement.

Existing switchboard assembly in good condition but approaching end of useful service life. Severely corroded existing cable pull box requires replacement. Existing panel boards are 53 years old and past their useful service life.

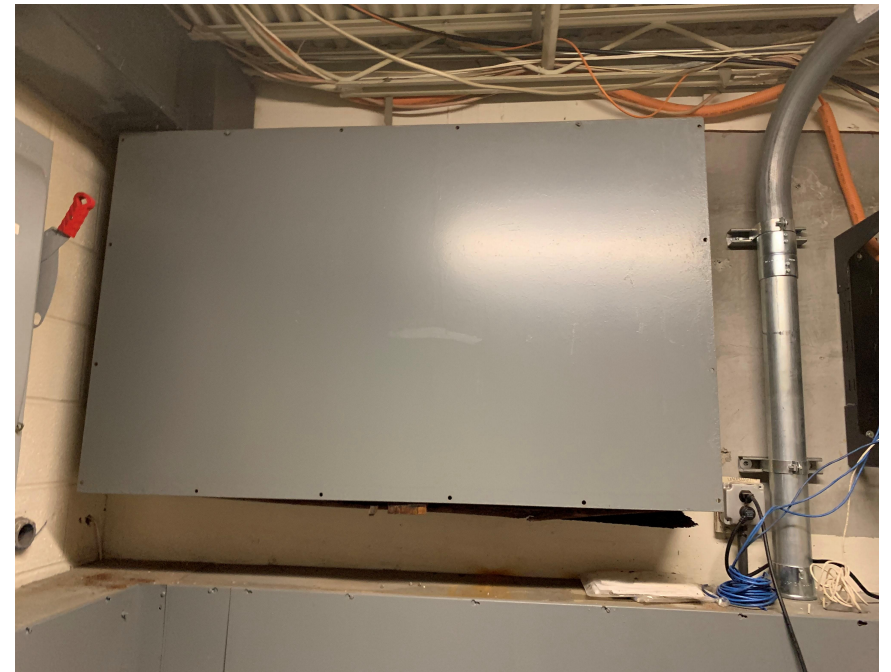
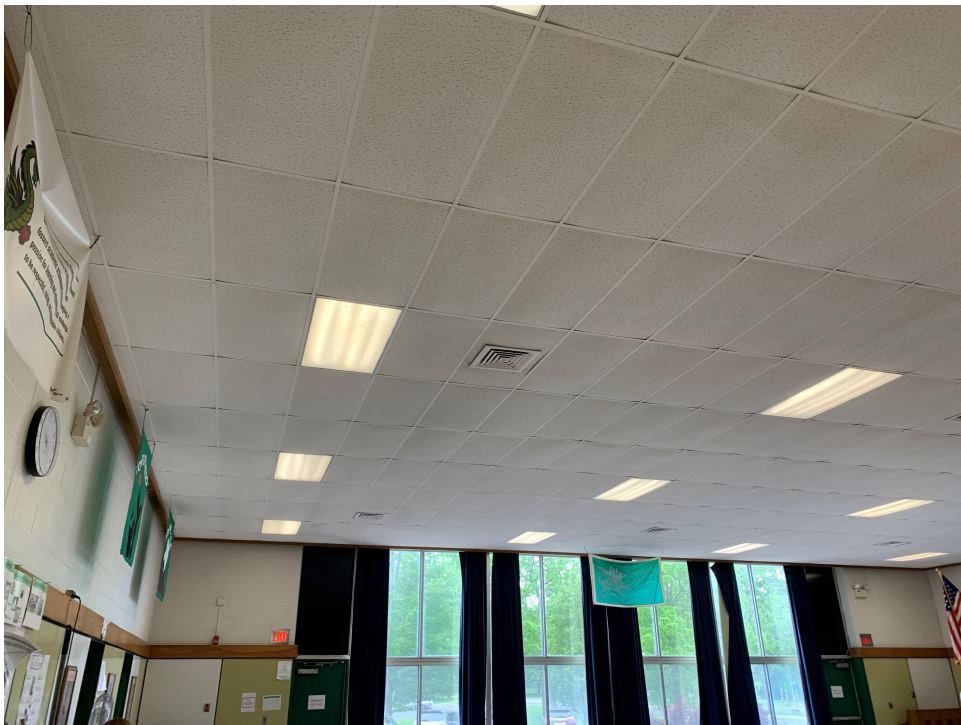
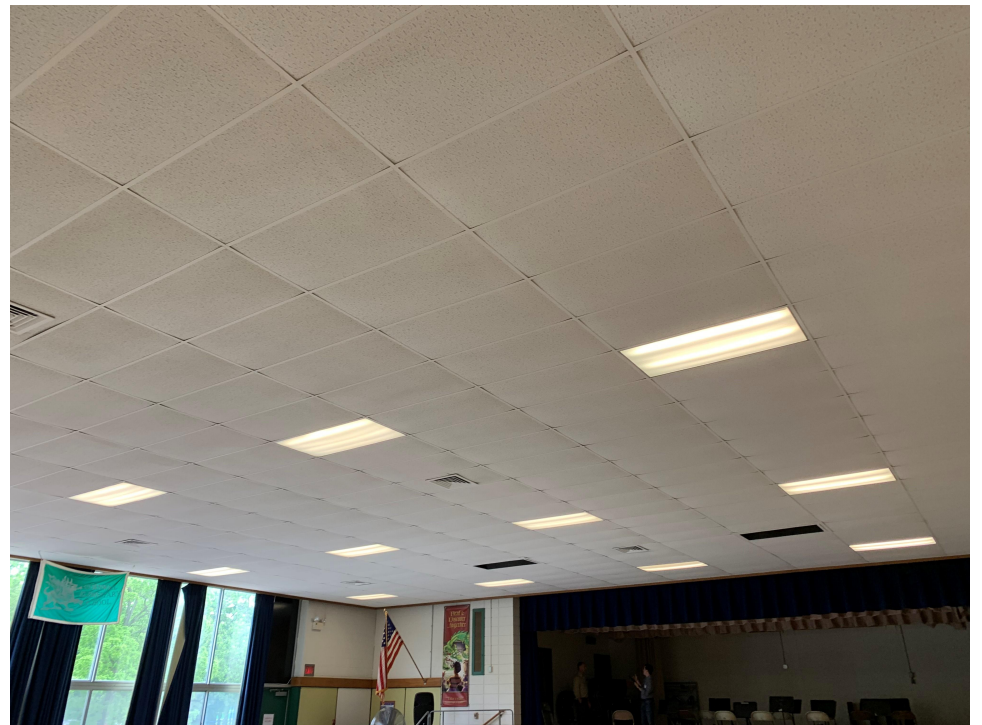
Existing classroom recessed fluorescent interior lighting fixtures and associated controls are in fair to poor condition. Classroom illumination levels appear to be deficient in certain areas.

Existing recessed lighting system is in fair to poor condition.
