**2020 BUILDING
CONDITION SURVEY
REPORT**

CORNWALL CENTRAL
SCHOOL DISTRICT

Cornwall-on-Hudson
Elementary School

January 2021

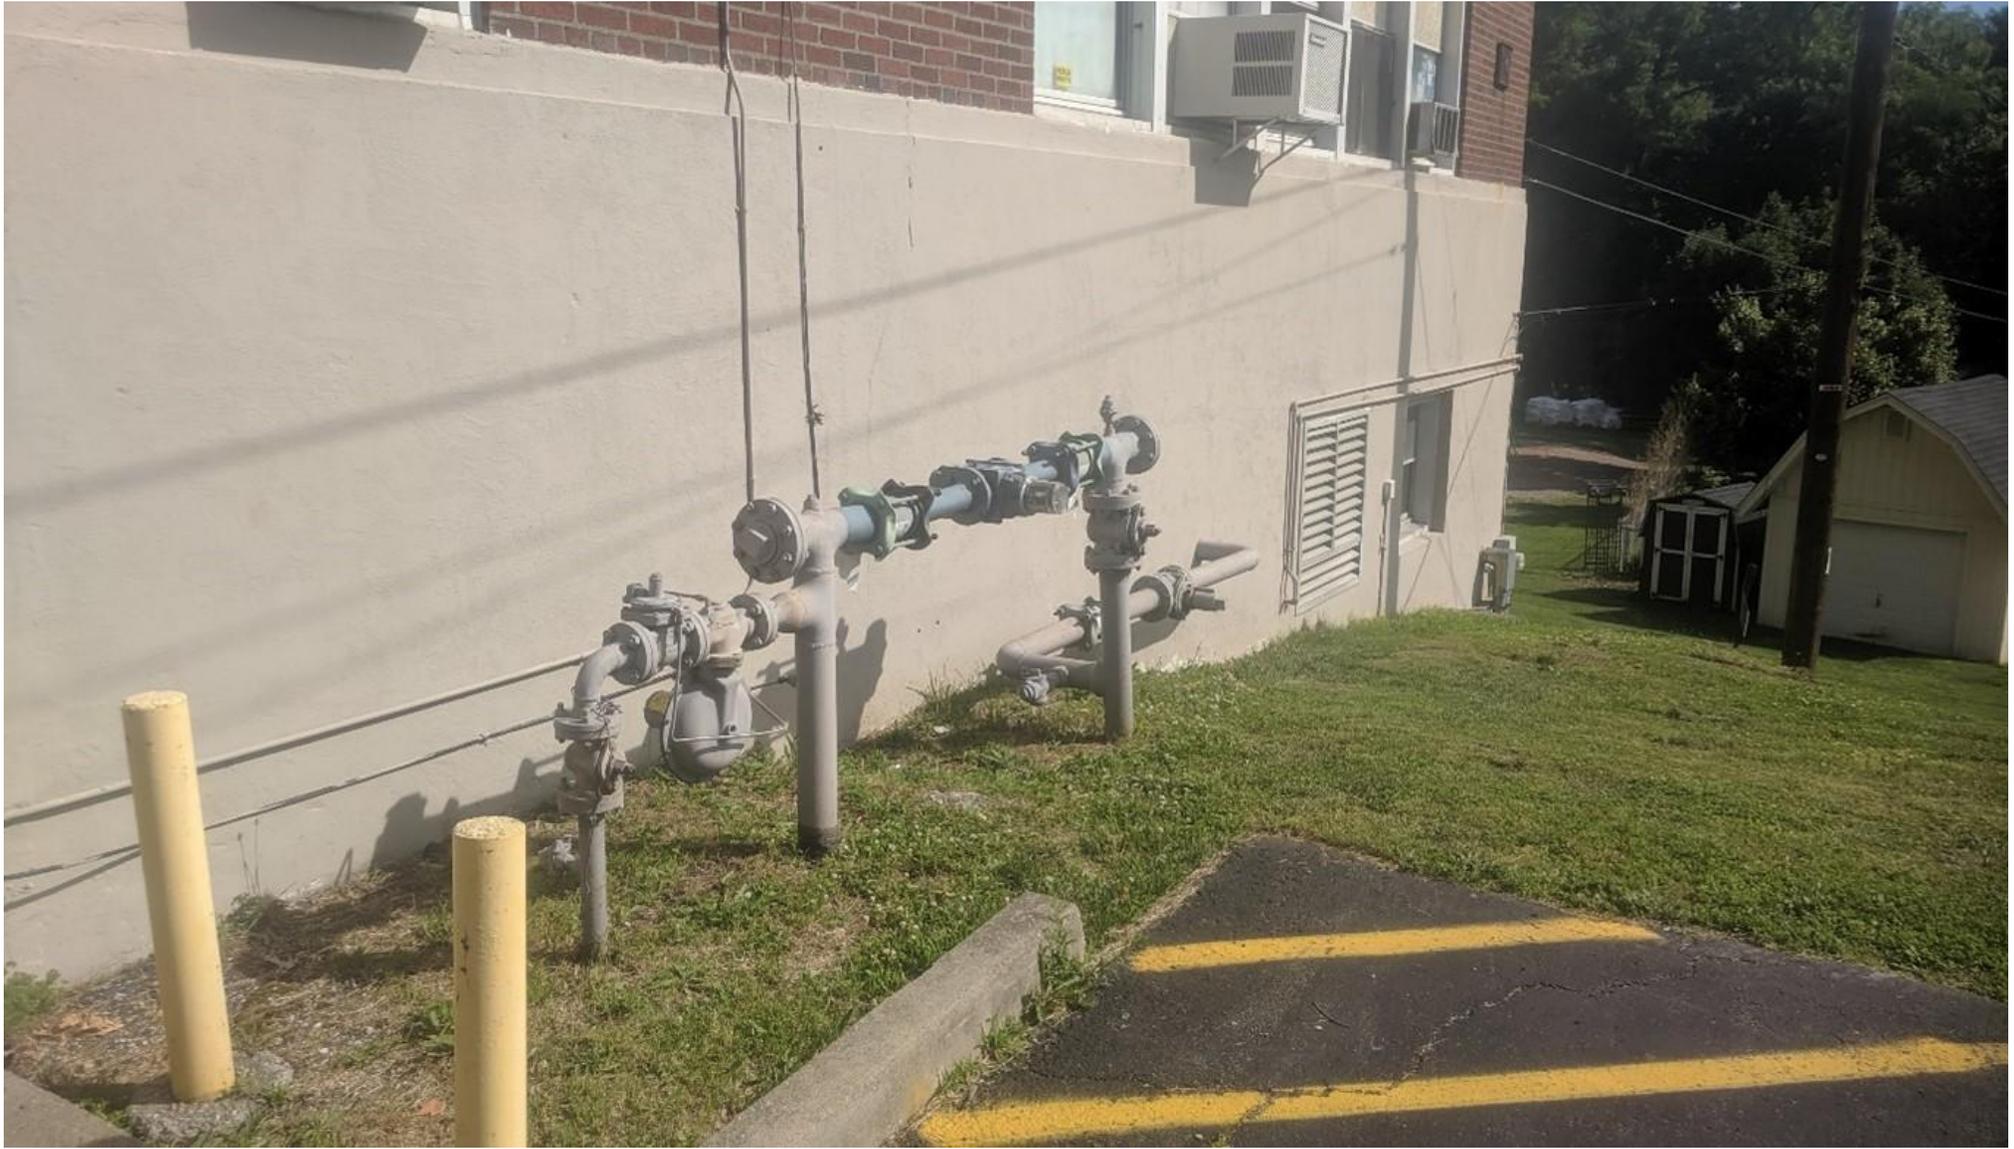
COH-01

Category 41: Site Gas

Replace/install bollards to protect gas regulator from traffic.

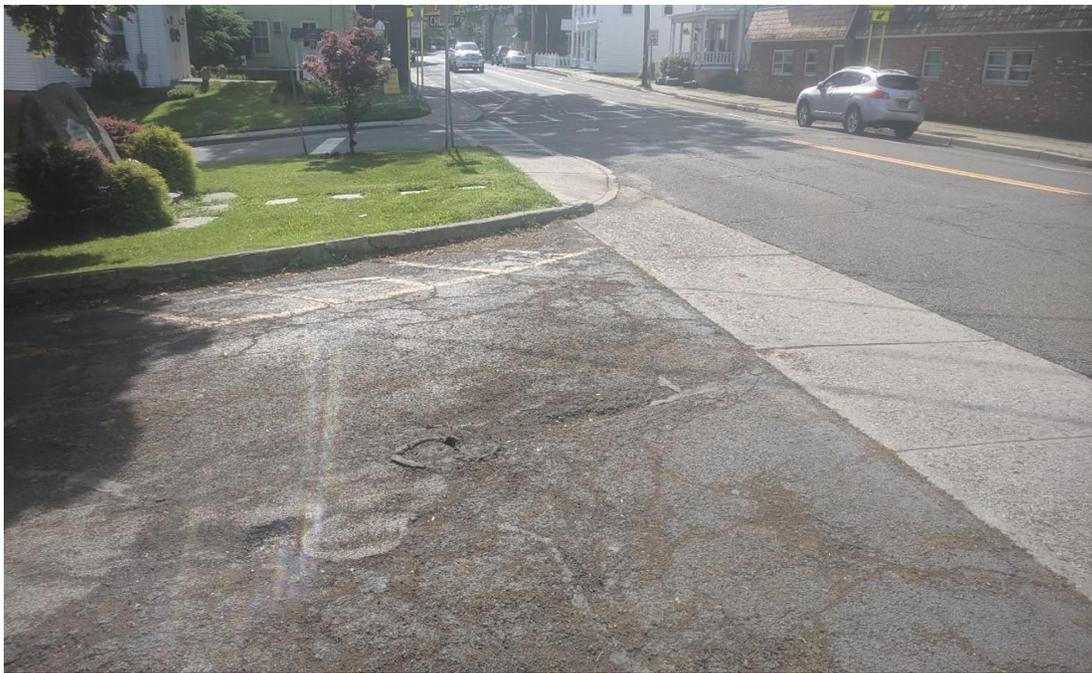
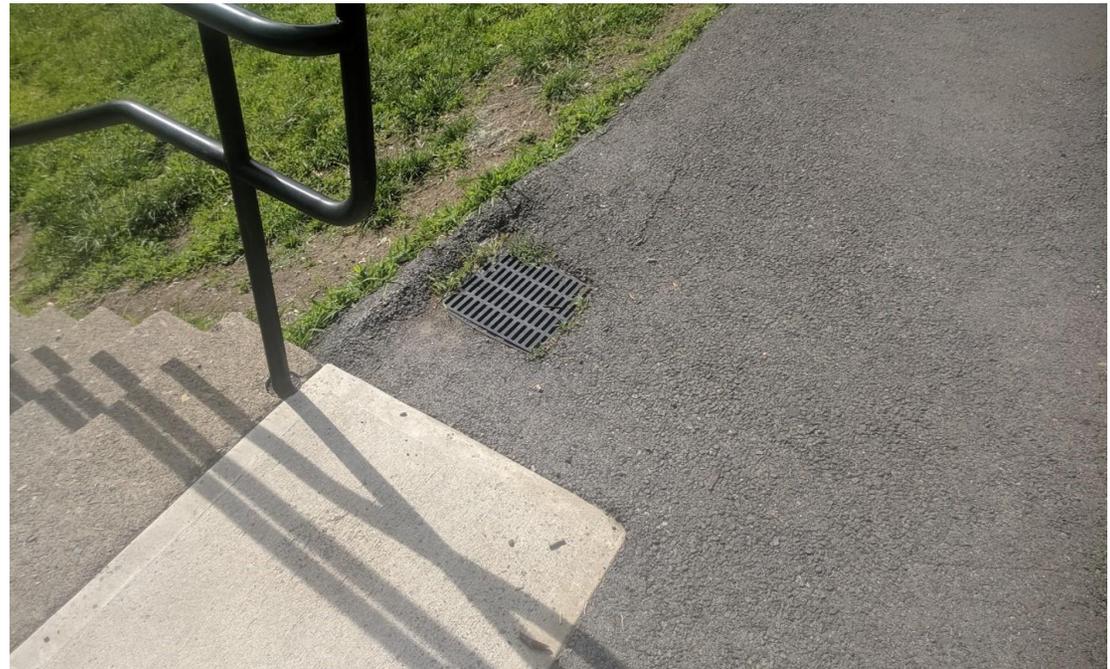
COH-02

Category 46: Catch Basins/ Drop Inlets/ Manholes

Install drainage along driveway in front of school to eliminate icing/ponding and erosion. Replace yard drain at stair in playground area with larger structure and piping to eliminate icing/ponding hazard and erosion.

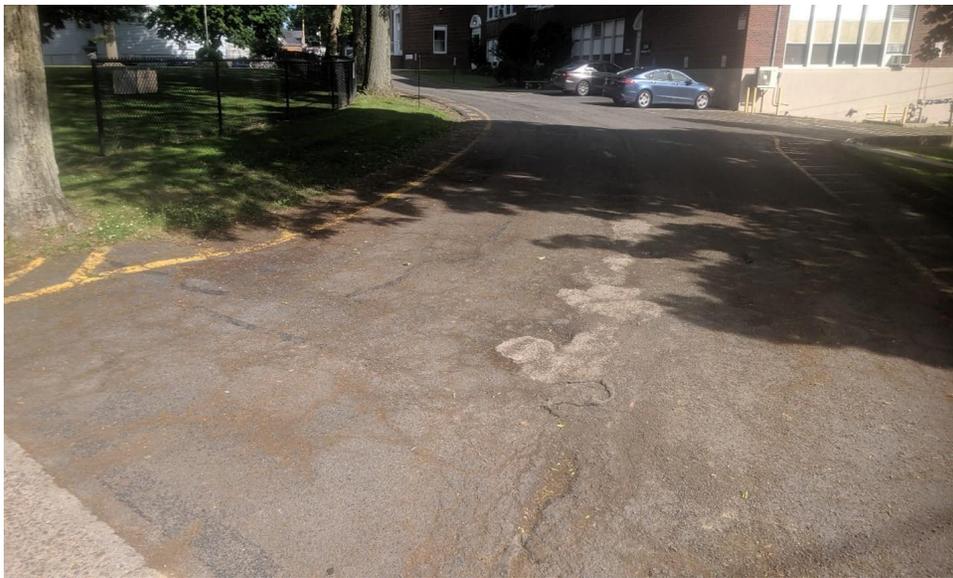
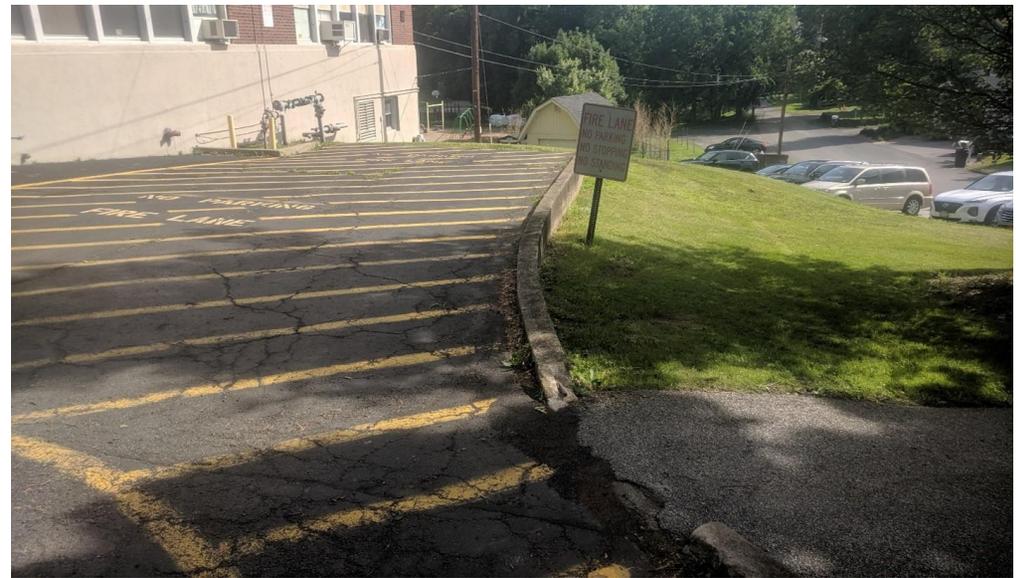
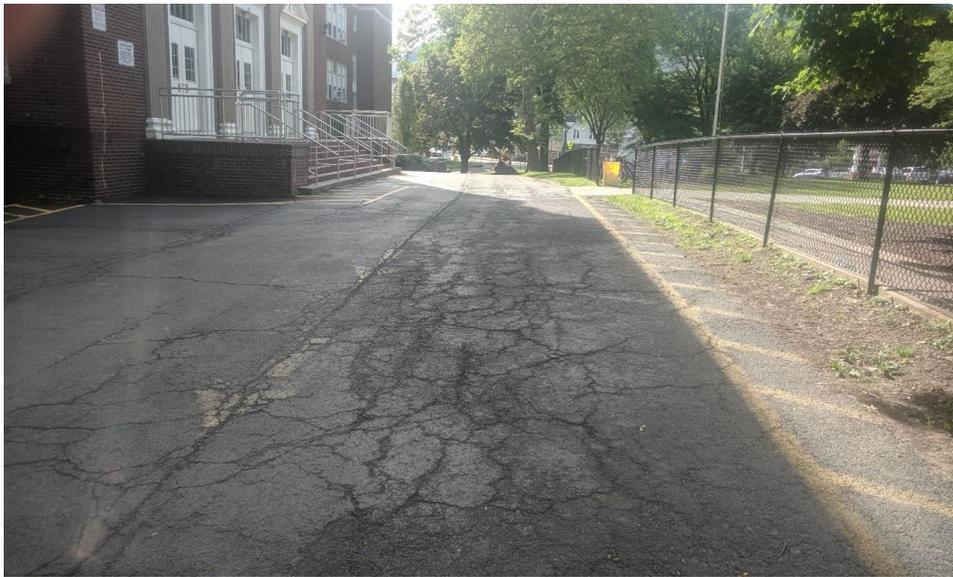
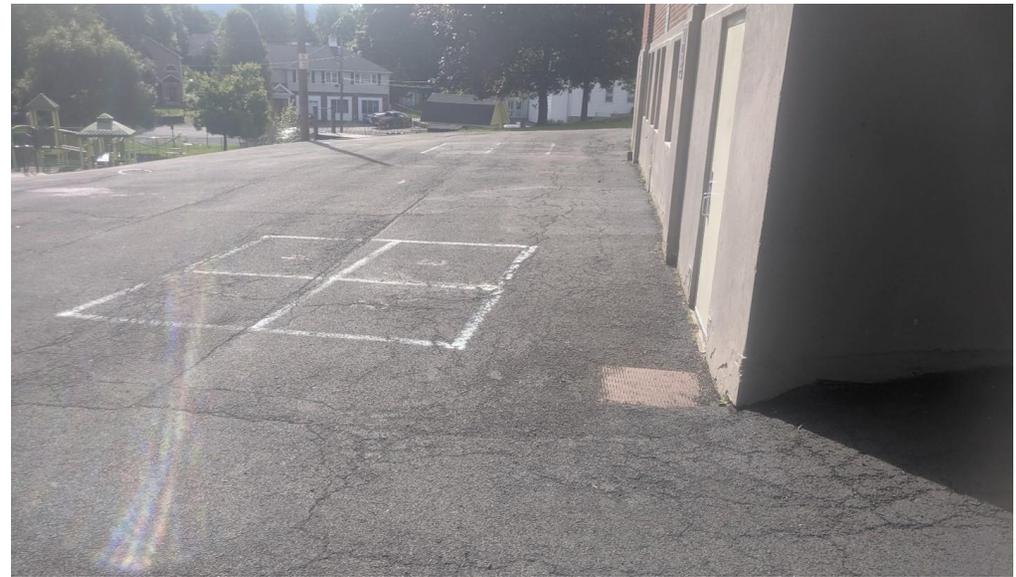
- The asphalt driveways are unsatisfactory. The asphalt pavement and concrete curbing are at the end of their useful life and should be replaced.
- Asphalt sidewalks along the bus drop off are at the end of their useful life and should be replaced.
- Concrete walks in front lawn indicate water ponding on the surface.
- The asphalt basketball court surface is in good condition.
- The baseball field backstop is in good condition.
- Playground structures and surfaces are in good condition.

Category 55: Pavement (Roadways and Parking Lots)

Replace driveway and curbing at front of building. Install safety fence/guide rail along edge of pavement at top of hill near playground slides. Barrier needed for safety of vehicles accessing pavement in rear, and for safety of students playing on/around the slide.

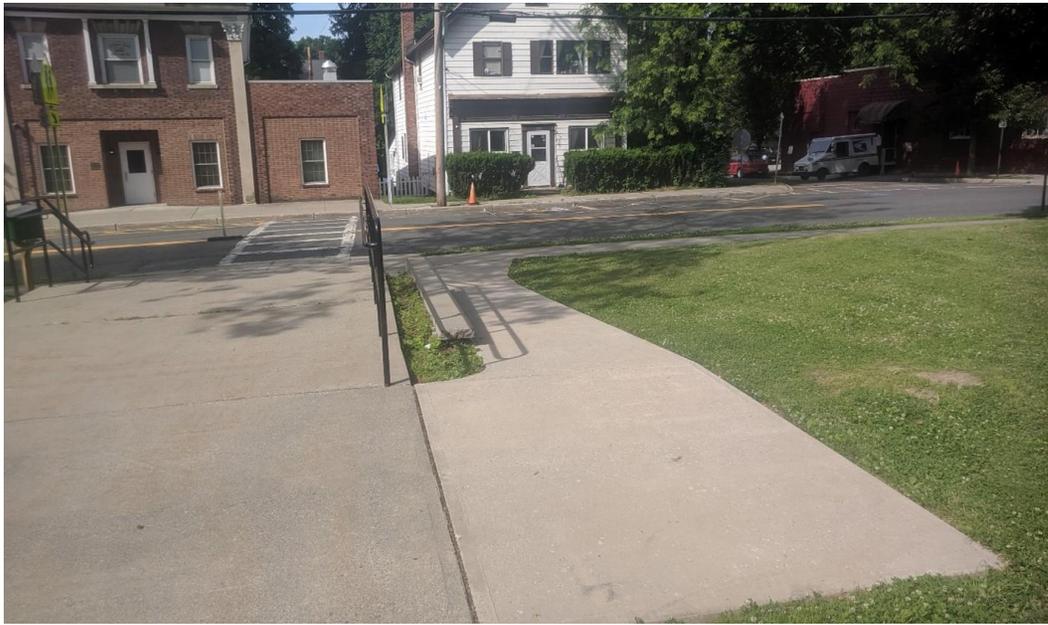
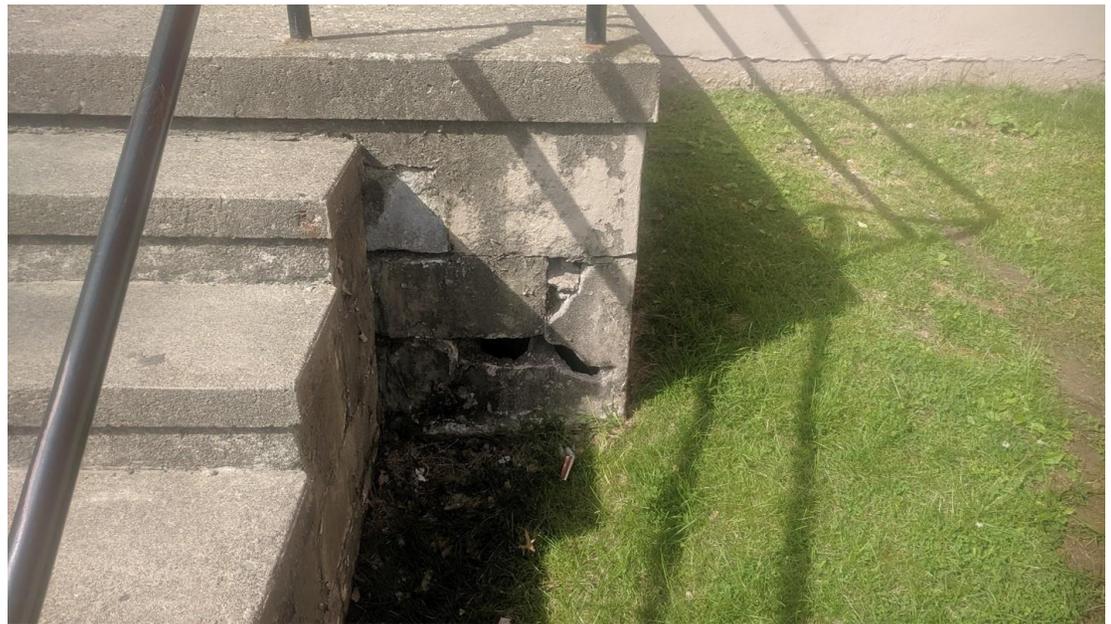
Category 56: Sidewalks

Replace concrete sidewalk. Icing/ponding hazard (too flat).
Replace concrete stair. Stair treads worn, surface uneven, and several large cracks throughout.

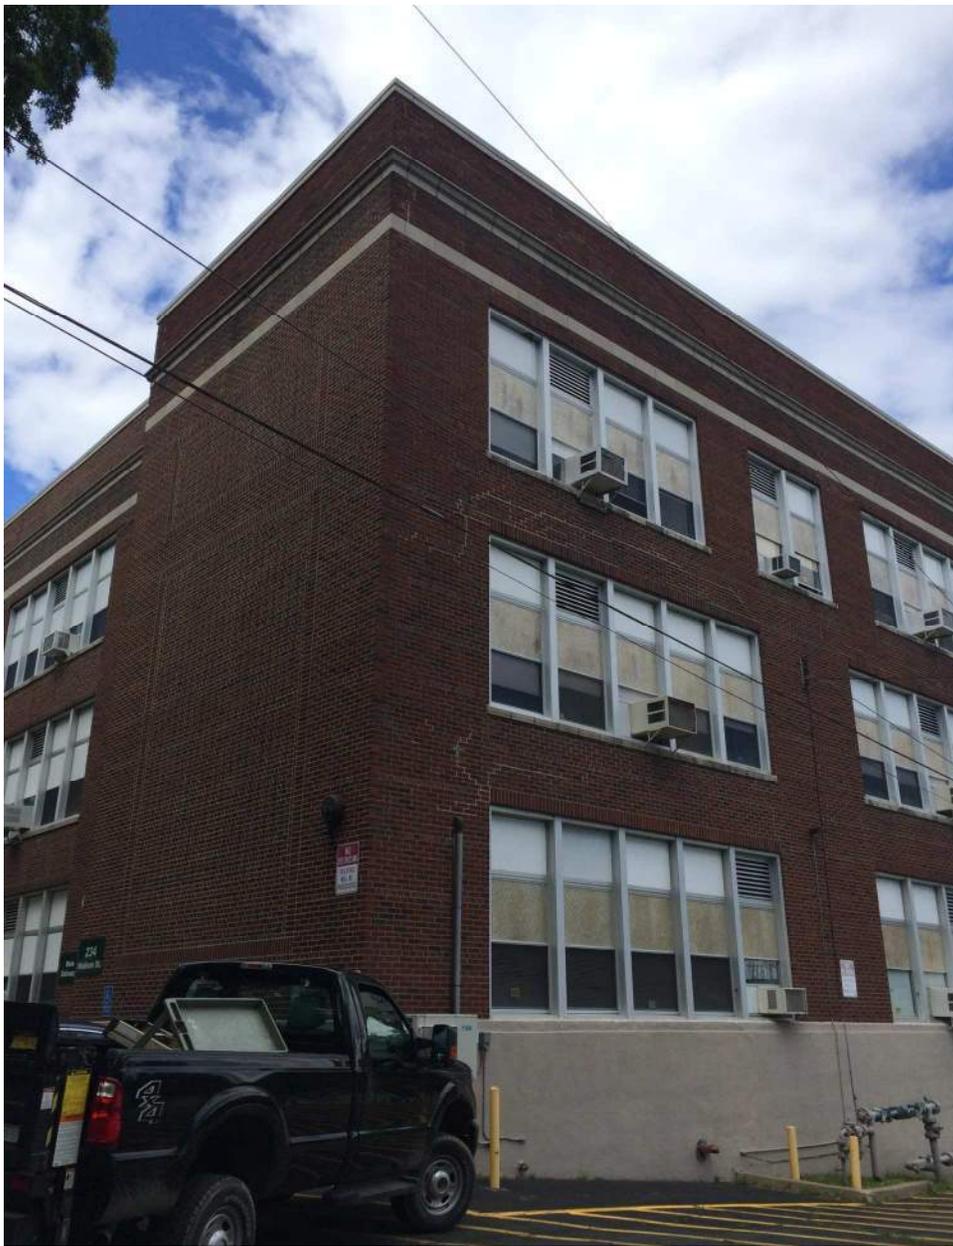
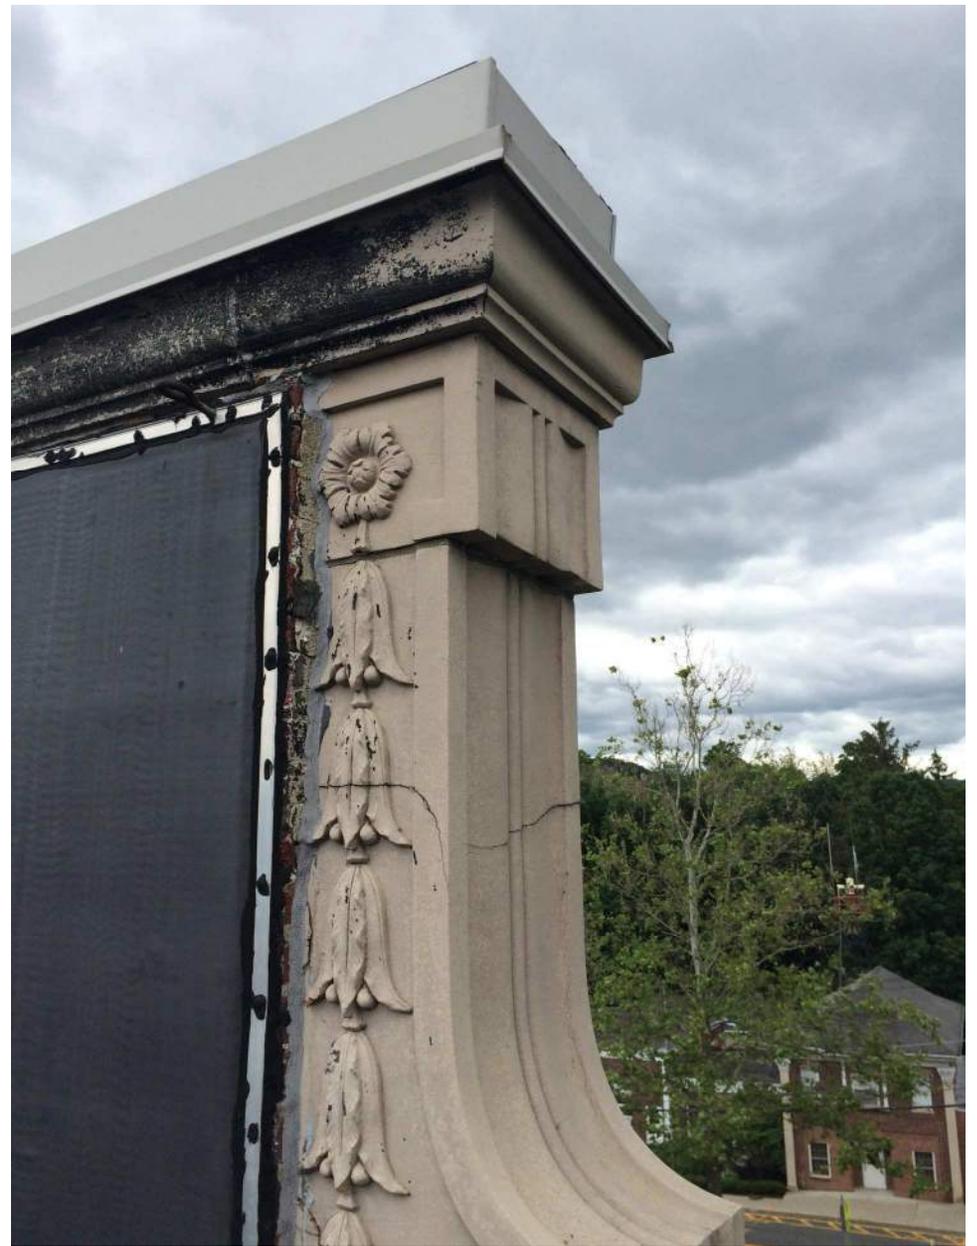
- The east elevation has previously repaired masonry cracks along the wall surface, but the existing repairs should be reevaluated, a masonry restoration program is recommended for the building. Some of the cracked masonry units are beyond repair, rebuilding the deficient areas is necessary.

- Windowsill stones are stained with dark streaks, masonry cleaning is recommended during restoration.
- Some terracotta detail pieces are cracked and have spalled, exposing the unglazed surface of the masonry to the elements.

Category 66: Exterior Walls/ Columns

Repair cracked masonry units along building elevations. Repoint unit masonry along building elevations. Repair/replace spalled unit masonry (terracotta) building-wide.

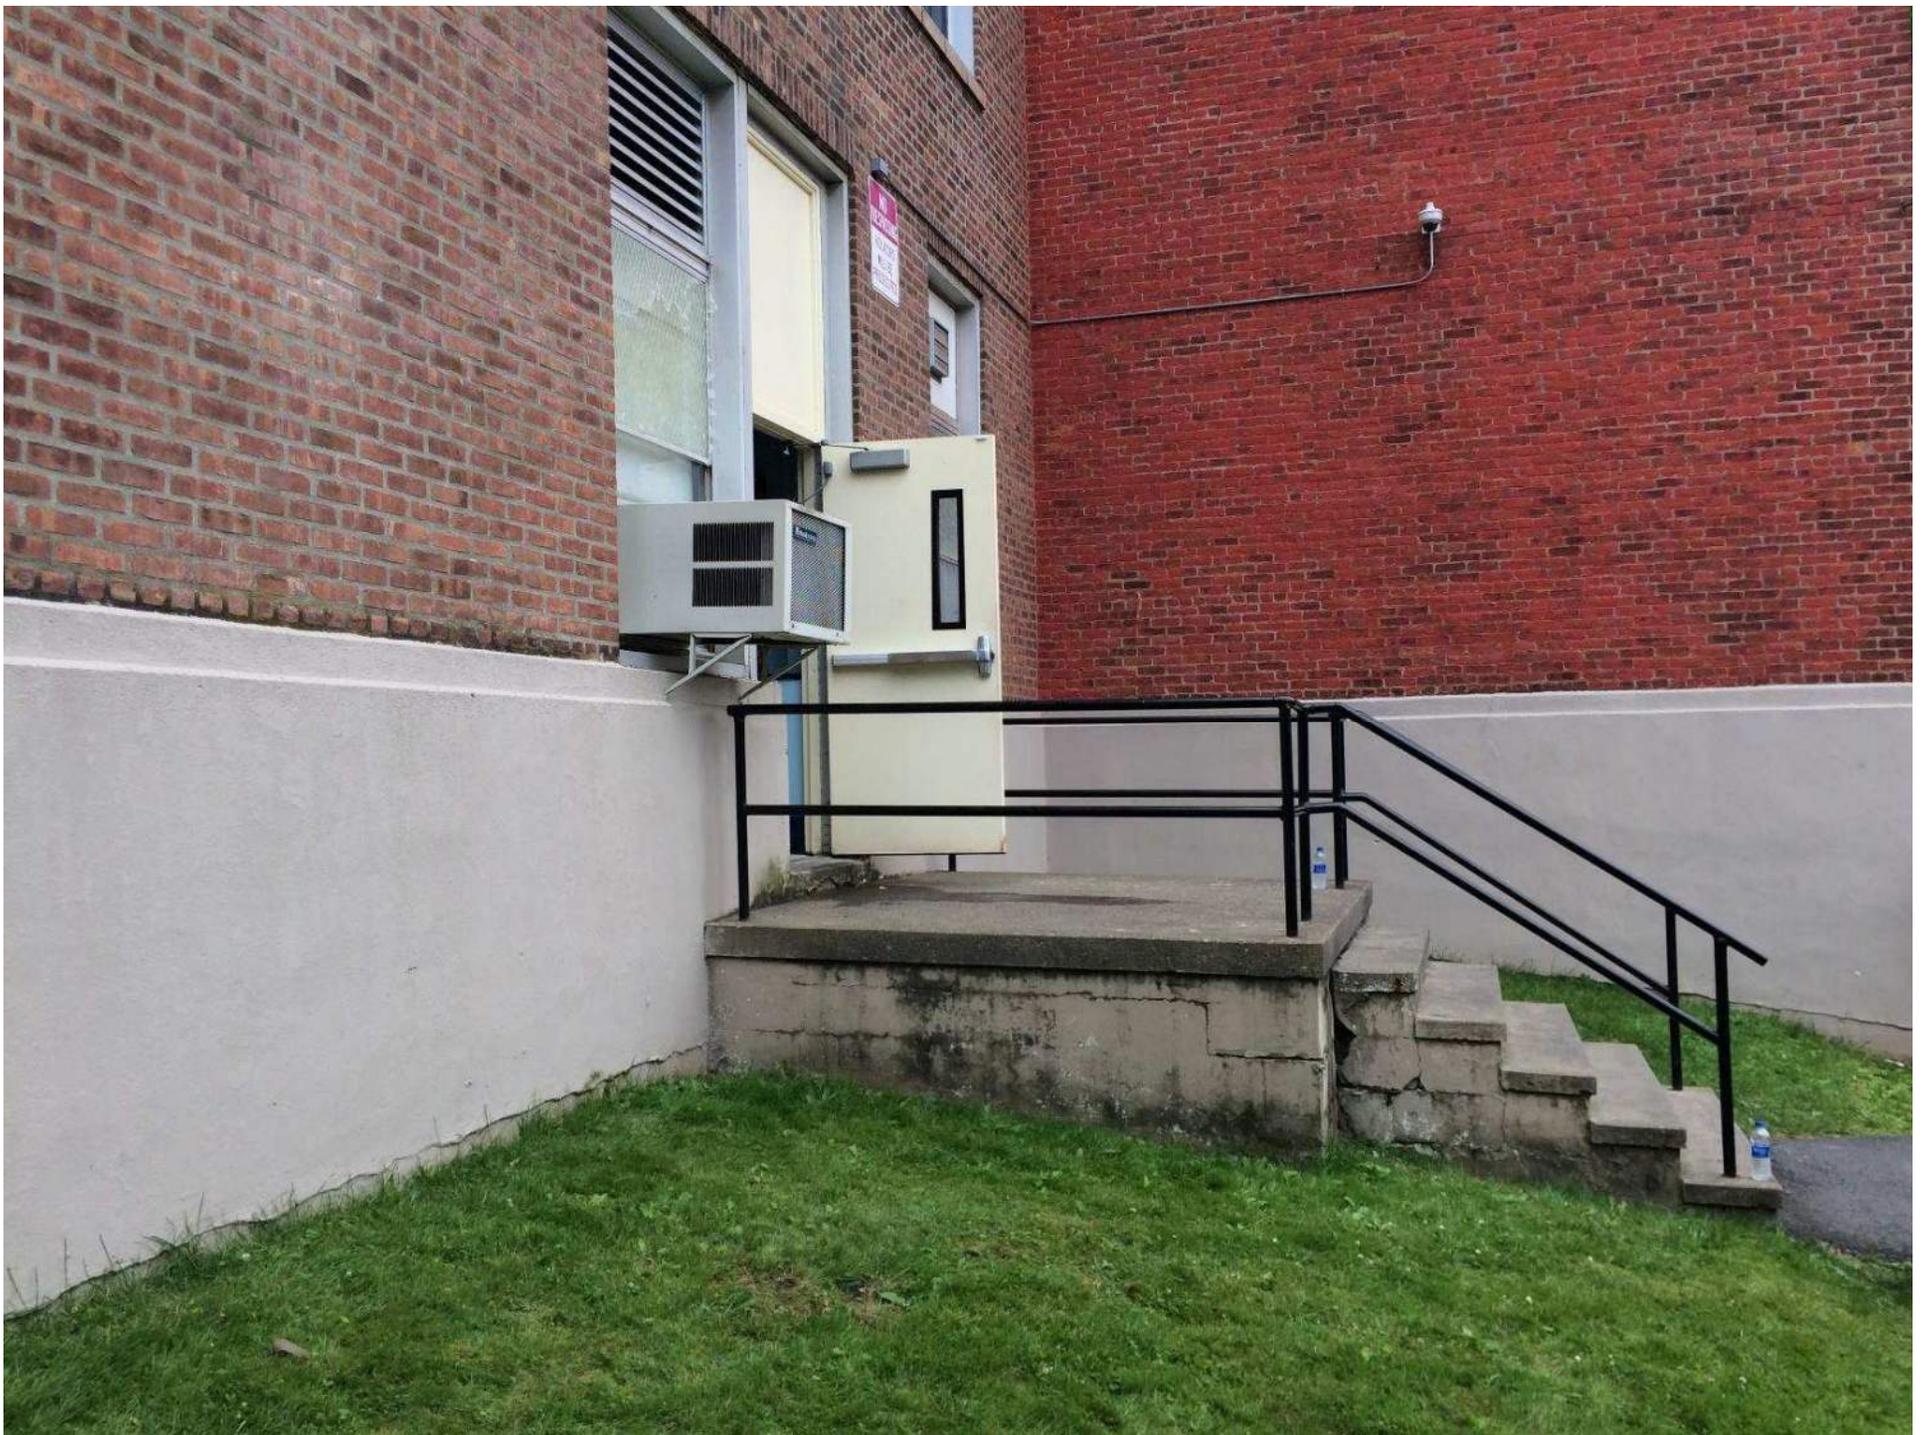
- The small stair system at the rear of the building is in poor condition and should be restored because the foundation is in disrepair.

Category 70: Exterior Stairs, Steps, and Ramp

Foundation at rear stair is in disrepair. Repointing and masonry replacement required for auditorium exterior entry stair.

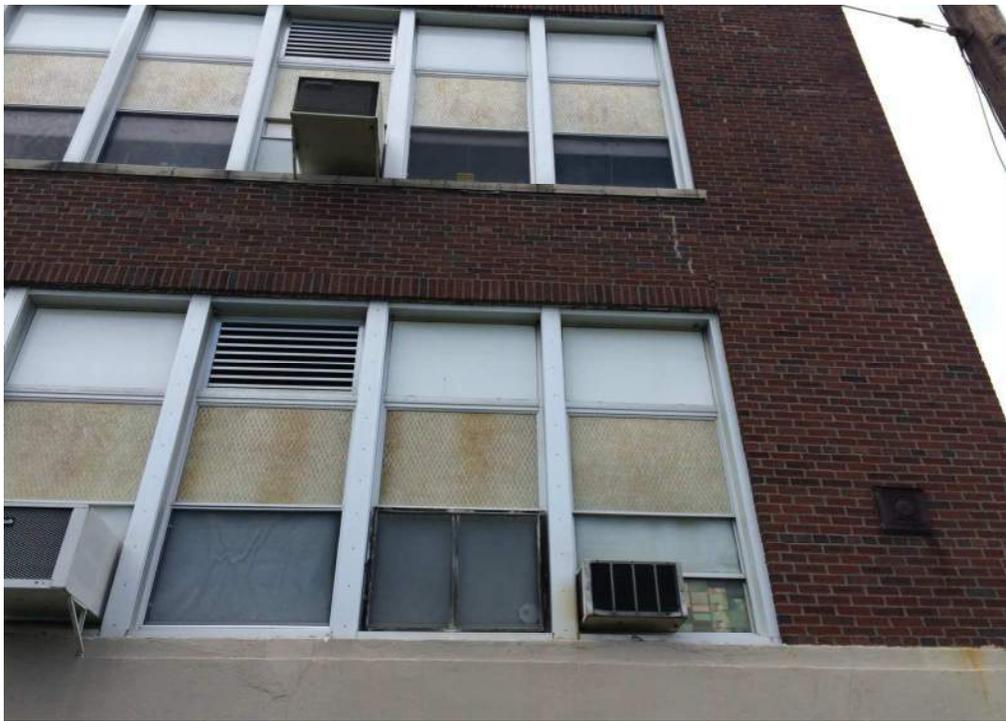
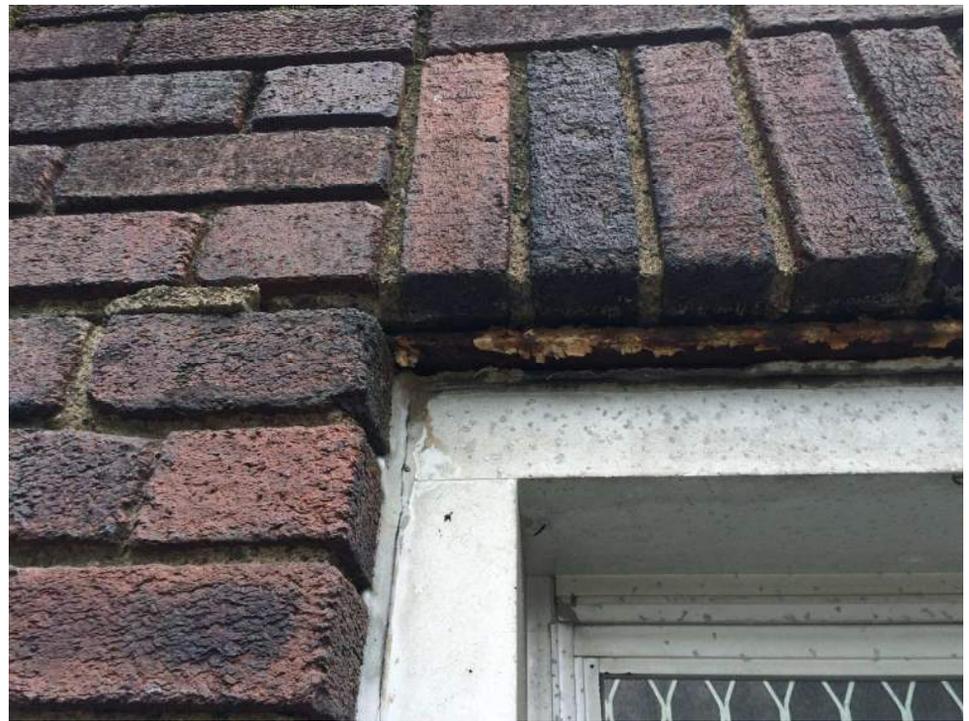
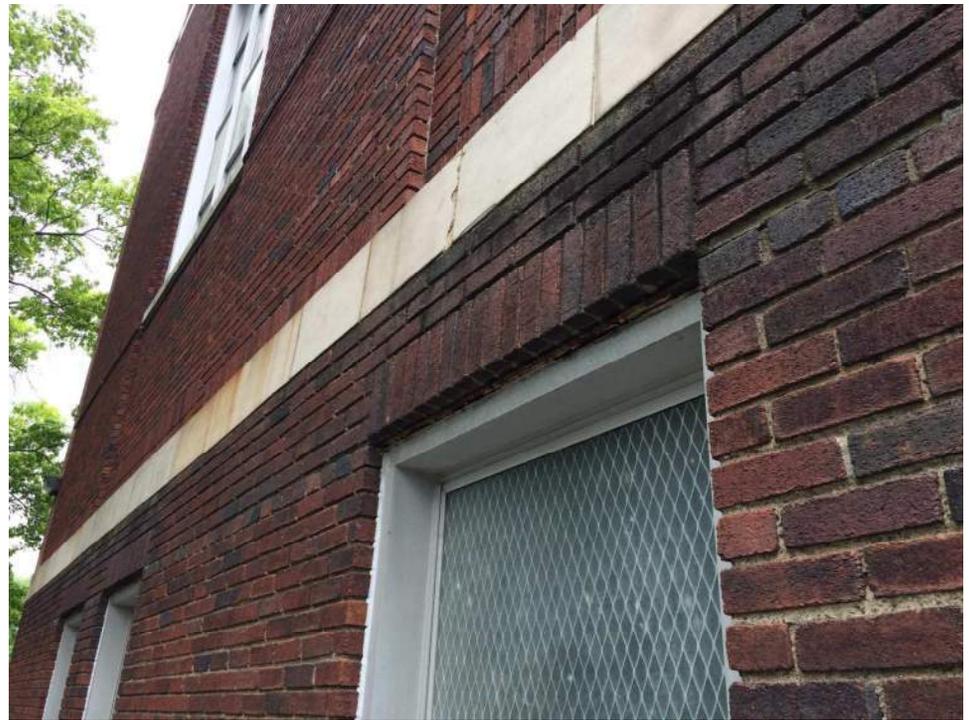
- Several steel lintels, bridging across window masonry openings, are rust jacking and cracking the bricks along the jamb of the masonry openings, the current condition should be corrected. The expansive force of rust jacking occurs when uncoated steel becomes corroded and displaces building materials at or adjacent to the window opening.

Category 72: Windows

Replace existing exterior window system (building wide).
Scrape, prime, and paint all rust jacked lintels that are not
to be replaced with windows.

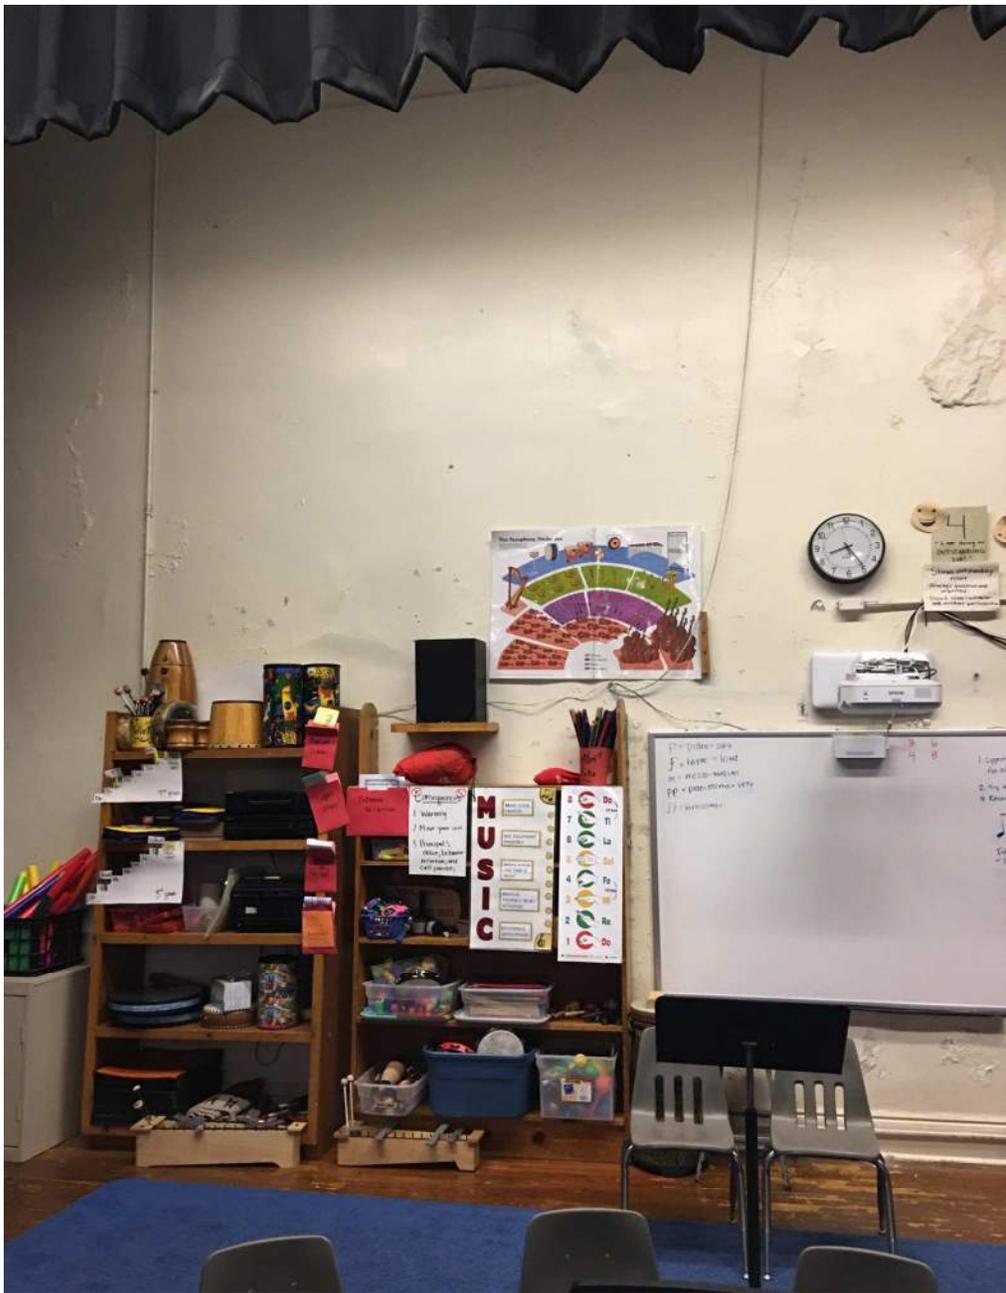
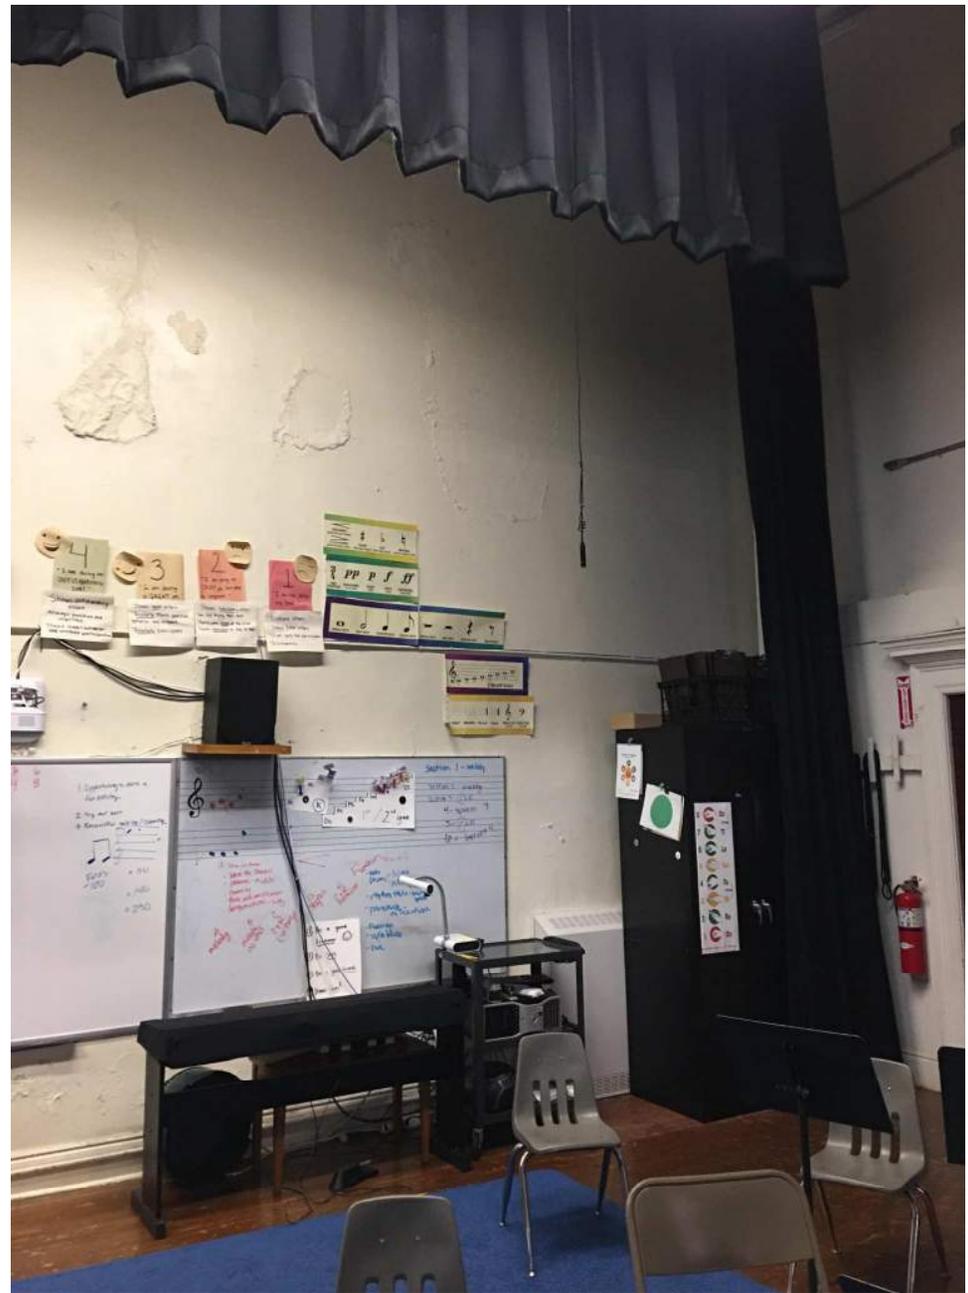
- In the auditorium, the back wall of the stage has evidence of water intrusion and a repair program is recommended. The source of water intrusion is unknown, but a deeper, comprehensive investigation is in order, culminating in repair recommendations.

Category 75: Other Interior Walls

Water damage is evident at auditorium stage and balcony walls. Further investigate with a structural consultant.

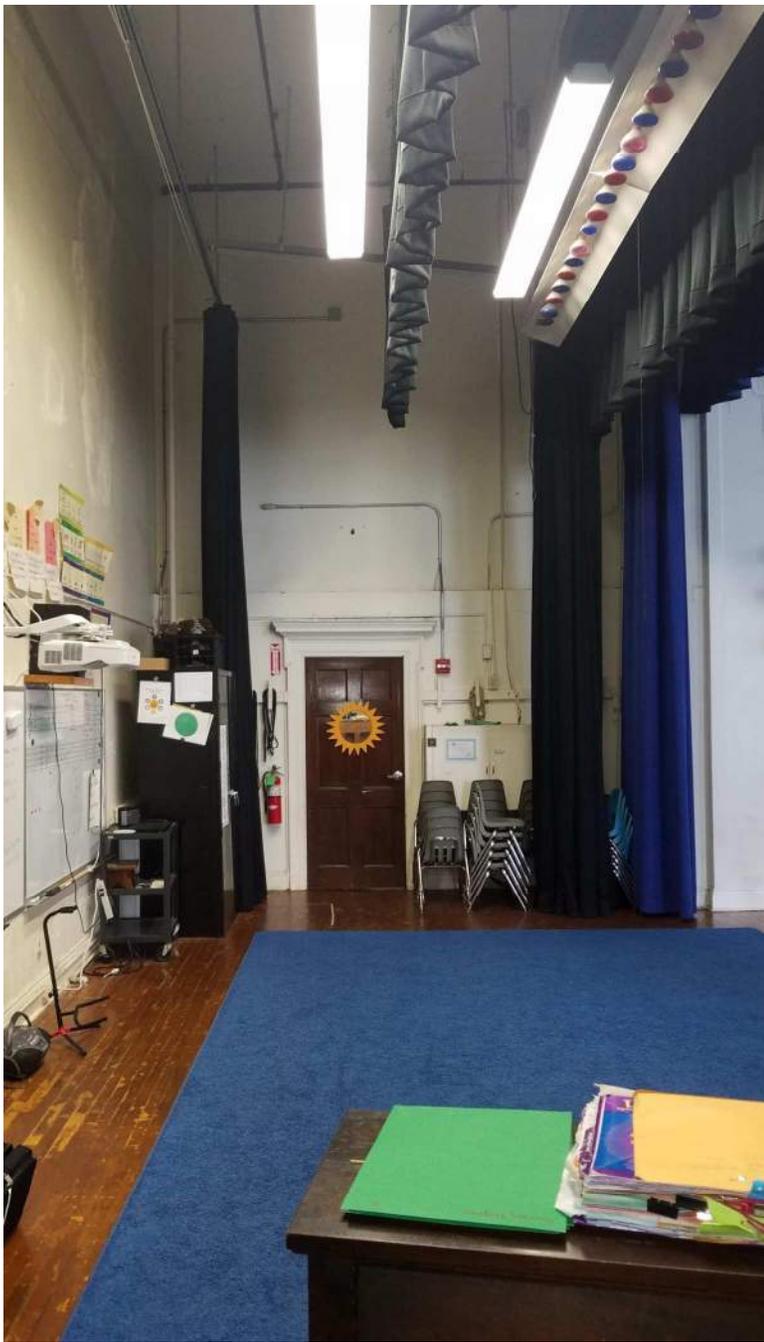
COH-18

- Auditorium stage floor has water damage from the back-wall damage mentioned in previous comment, investigate overall damage; repair and/or restore wood floor.

Category 79: Wood Flooring

Stage floor has water damage. Consider repairing or refinishing the stage floor.

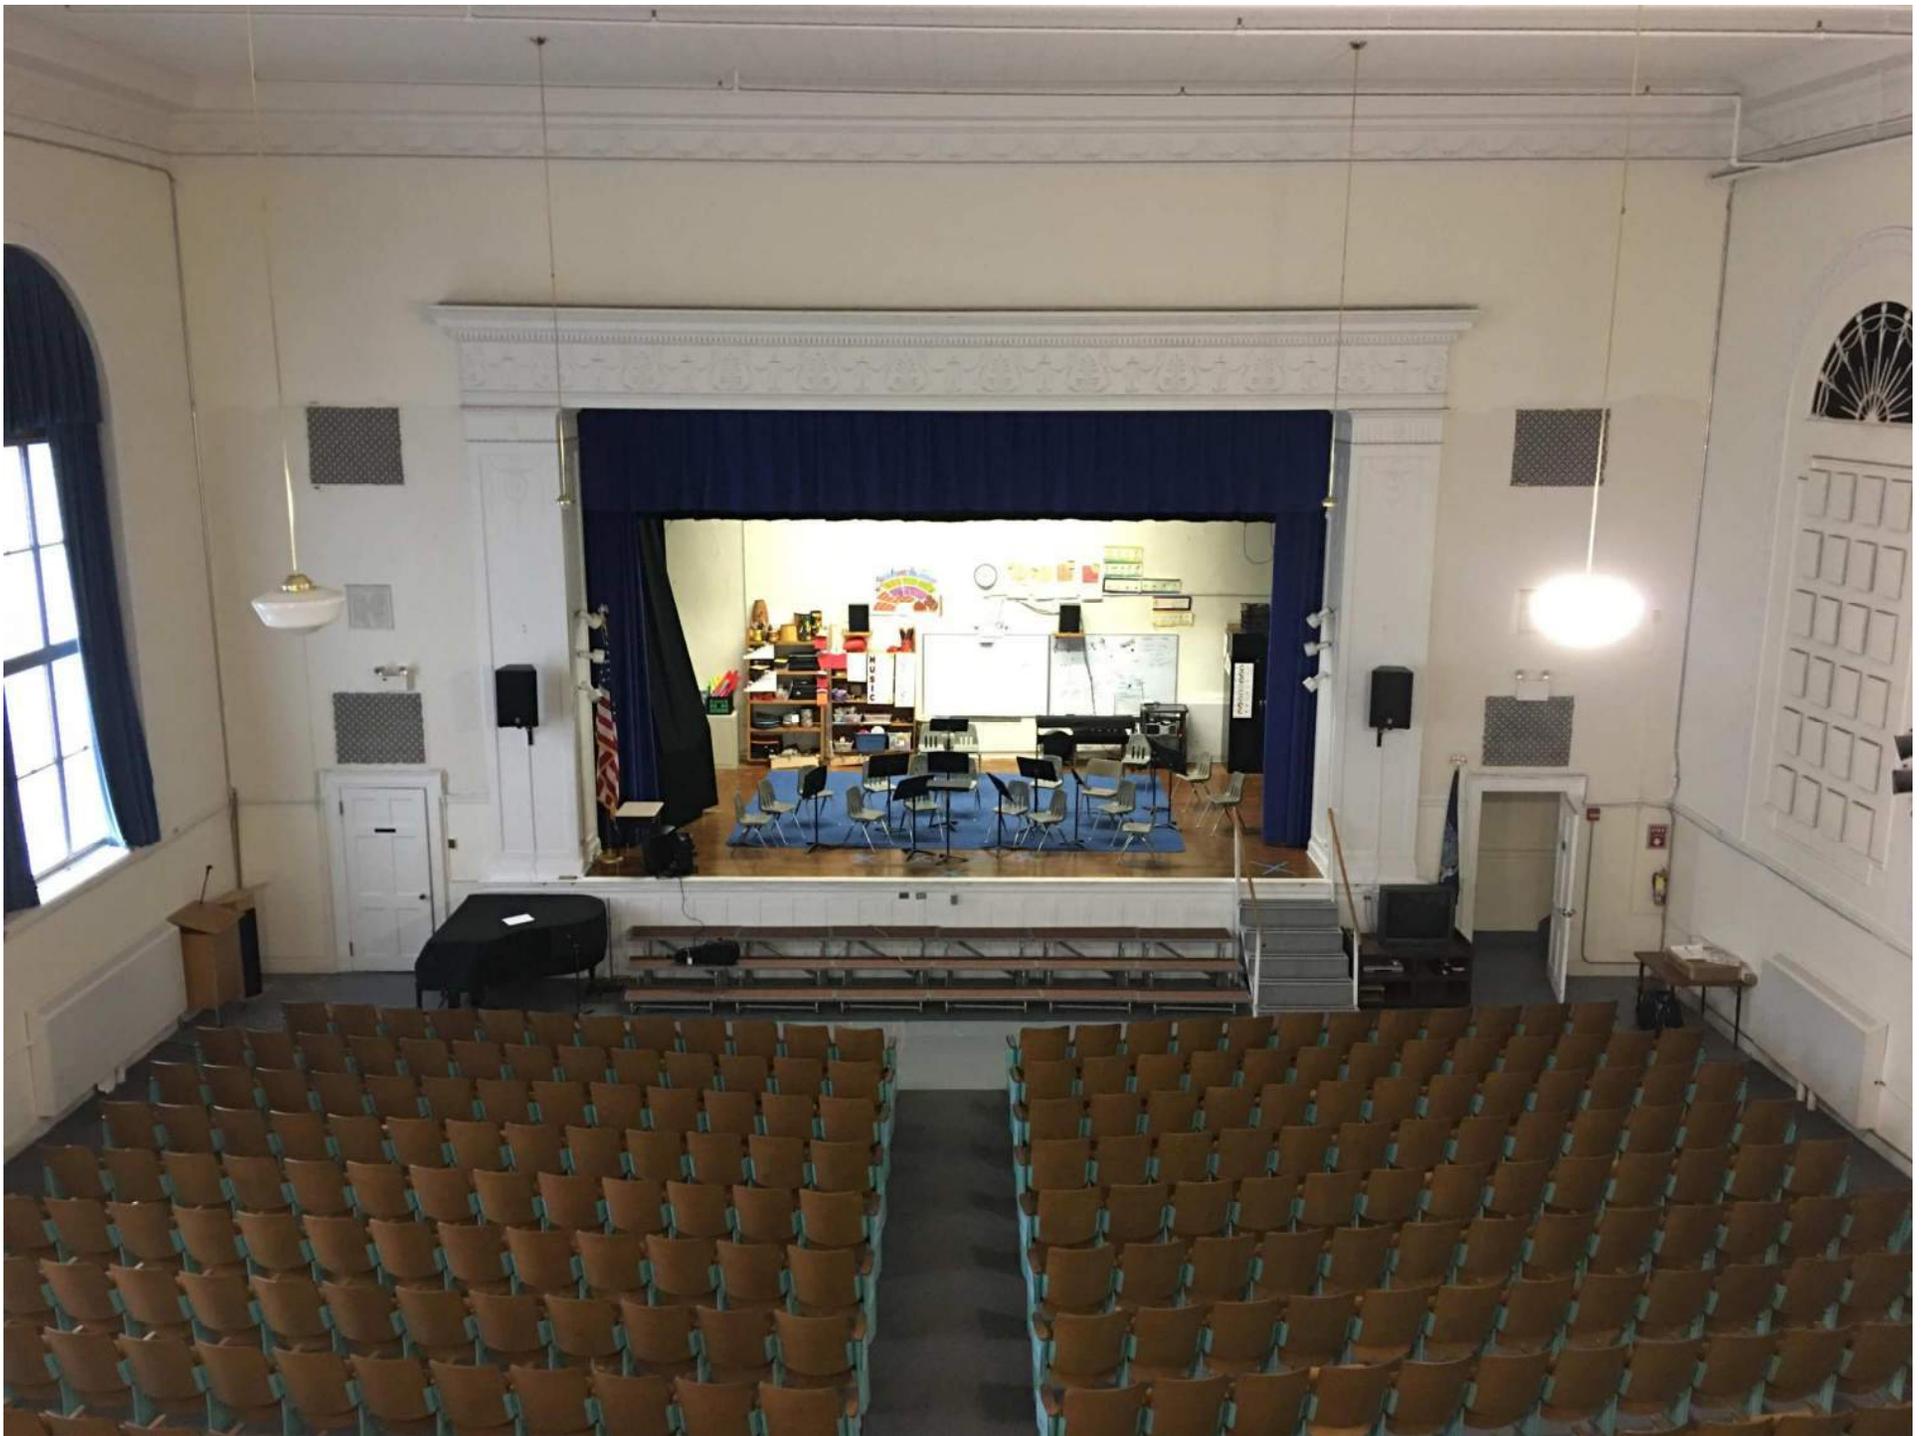
Category 115 & 116: Interior Accessible Route, Access to Goods & Services, and Restroom Facilities
Auditorium stage is not accessible. Consider installing a lift.
