**2020 BUILDING
CONDITION SURVEY
REPORT**

CORNWALL CENTRAL
SCHOOL DISTRICT

Cornwall-on-Hudson
Elementary School

January 2021

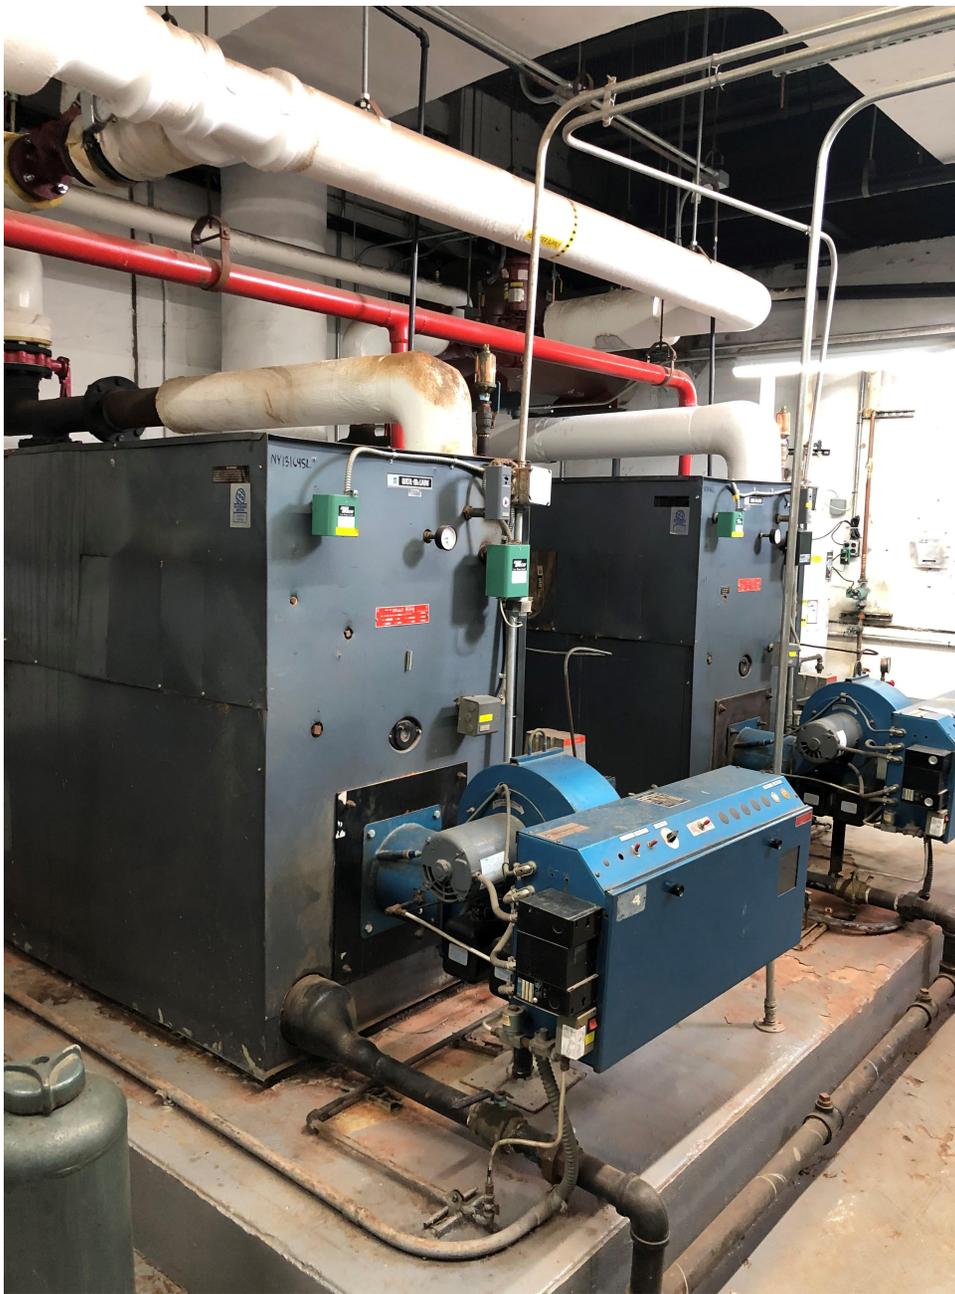
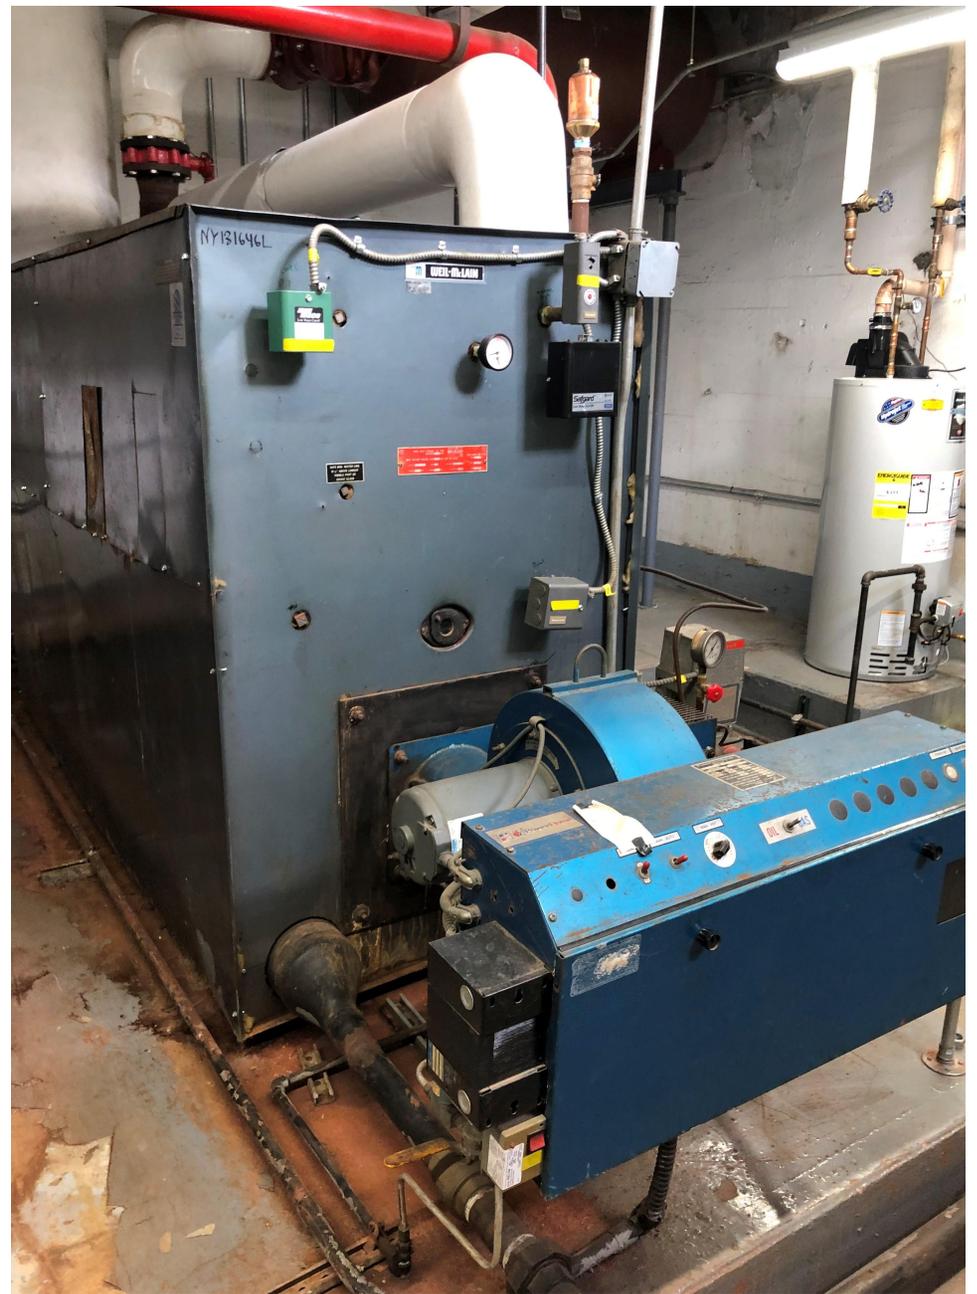
- The HVAC controls are in good condition.
- The boilers will require replacement within the next three years. Additionally, the system pressure requires further investigation due to air in the heating water system.
- The systems appear to be well maintained.
- The present preventive maintenance policy should continue.

Category 87: Heat Generating Systems

Gas fired boilers are starting to fail and near their useful service life.

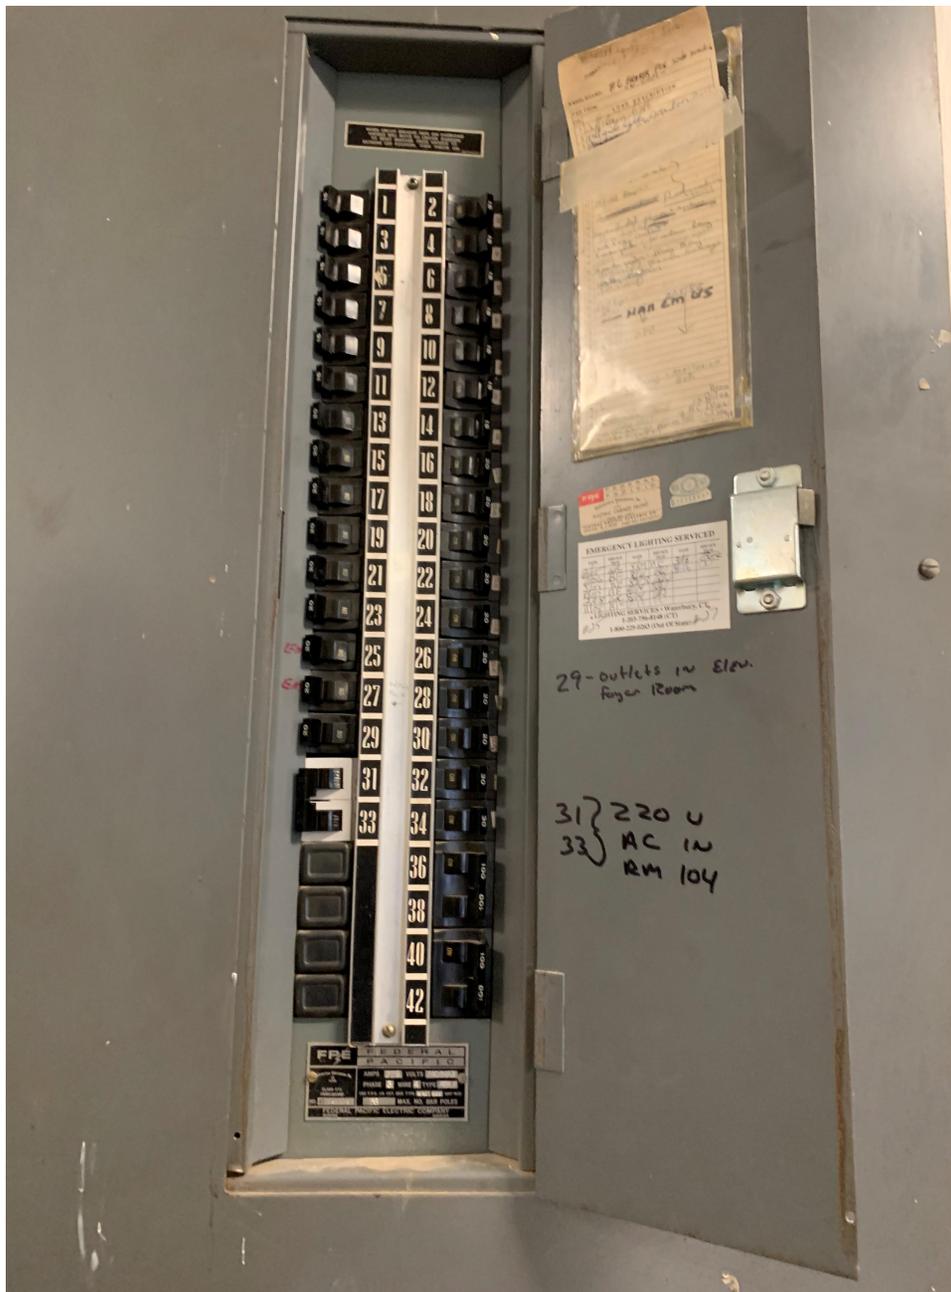
COH-26

Many of the power distribution panelboards, located throughout the building, are approximately 50 years old. Replacement circuit breakers and associated spare parts are very difficult to find and are only available as reconditioned aftermarket items.

Category 101: Electrical Power Distribution

Existing panel boards are approximately 50 years old and require replacement.
