**2020 BUILDING  
CONDITION SURVEY  
REPORT**

CORNWALL CENTRAL  
SCHOOL DISTRICT

Willow Avenue  
Elementary School

January 2021

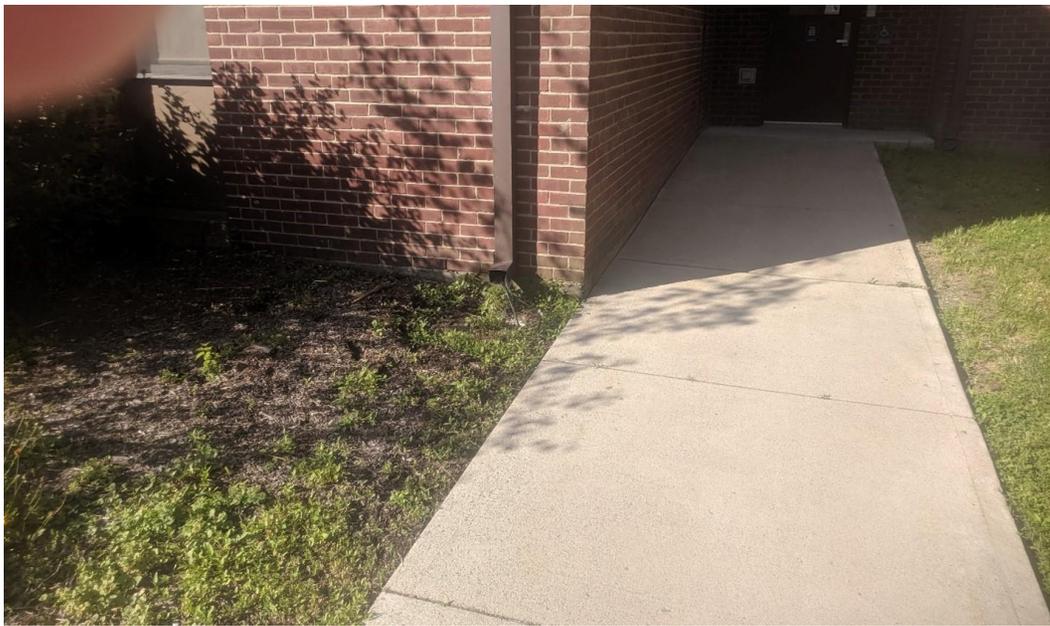
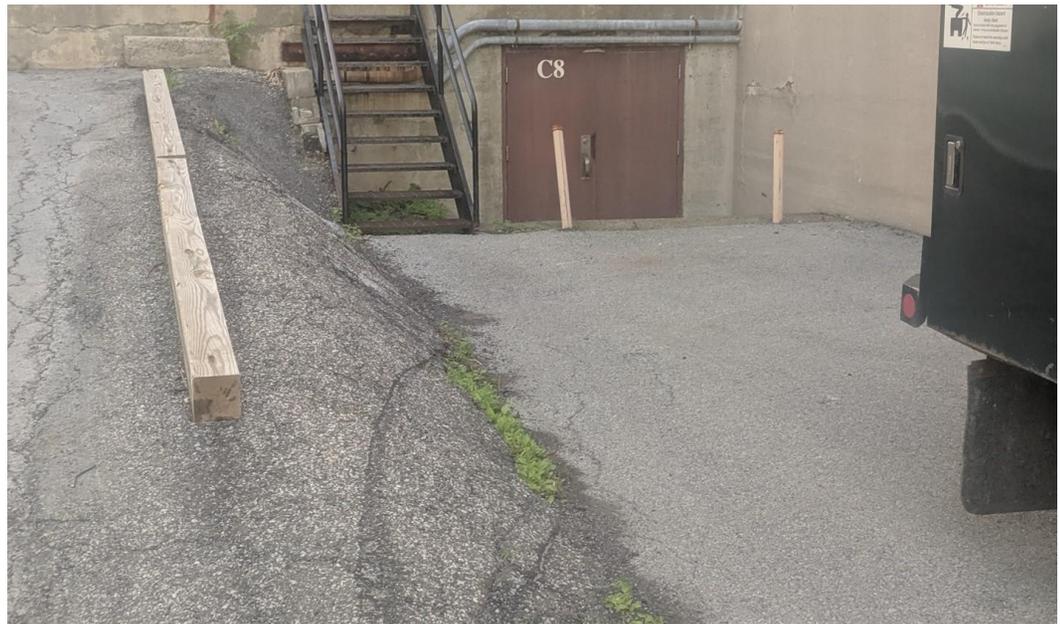
**Category 46: Closed Drainage Pipe Stormwater Management System**

Direct roof leader runoff. Provide drainage at loading dock/ electrical room.

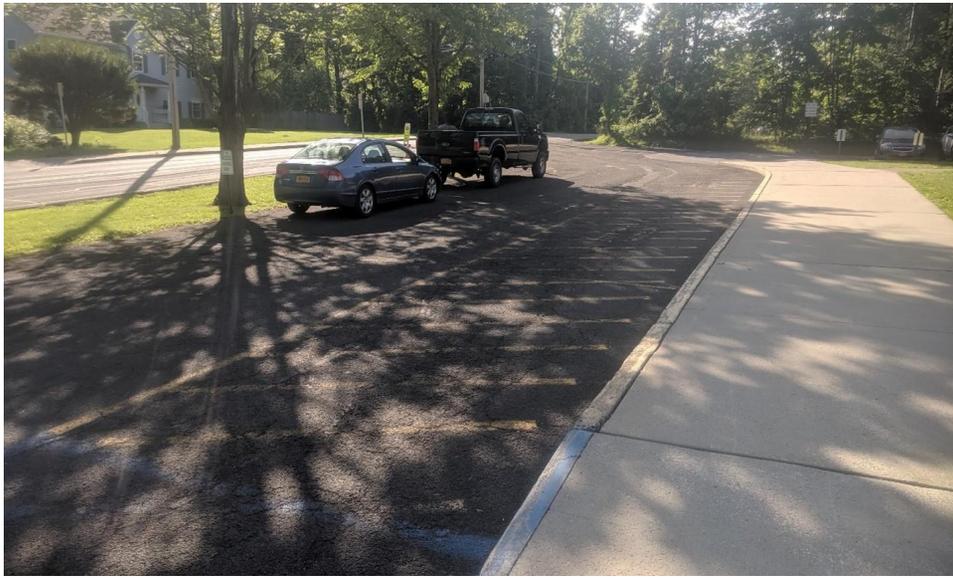
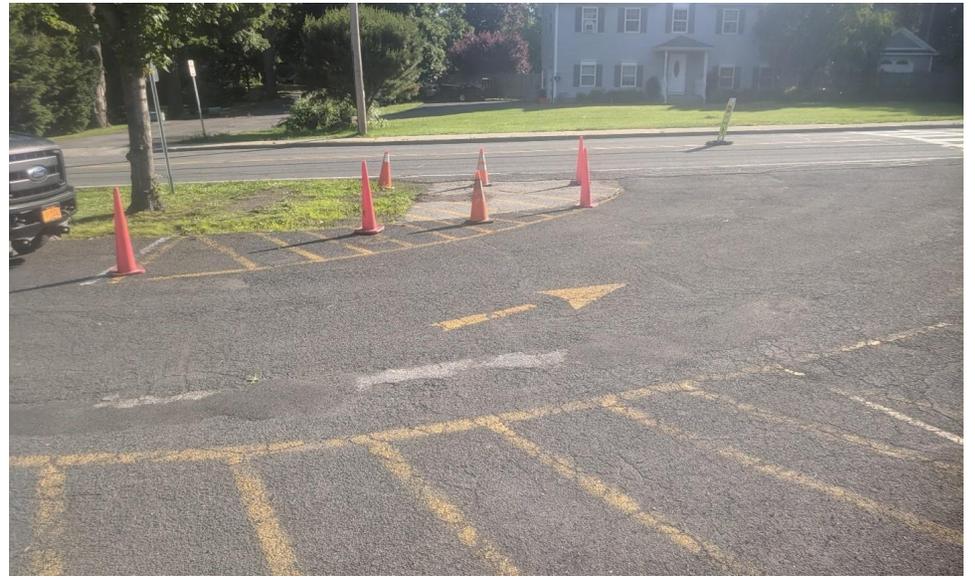
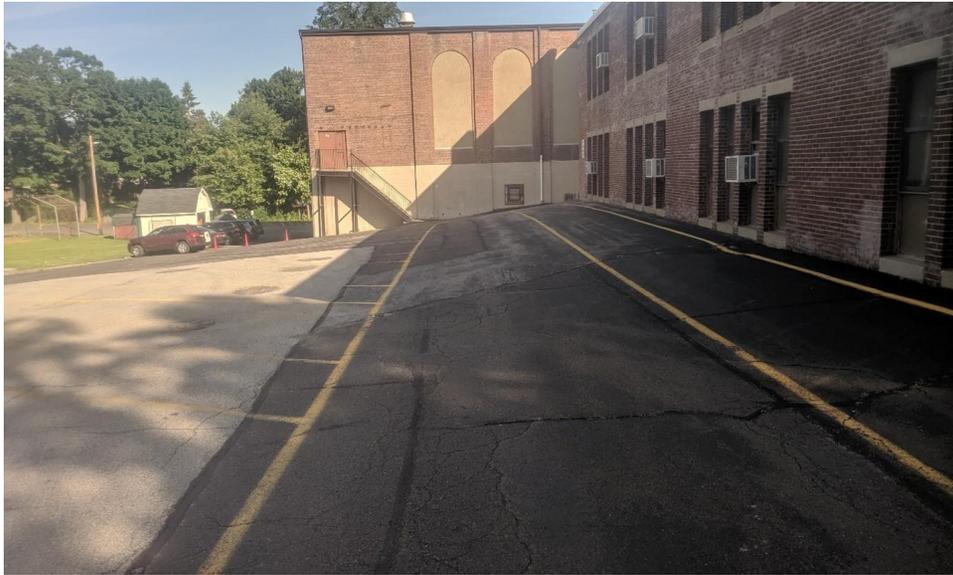
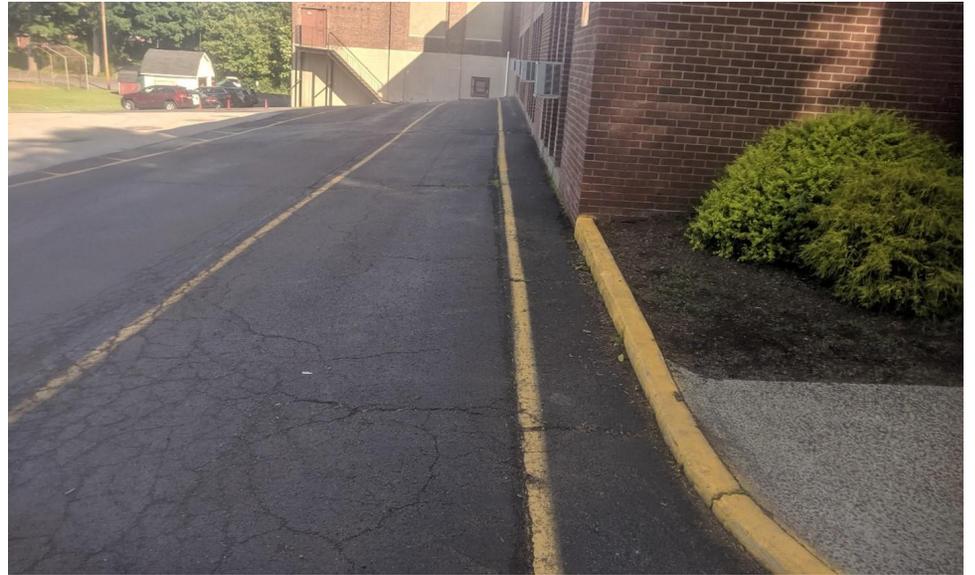
**Category 55: Pavement (Roadways and Parking Lots)**

Replace front driveway/ drop off. Replace rear pavement area used for bus drop/ load zone. Proper sloped to be used for rear pavement

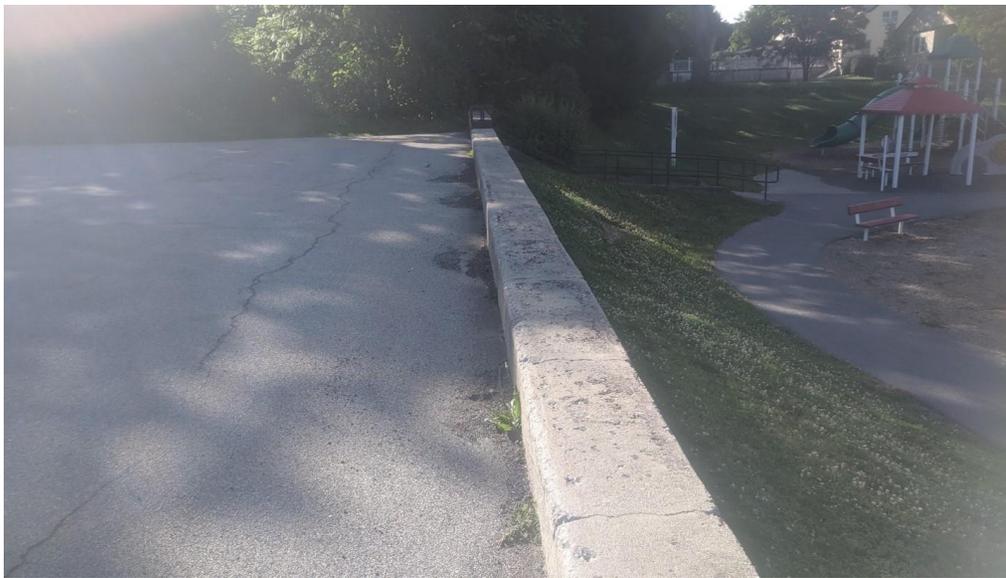
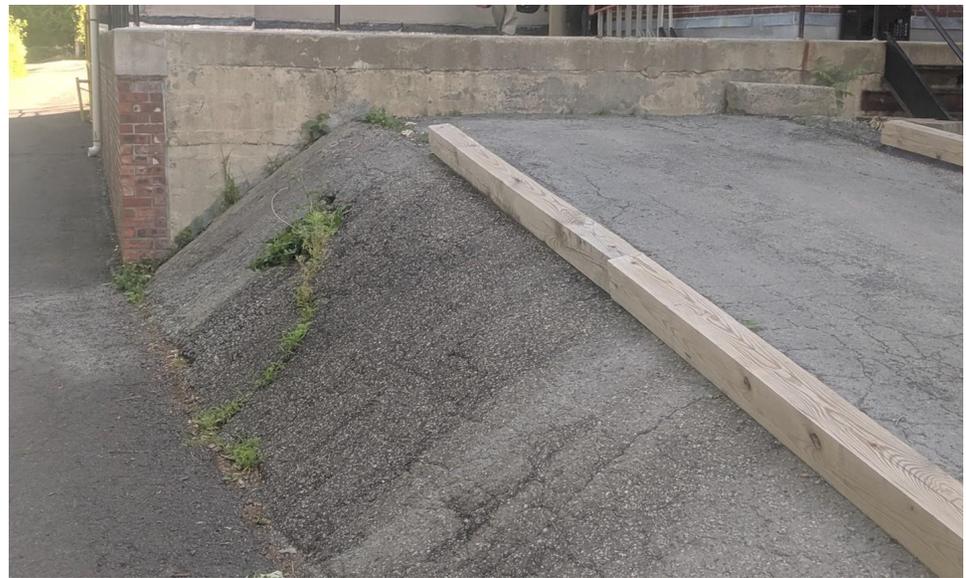
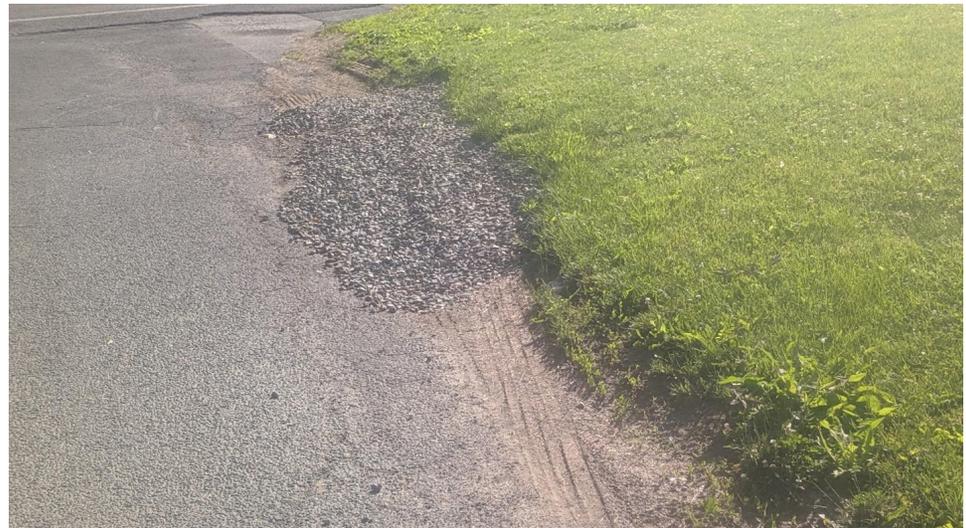
**Category 55: Pavement (Roadways and Parking Lots)**

Replace retaining wall supporting rear driveway/parking area pavement.  
Retaining wall worn and should be taller to reduce steep slope of pavement.  
Provide proper/safe loading dock. Replace driveway to staff parking.

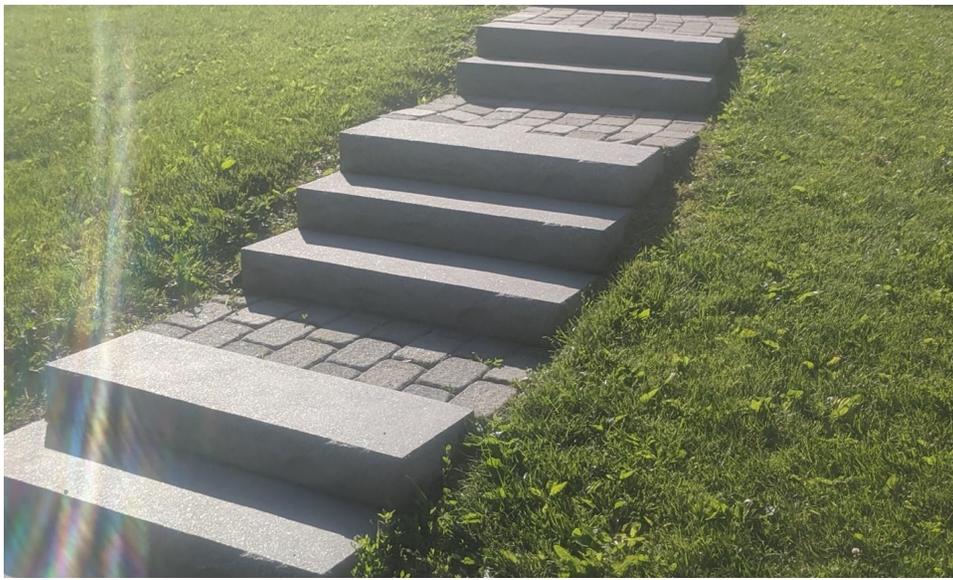
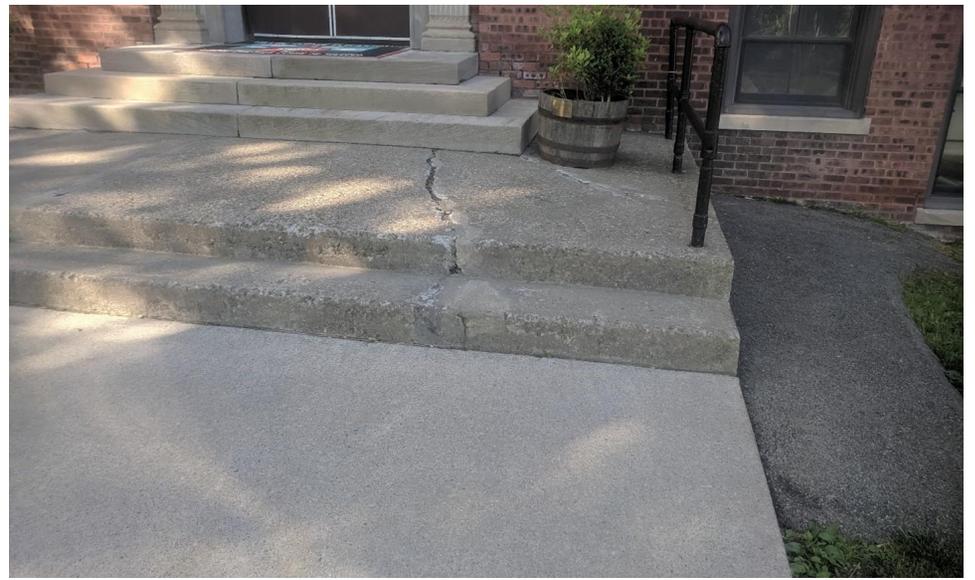
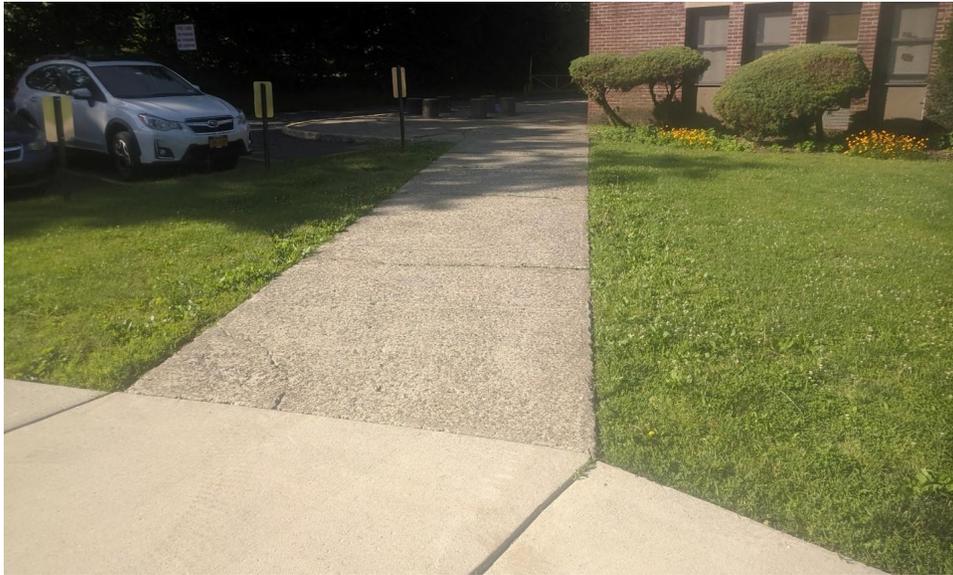
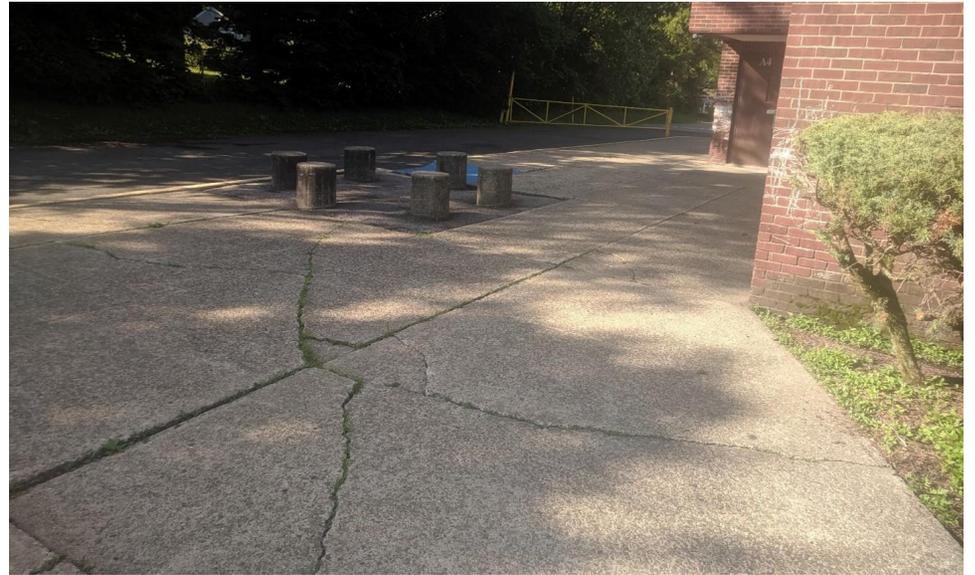
**Category 56: Sidewalks**

Repair/reset paver stairs at front of building. Replace stairs at front of building. Replace side entrance sidewalk. Reached useful life limit.

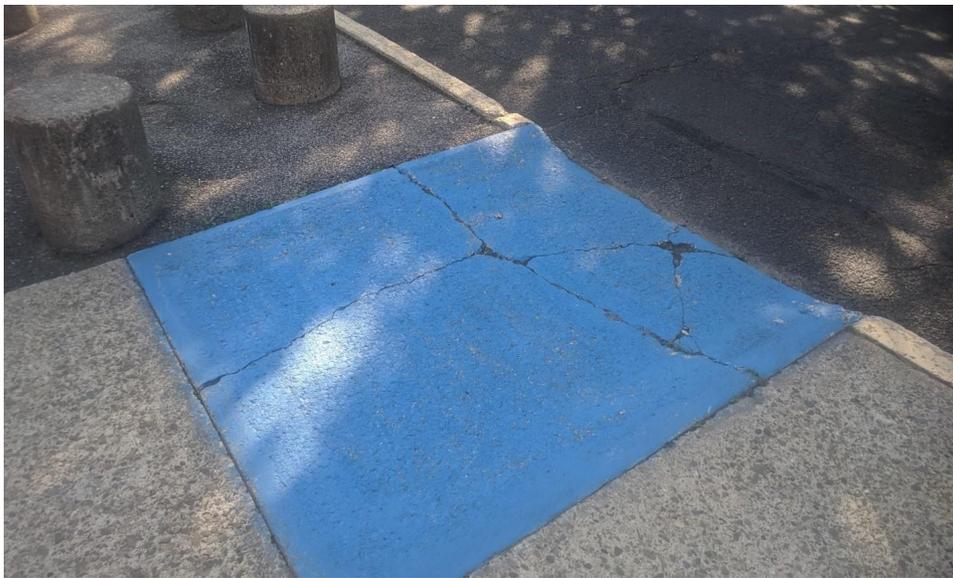
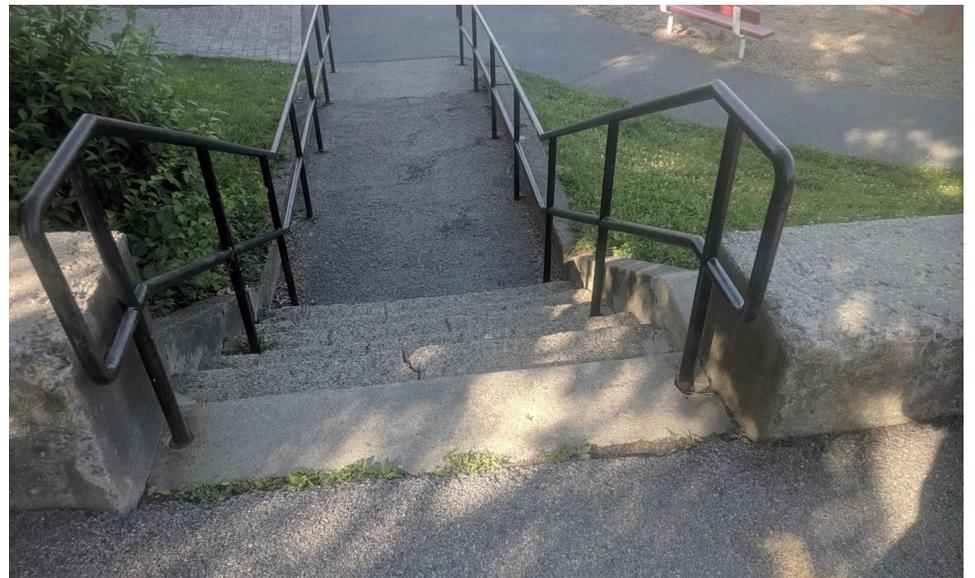
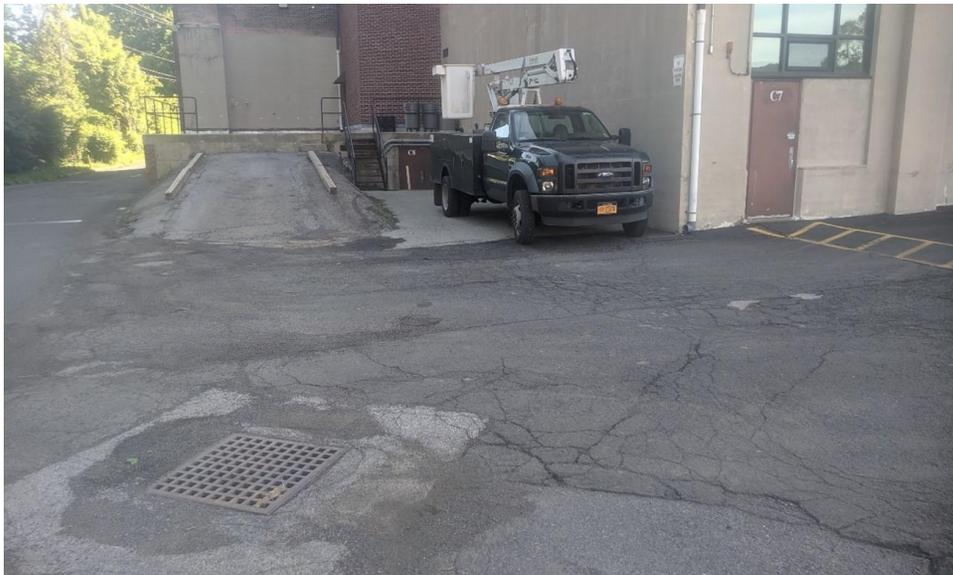
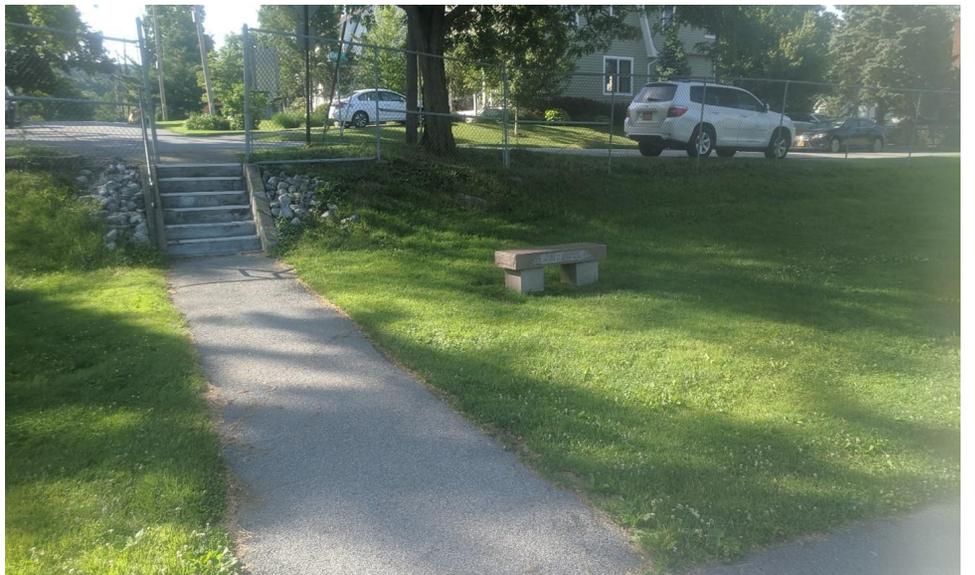
**Category 56: Sidewalks**

Install proper ADA ramp curbs. Replace concrete stair at retaining wall.  
Replace concrete stair at retaining wall between playground and Elm Street.  
Concrete stair in poor condition (especially top landing). Replace loading dock  
and stairs. Loading dock and stairs at end of useful life and not code compliant.

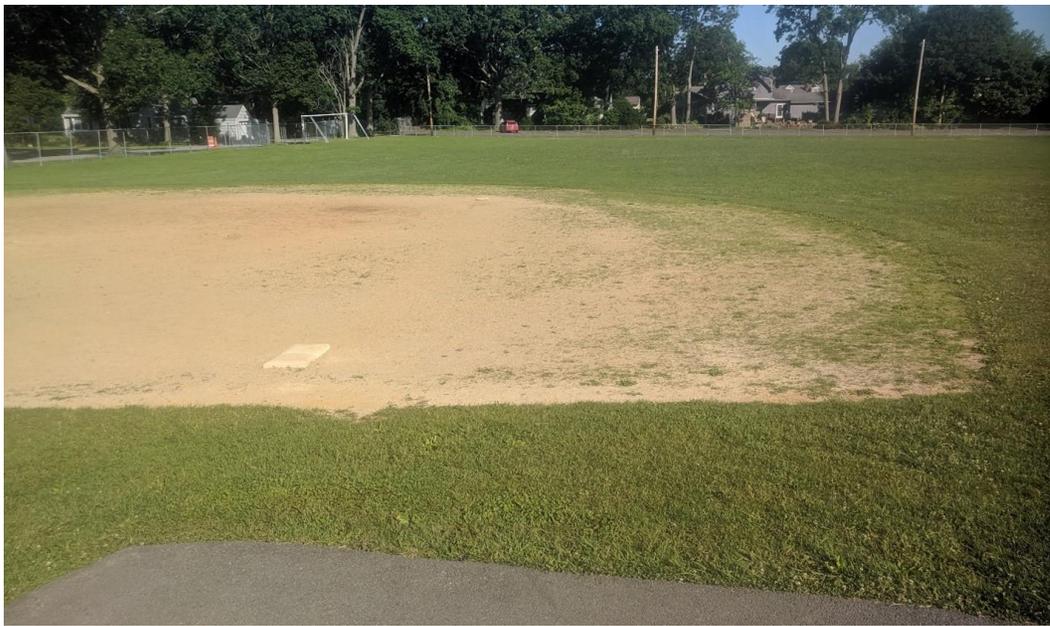
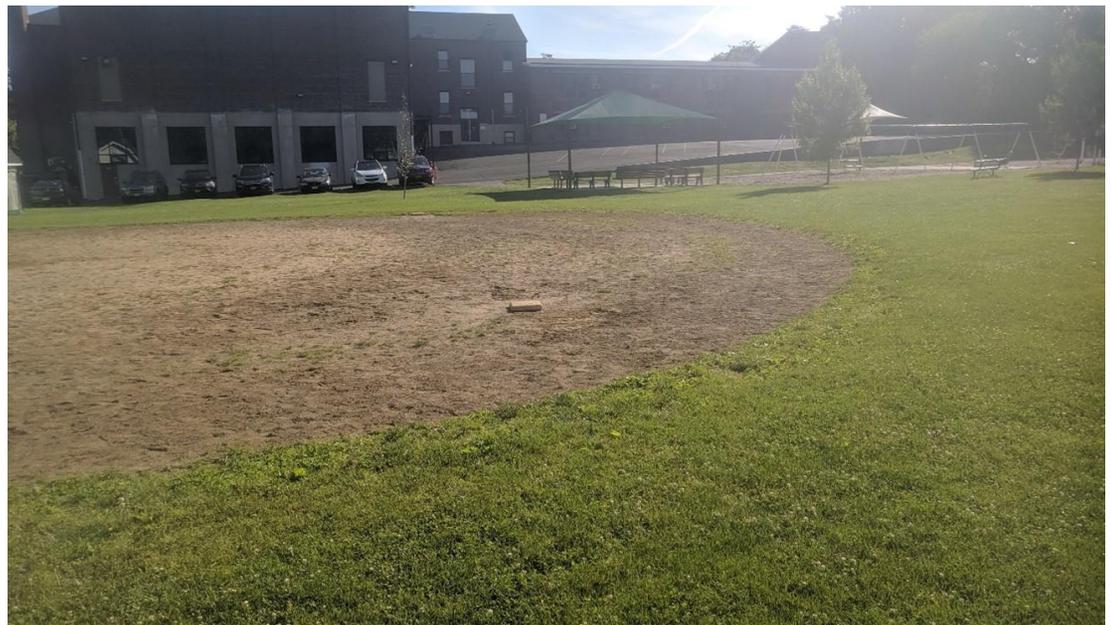
**Category 58: Athletic Fields and Play Fields**  
Repair/replace drainage at baseball fields. Visible ponding of water.

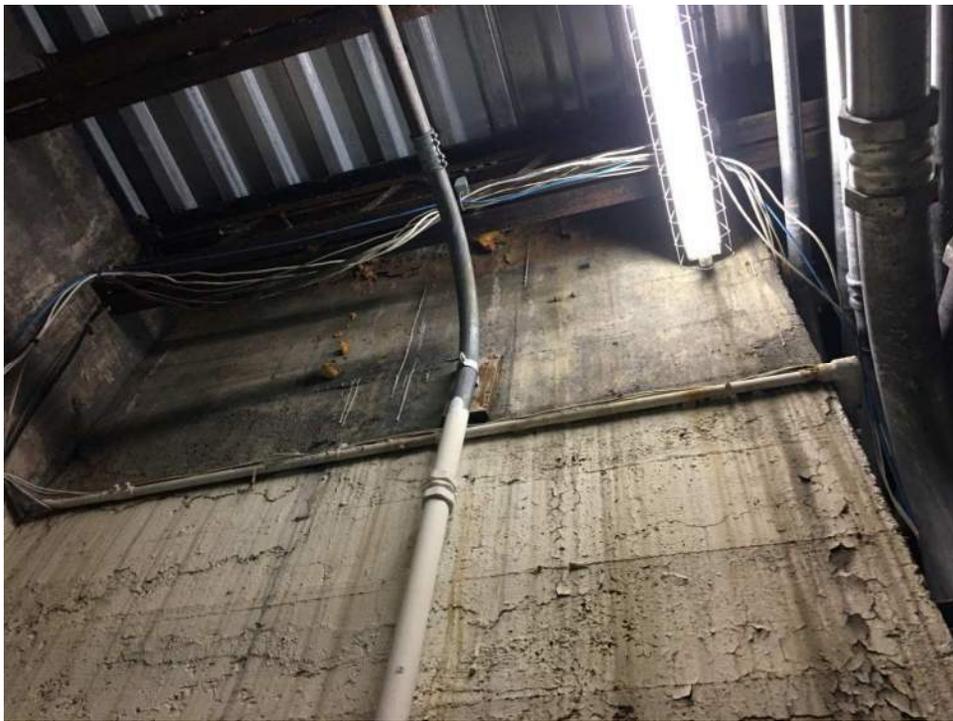
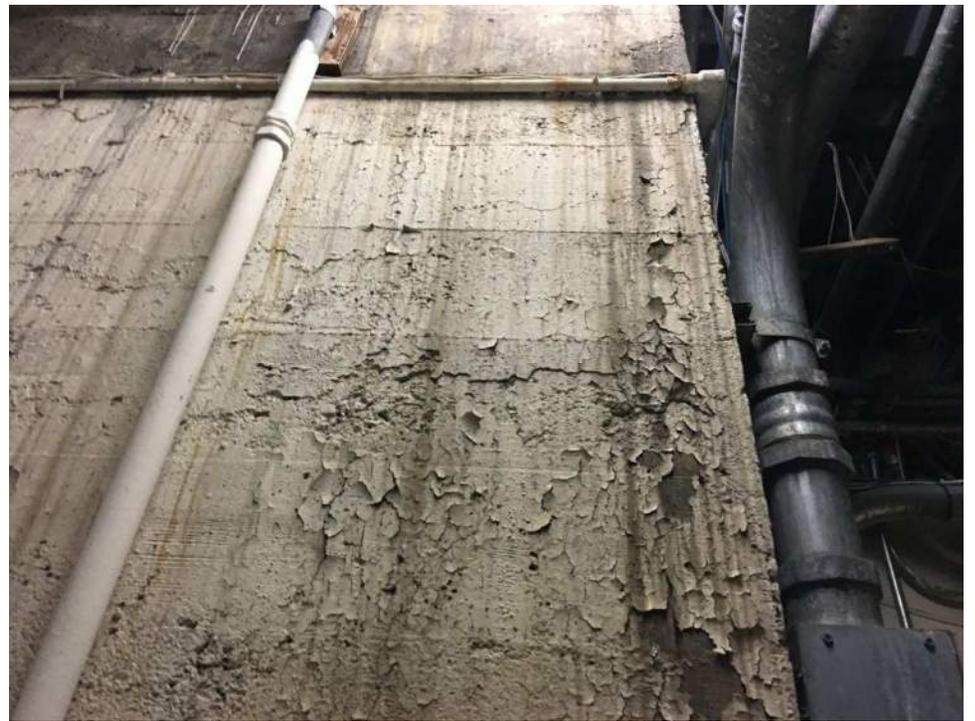
**Category 61: Foundation**

Water intrusion noted at loading dock basement area.  
Further investigate with a civil/ structural consultant.

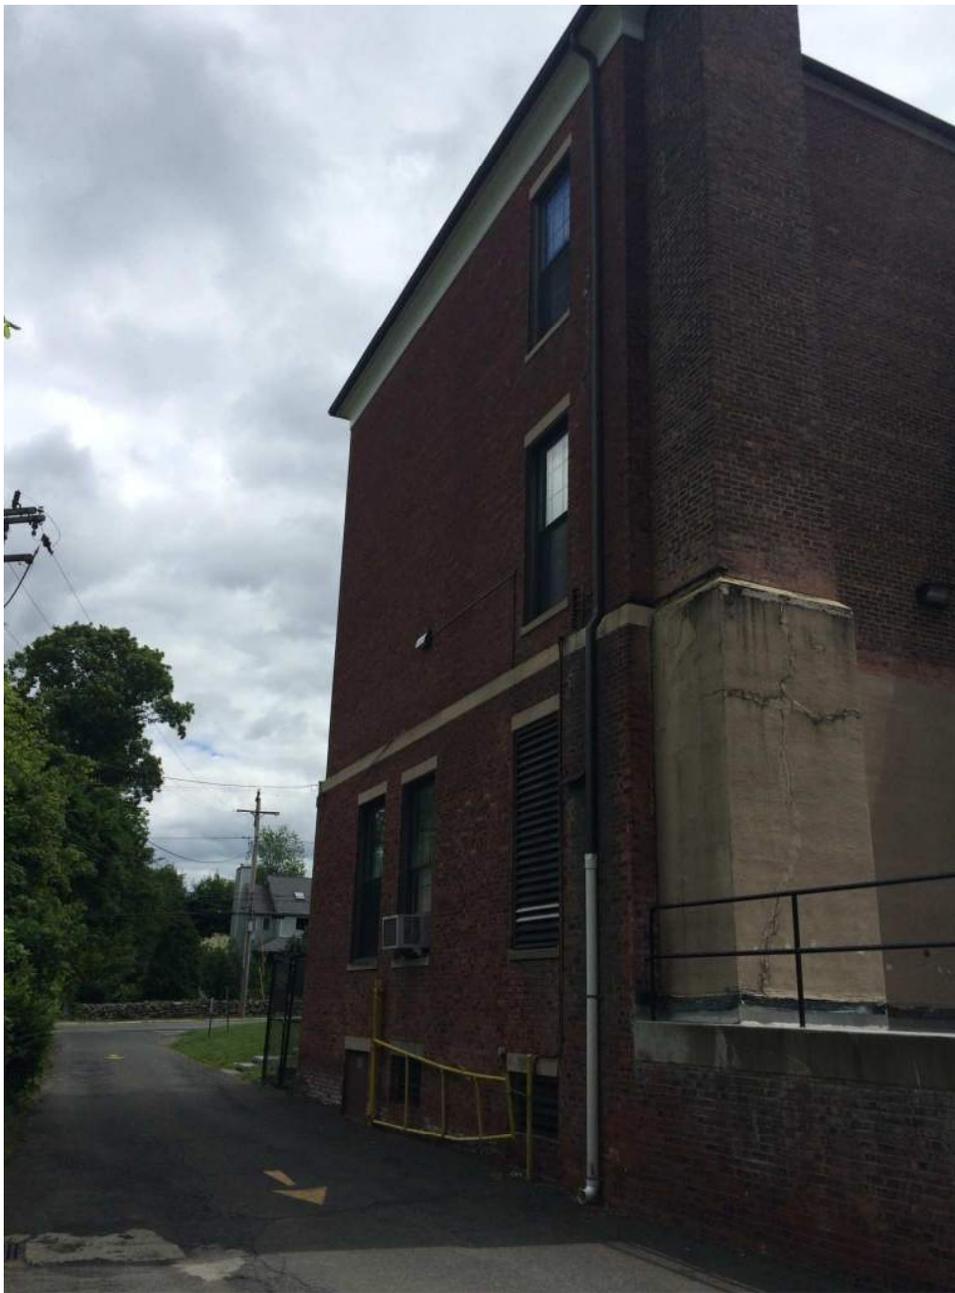
WA-25

**Category 67: Chimneys**

Repair cracking at lower stucco wall finish at the back of the building near loading dock.

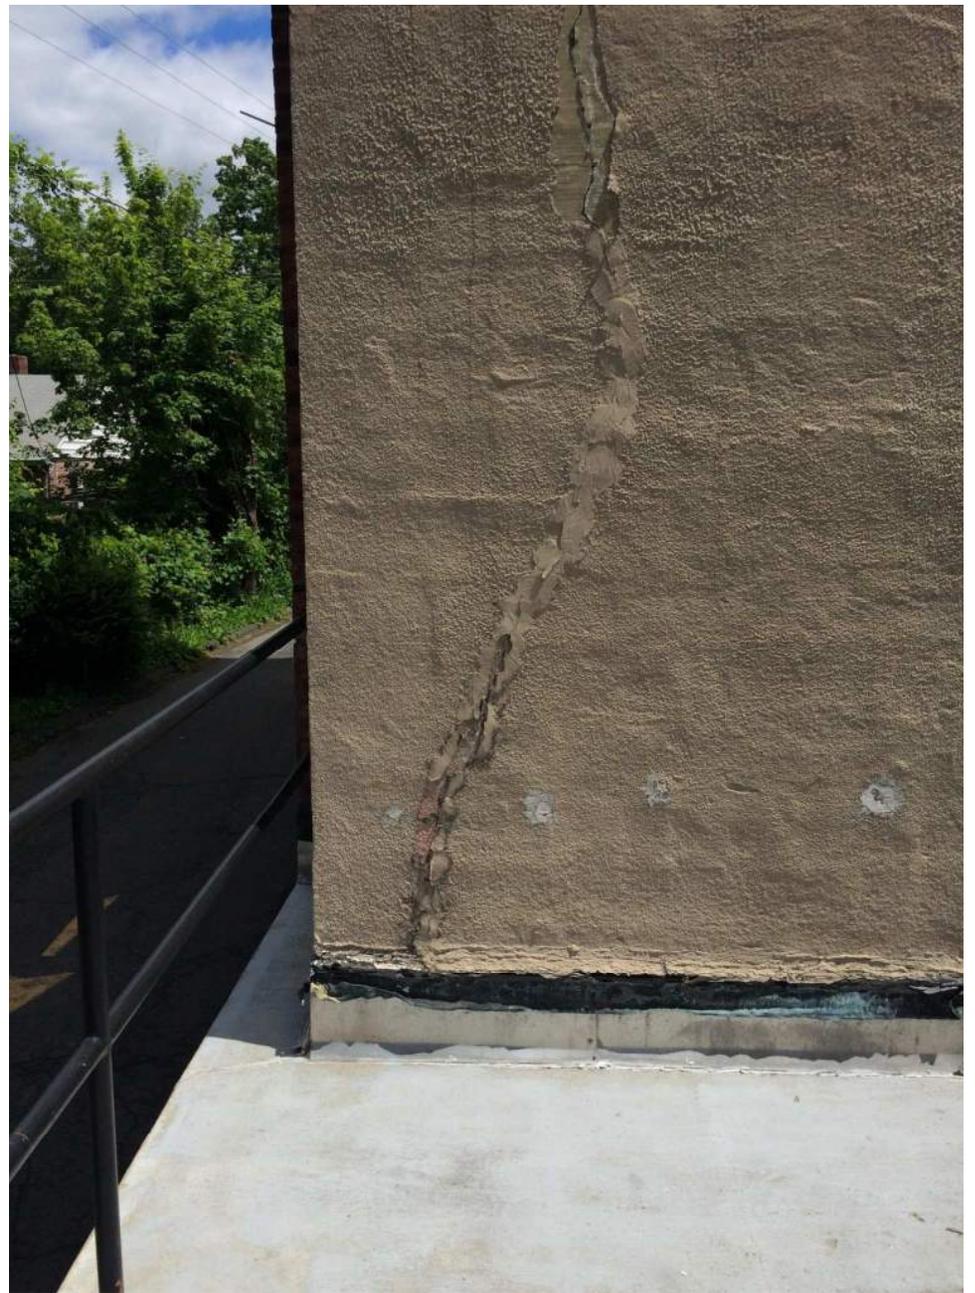
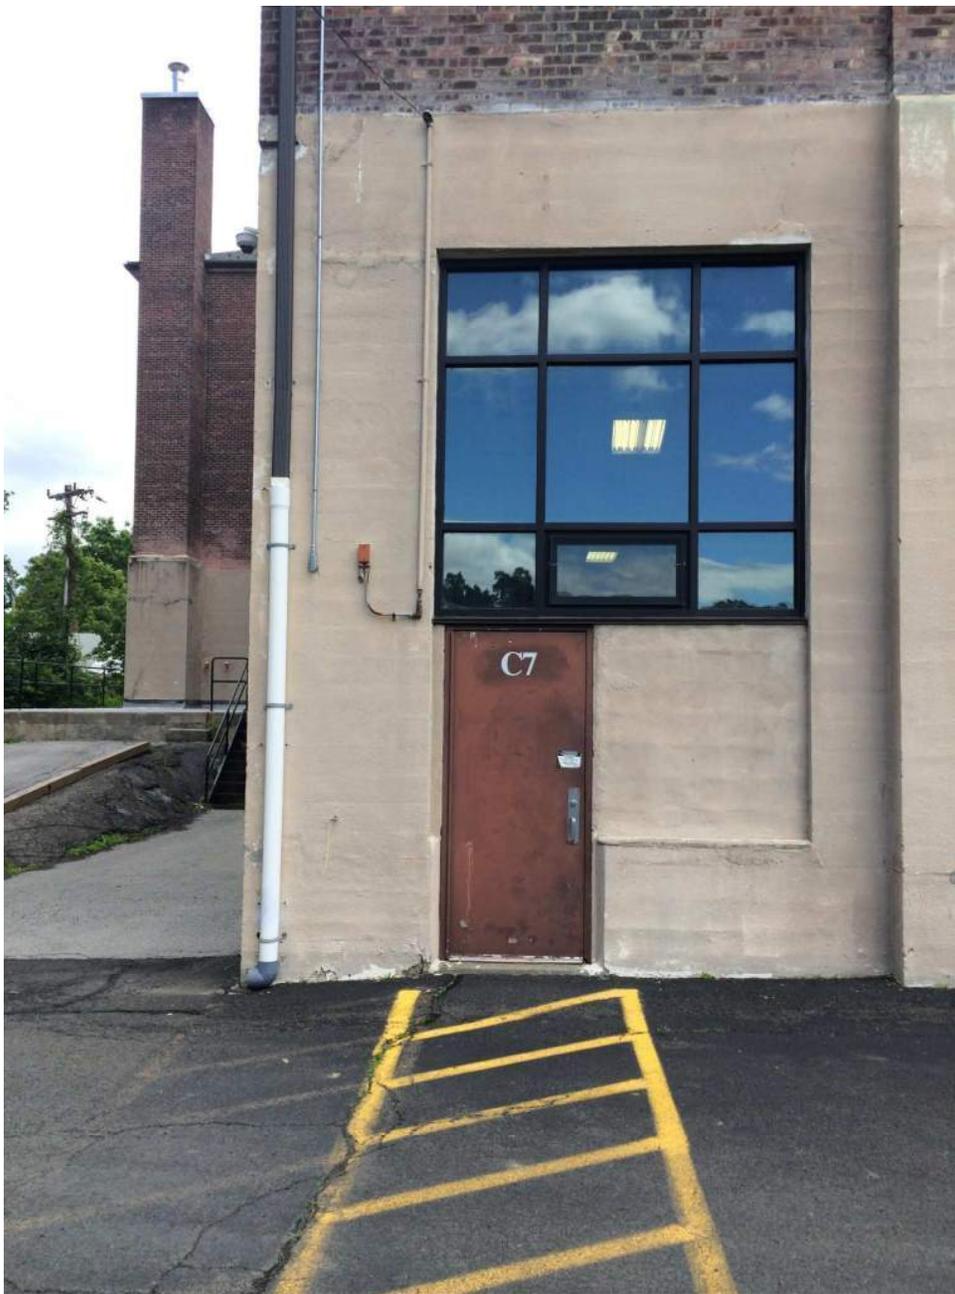
**Category 69: Exterior Doors**

Replace exterior doors and frames (hollow metal).

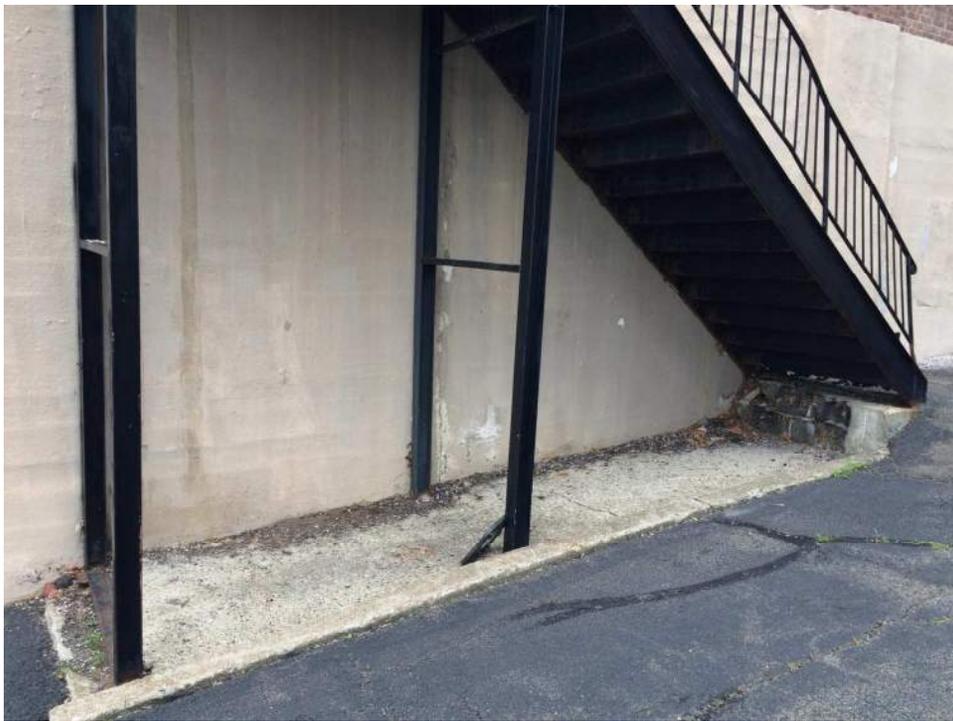
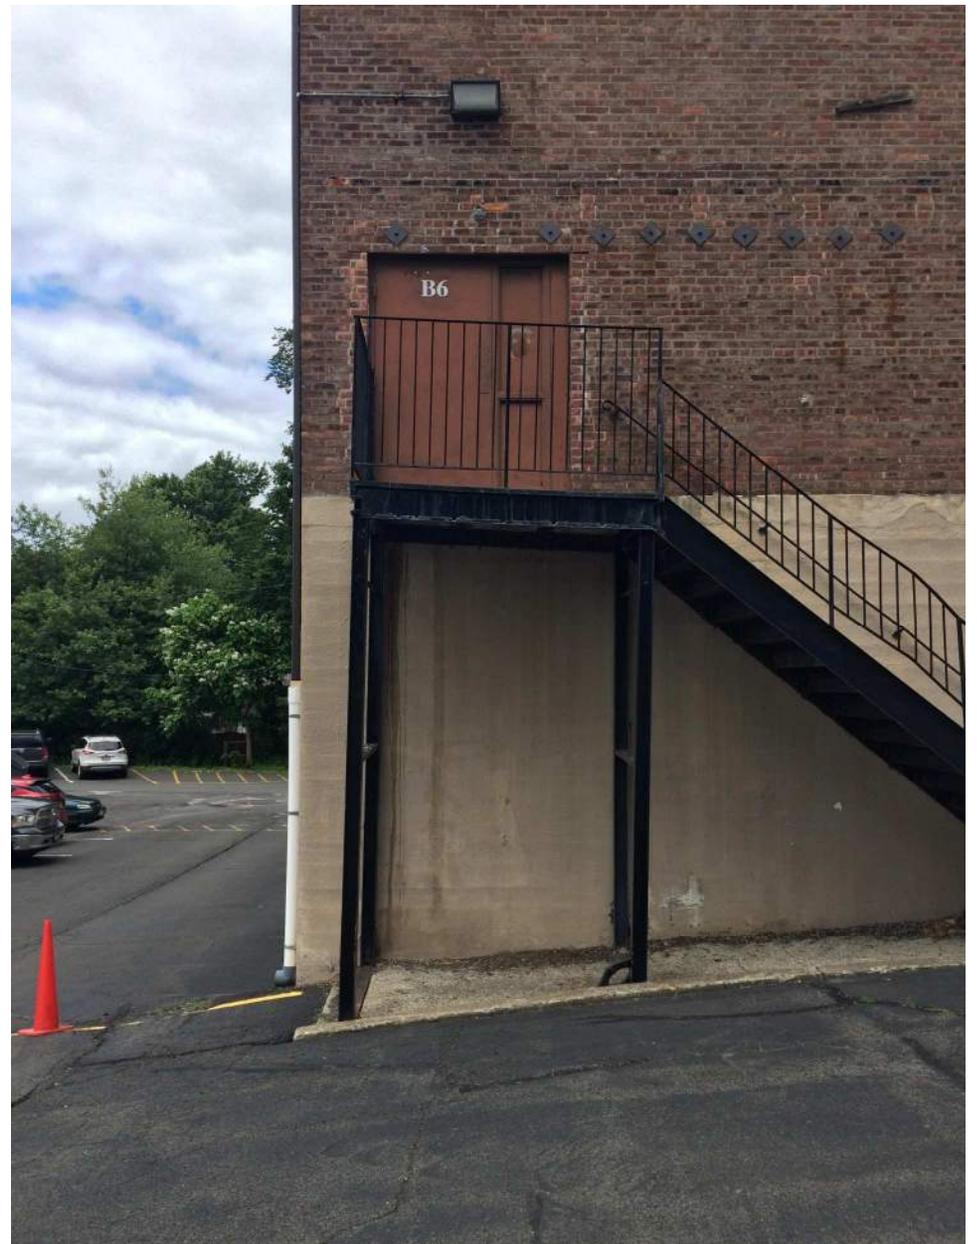
**Category 71: Fire Escapes**

Fire escape replacement- construct additional exiting to the auditorium.

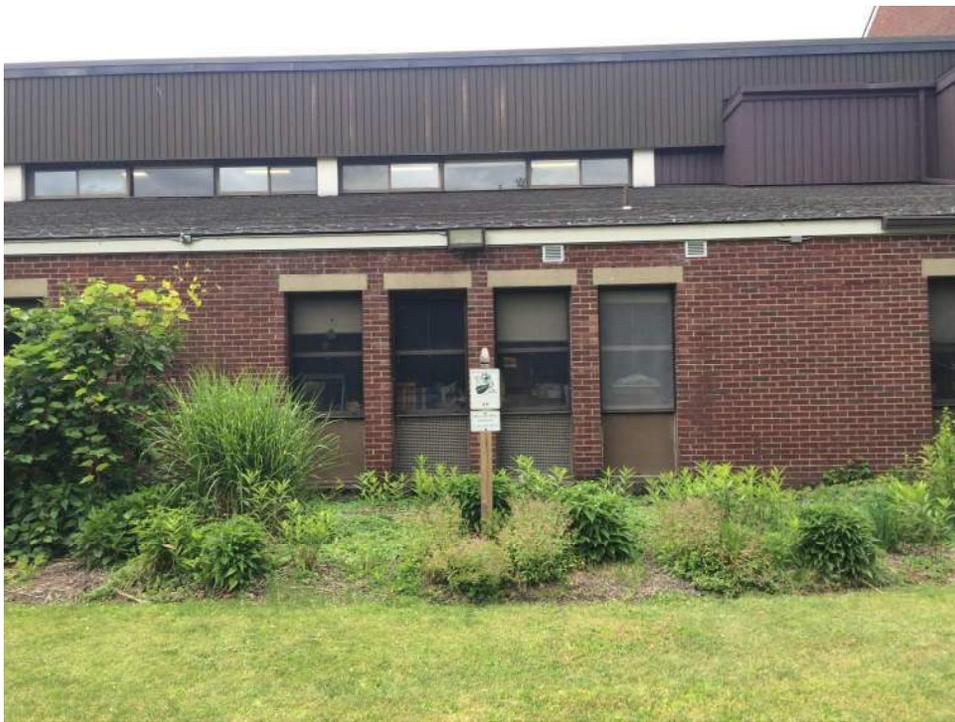
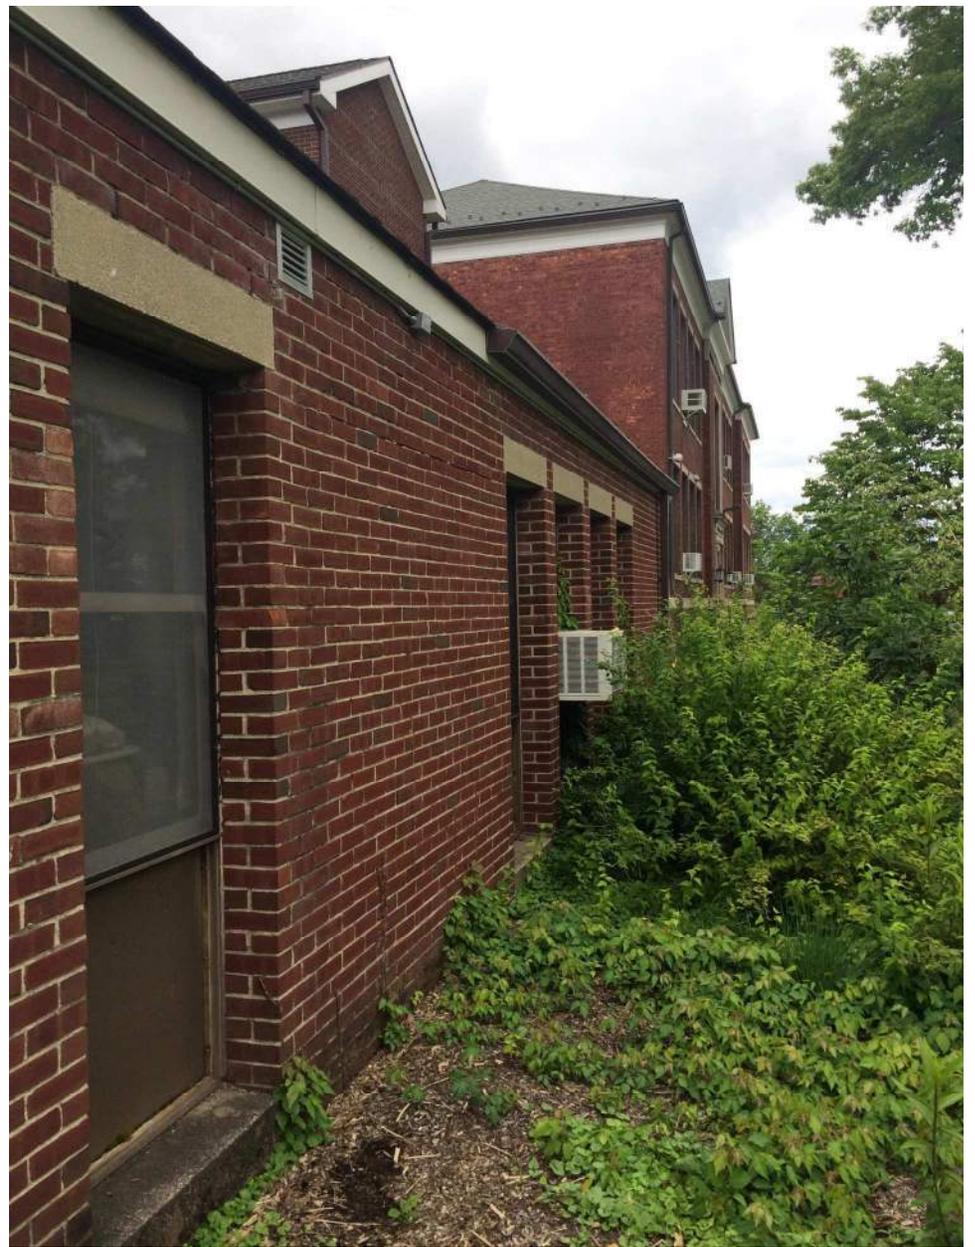
**Category 72: Windows**

Replace existing window systems in the 1972 wing.

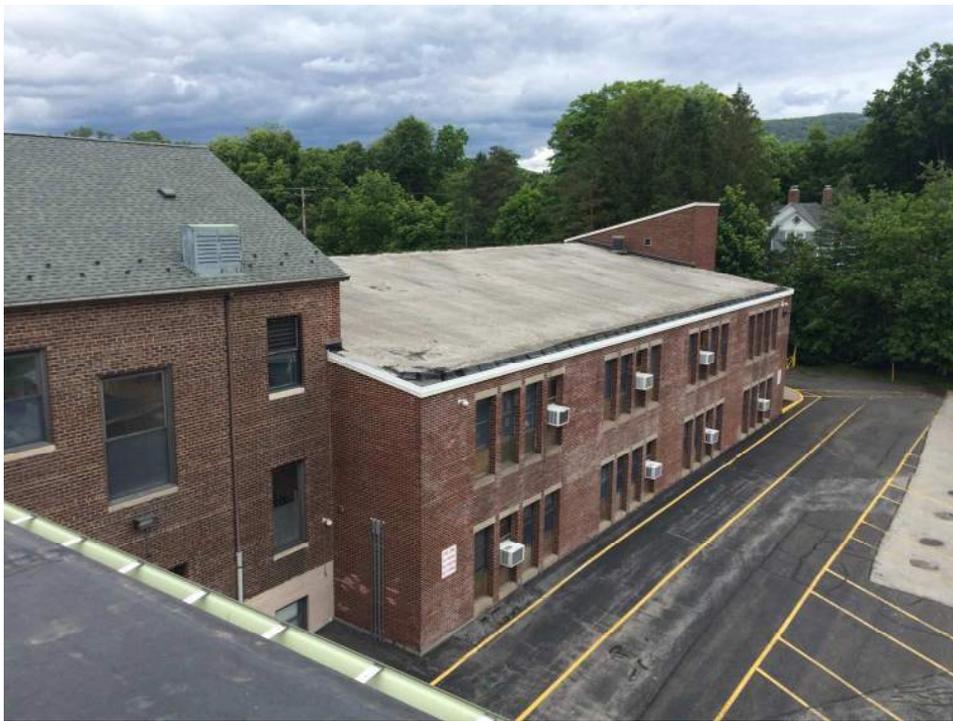
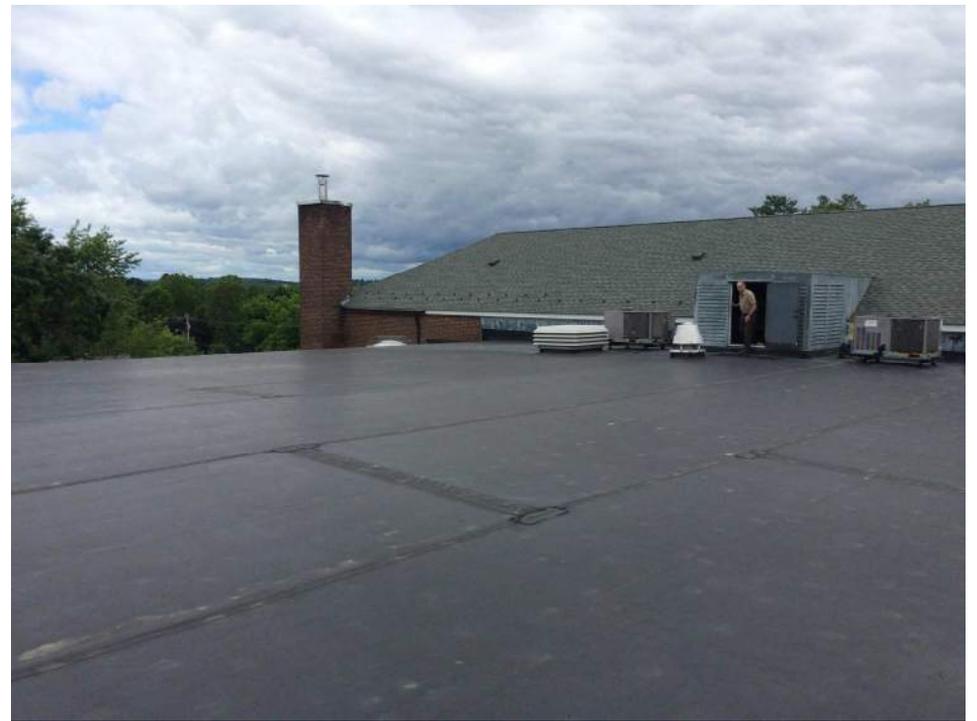
**Category 73: Roof & Skylights**

Replace roof area along the back of the 1972 wing.  
Existing ballasted built-up roofing. Evaluate the need for  
fall protection of flat roofs with mechanical equipment  
within 10'-0" of roof edge.
