**2020 BUILDING  
CONDITION SURVEY  
REPORT**

CORNWALL CENTRAL  
SCHOOL DISTRICT

Willow Avenue  
Elementary School

January 2021

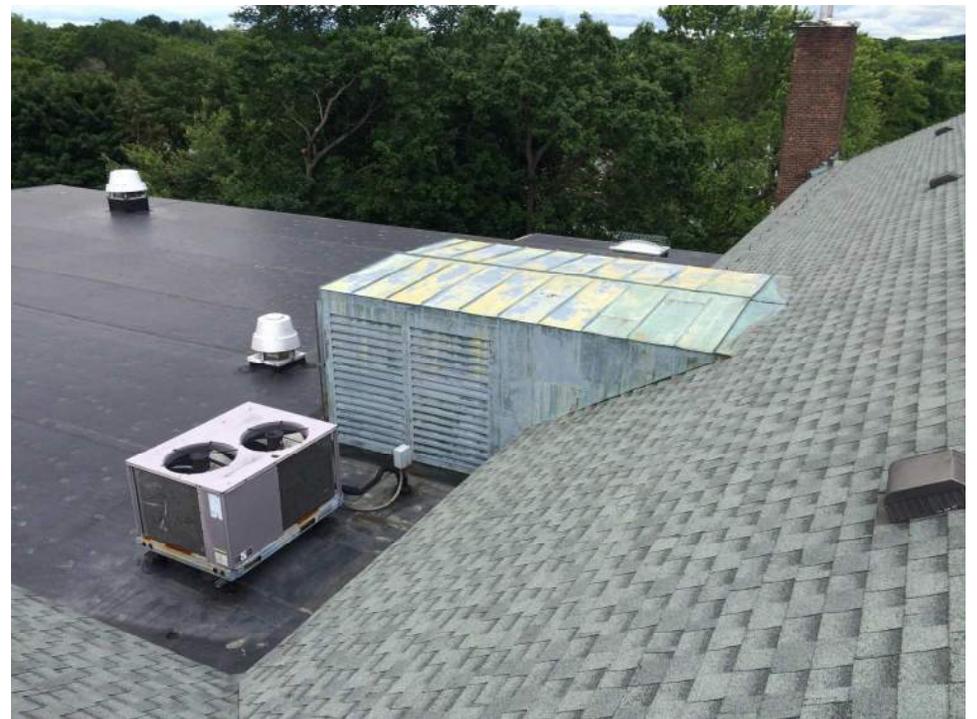
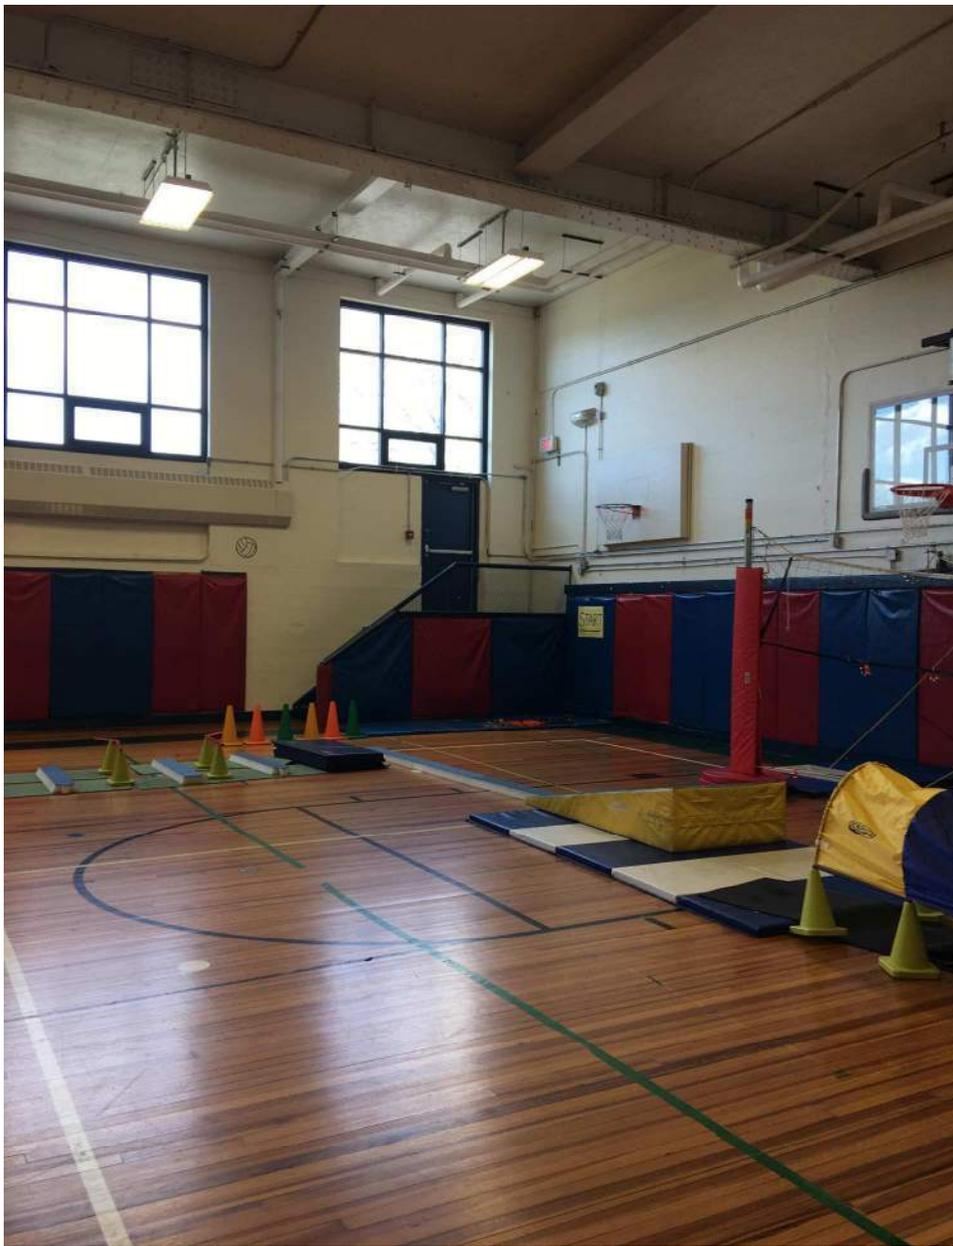
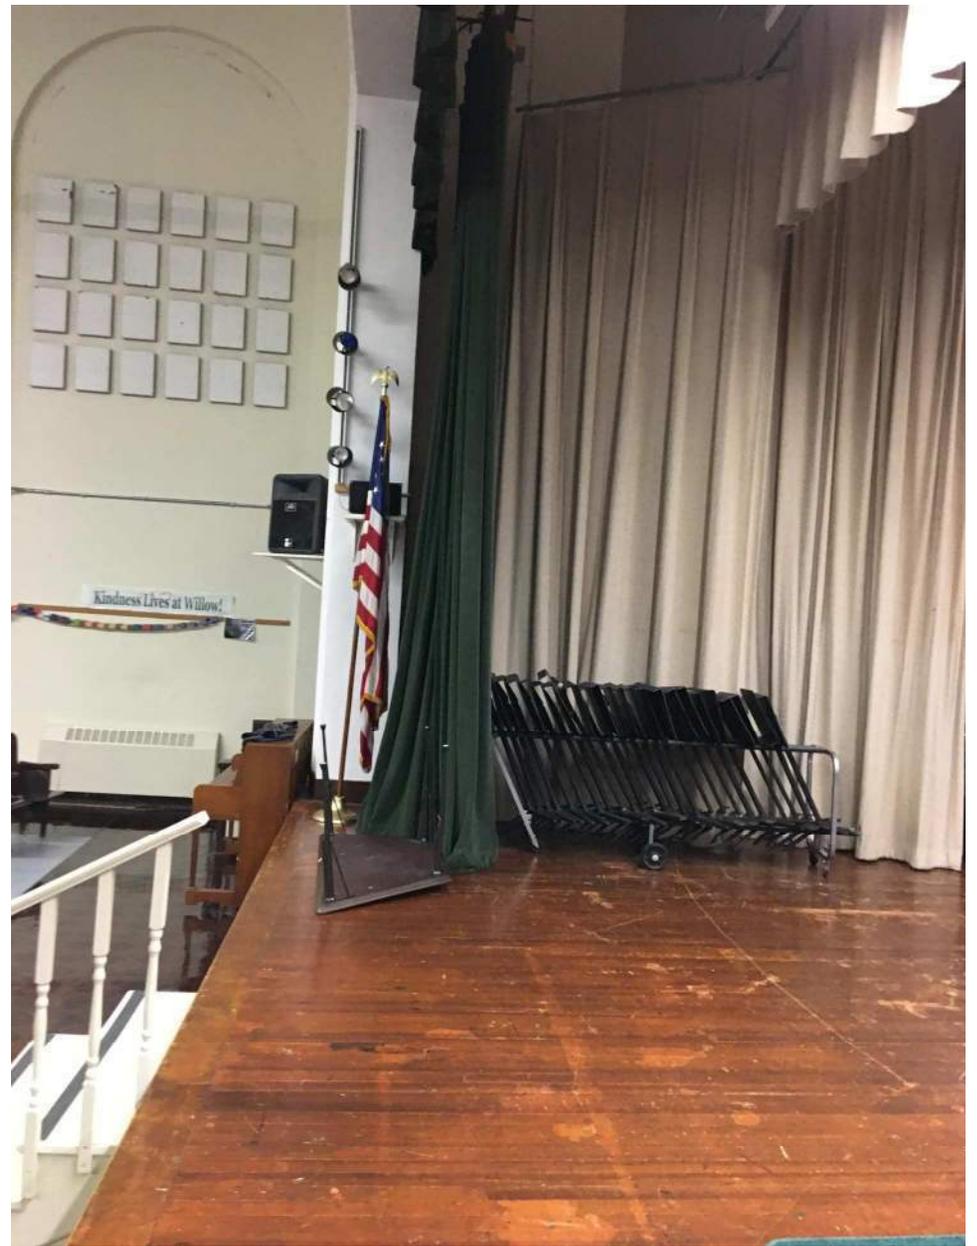
**Category 79: Wood Flooring**

Replace gymnasium flooring. Consider refinishing stage flooring.

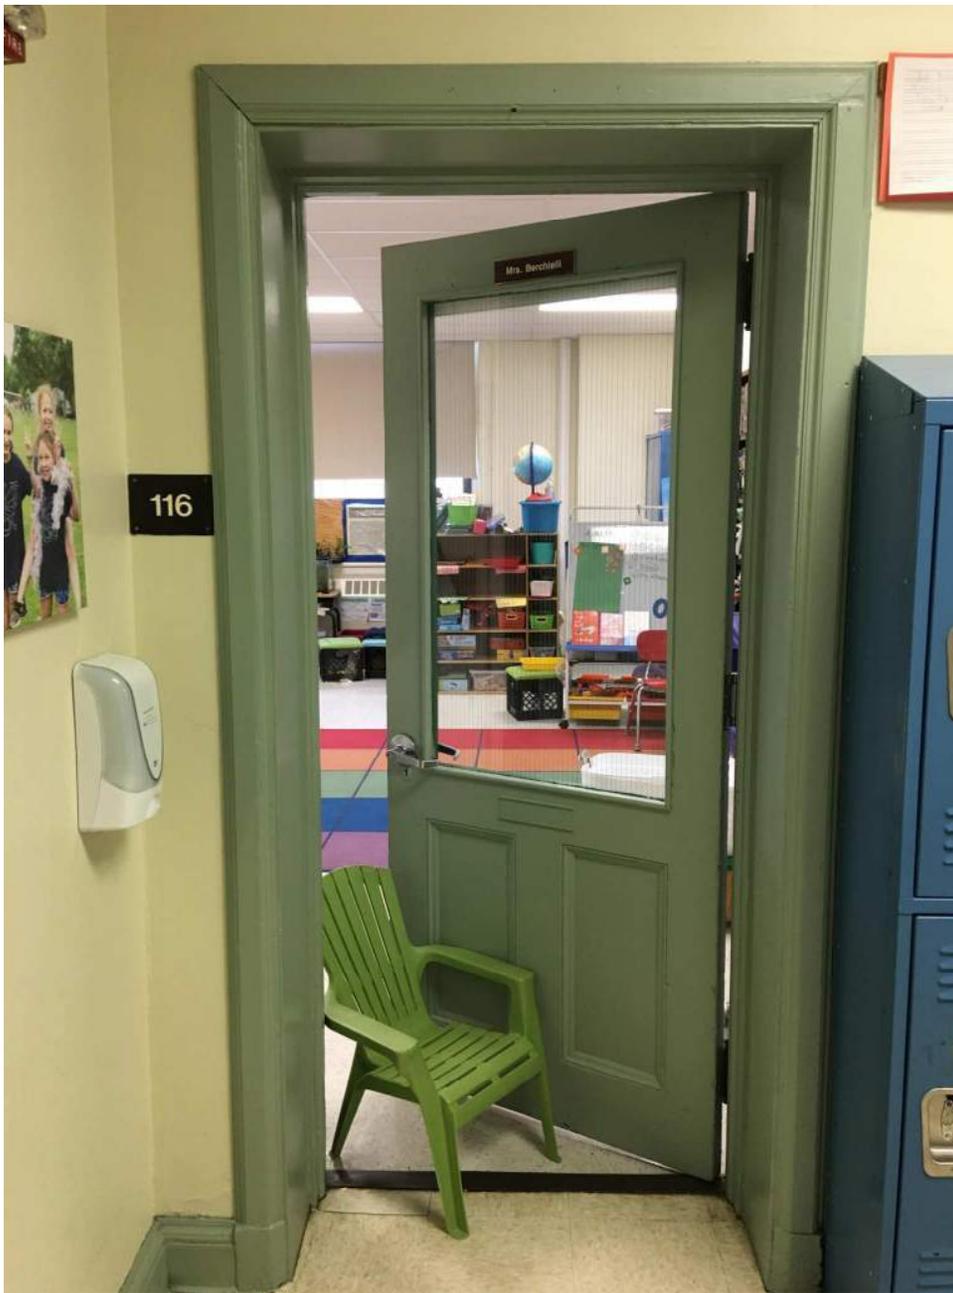
WA-43

**Category 82: Interior Doors**

Replace doors and frames in classrooms. Replace central stairwell doors.

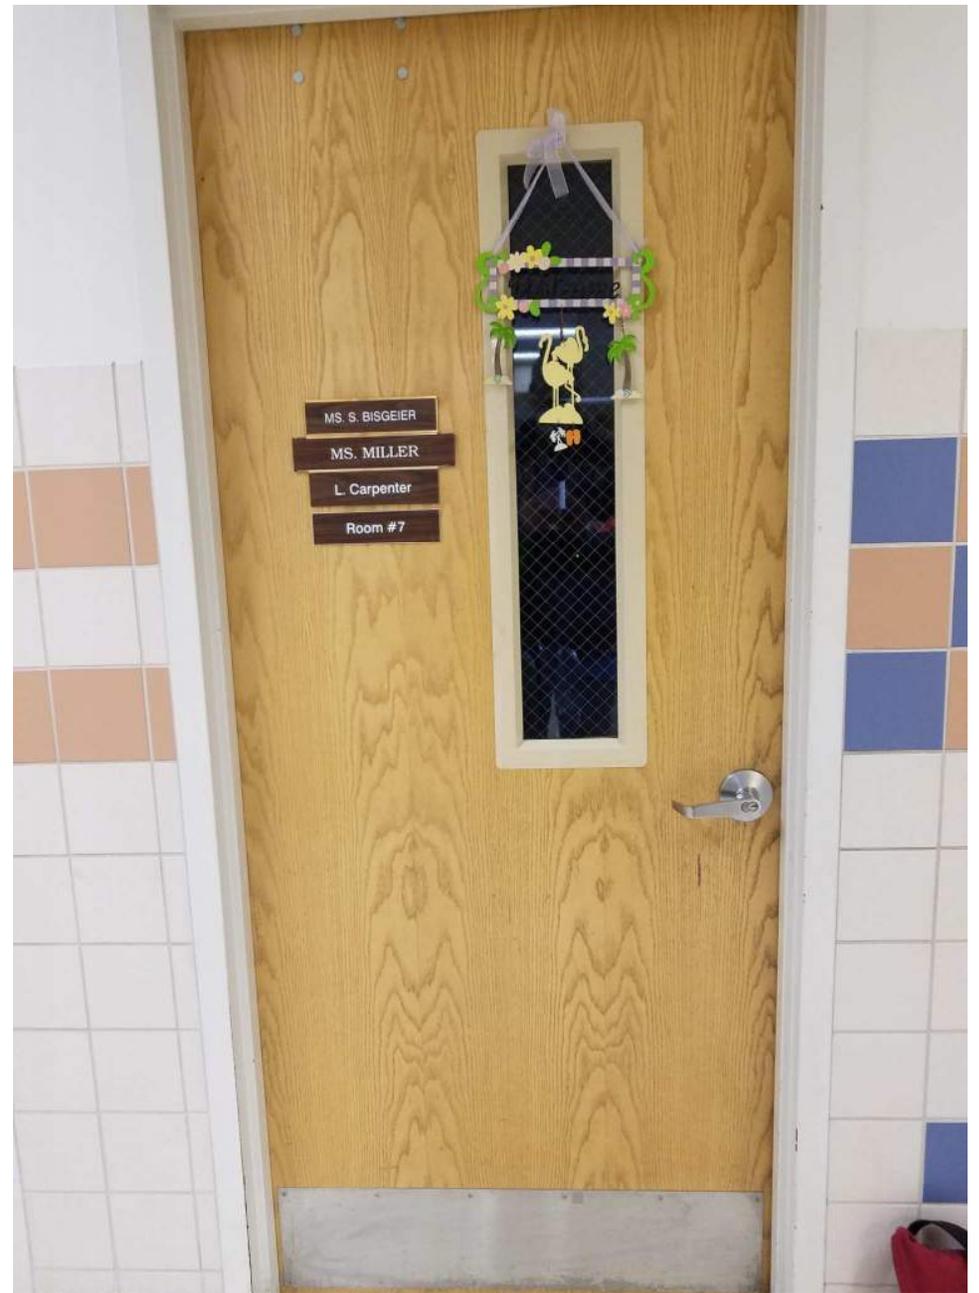
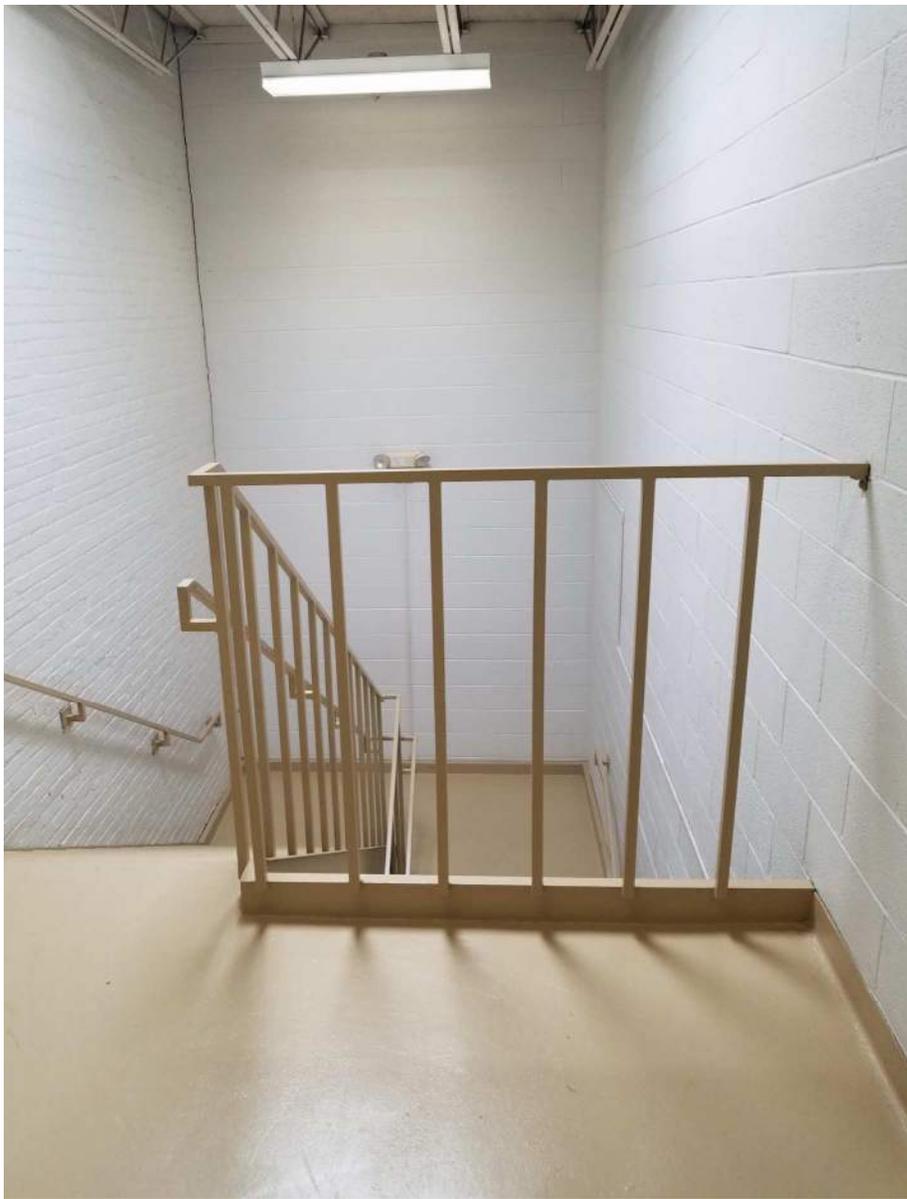
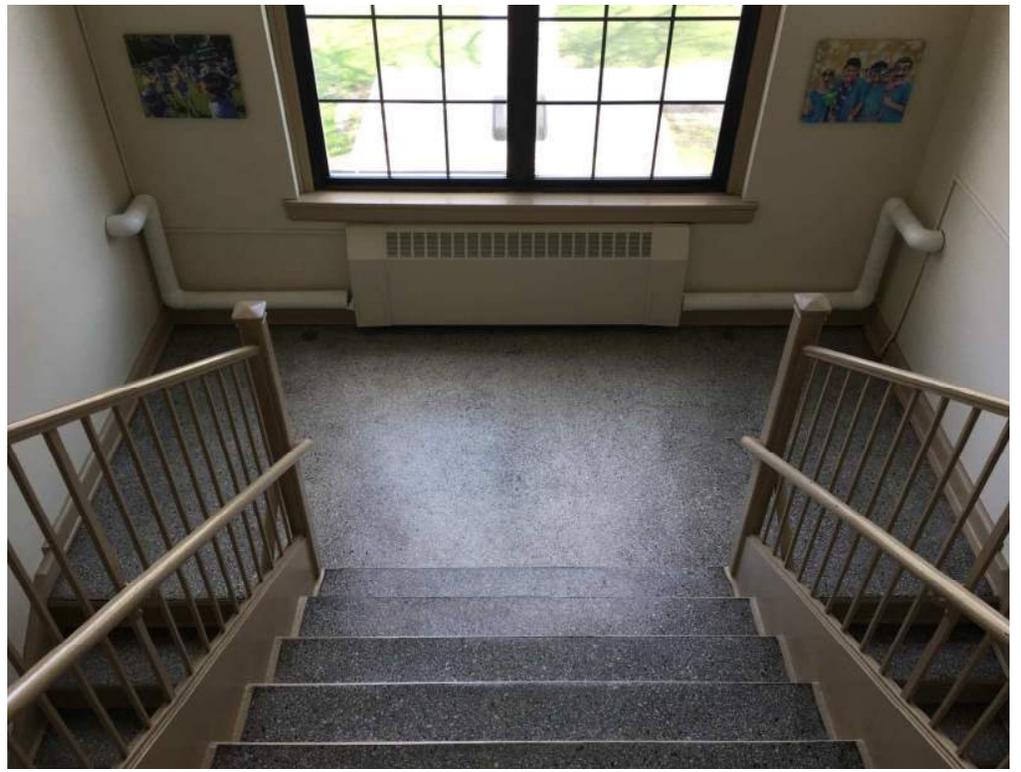
**Category 83: Interior Stairs**

Replace hand and guard rails building wide.

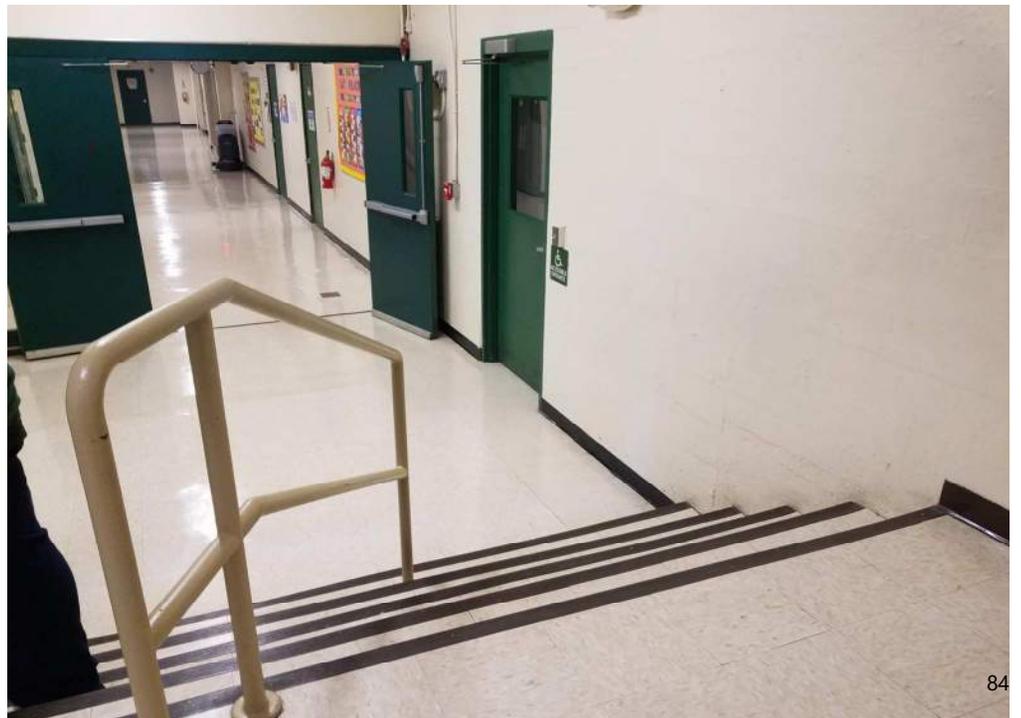
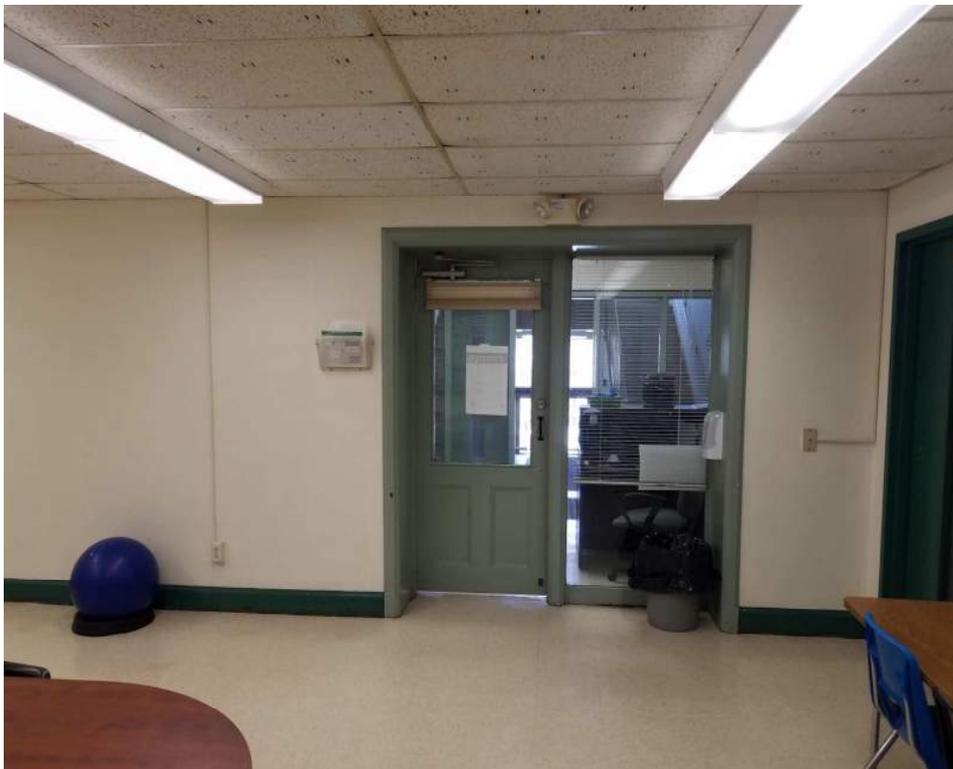
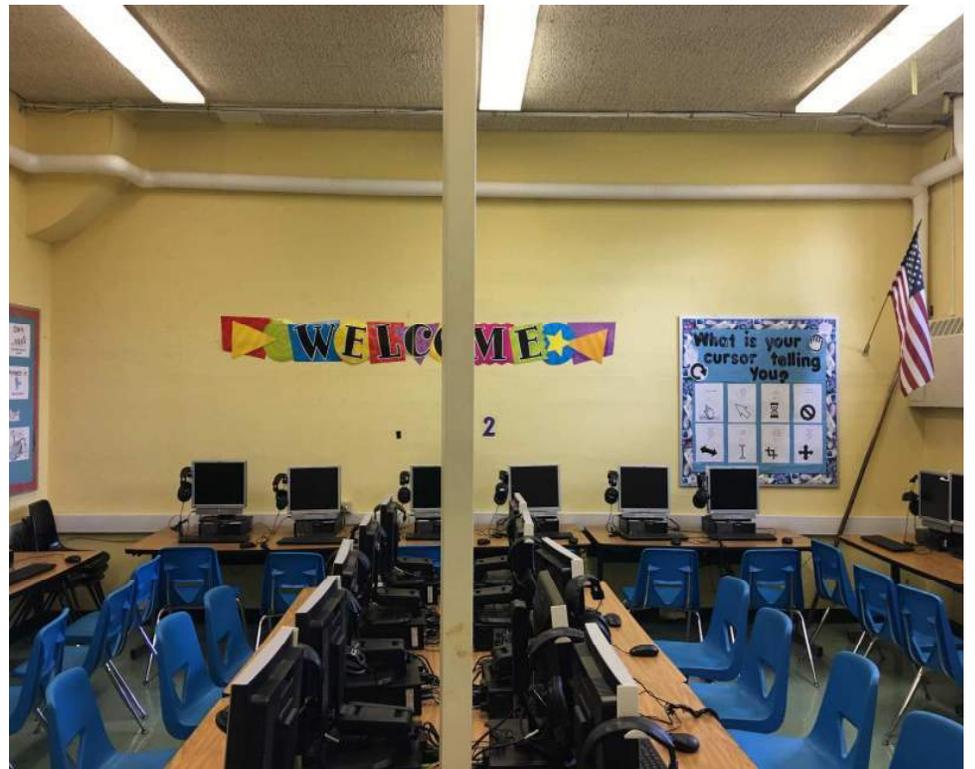
**Category 102: Lighting Fixtures**

Replace old 2x4 T8 lighting fixtures with high efficiency LED fixtures (include controls).

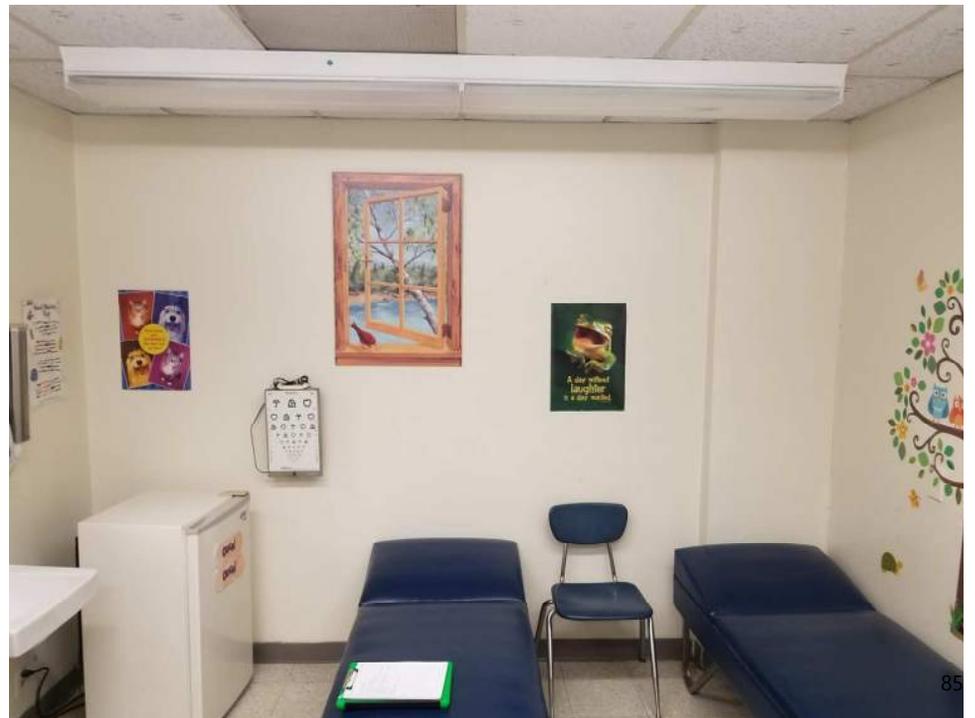
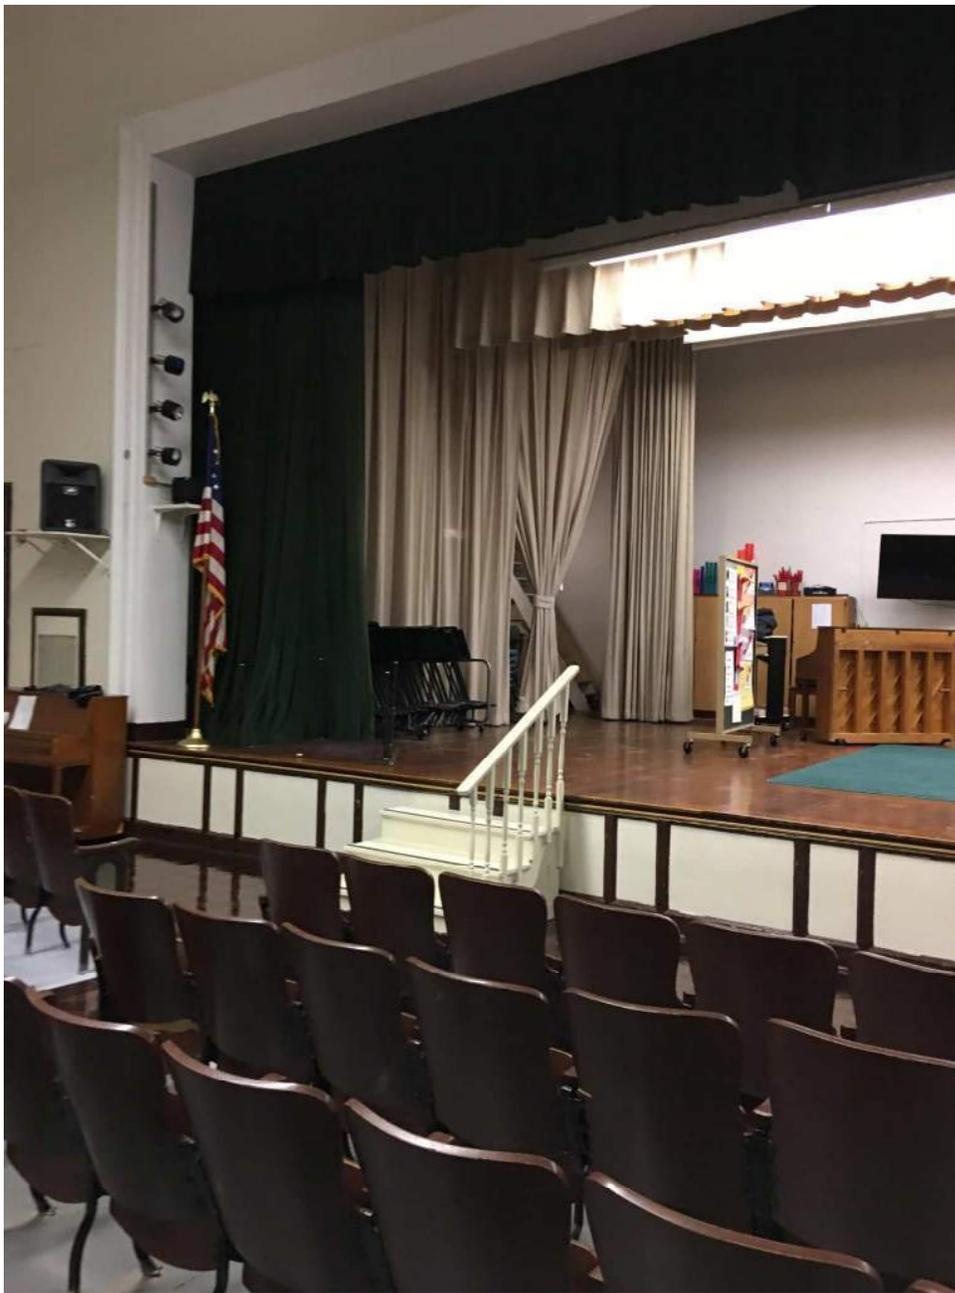
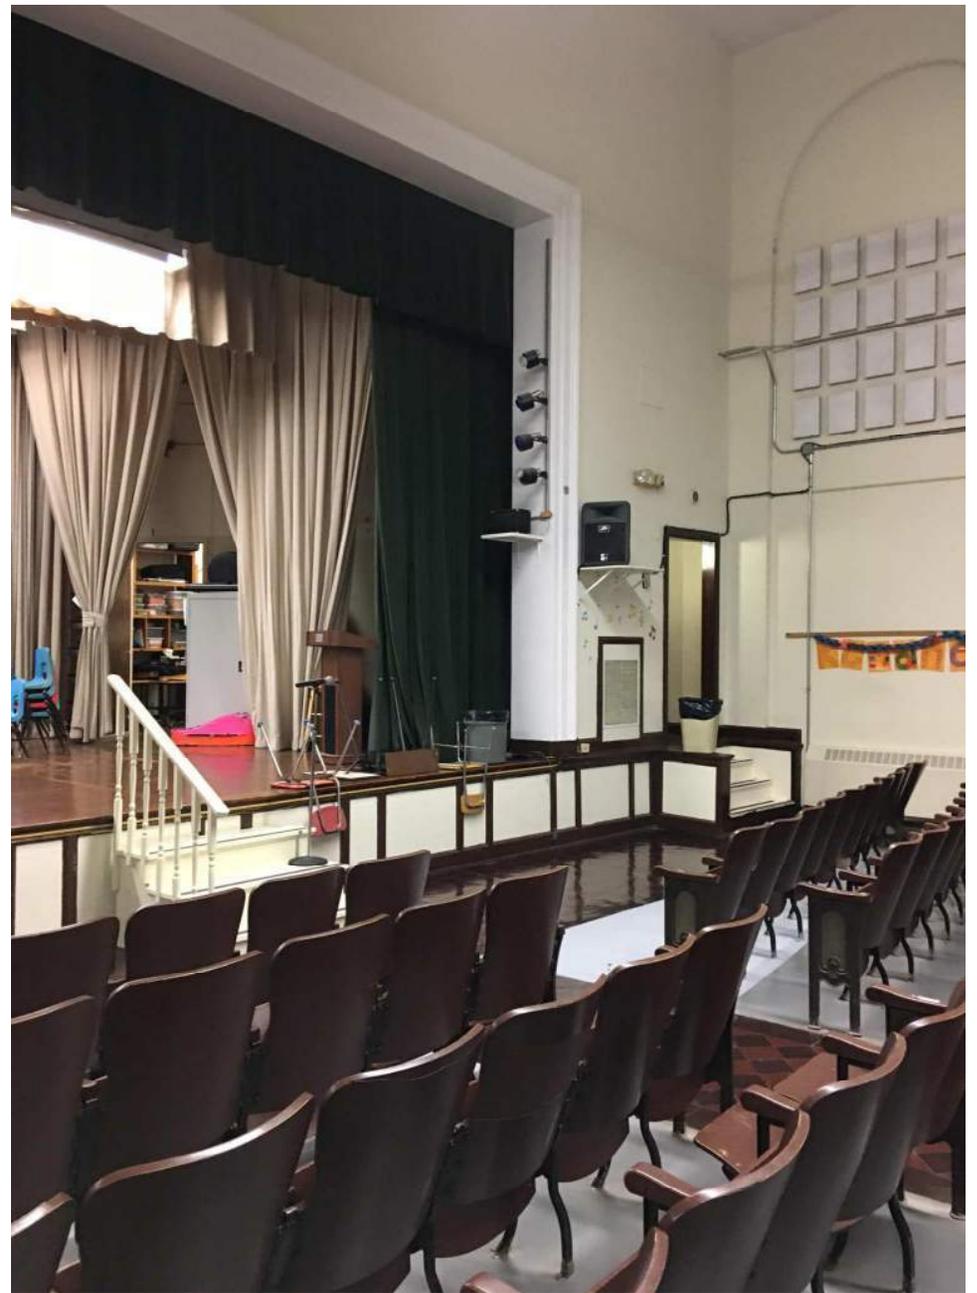
**Category 115 & 116: Interior Accessible Route, Access to Goods & Services, and Restroom Facilities**  
Auditorium stage not accessible. Consider installing a lift.

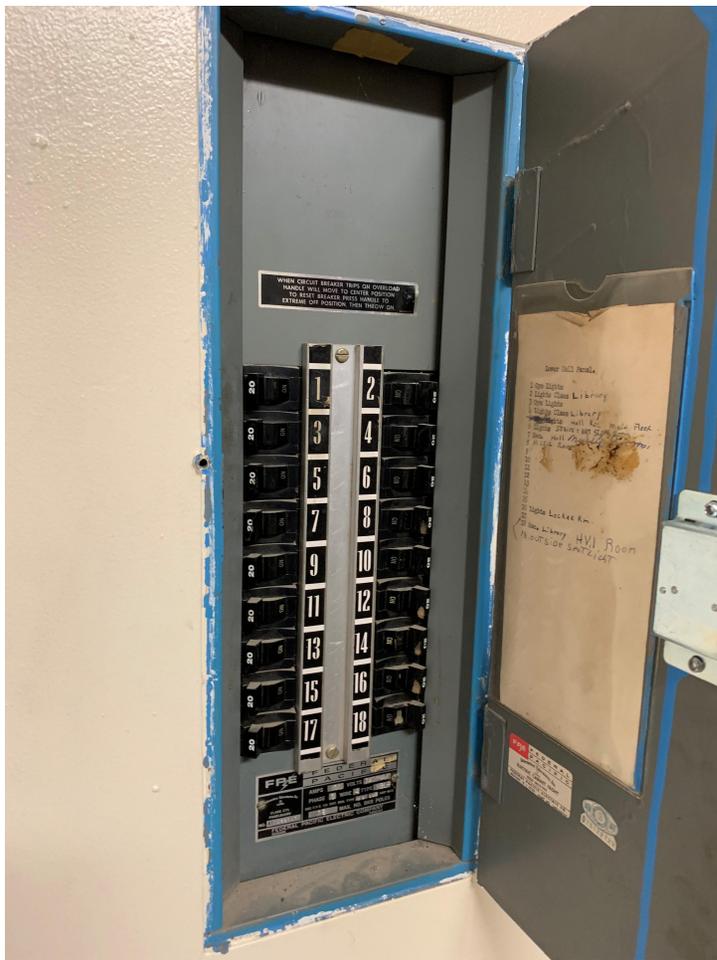
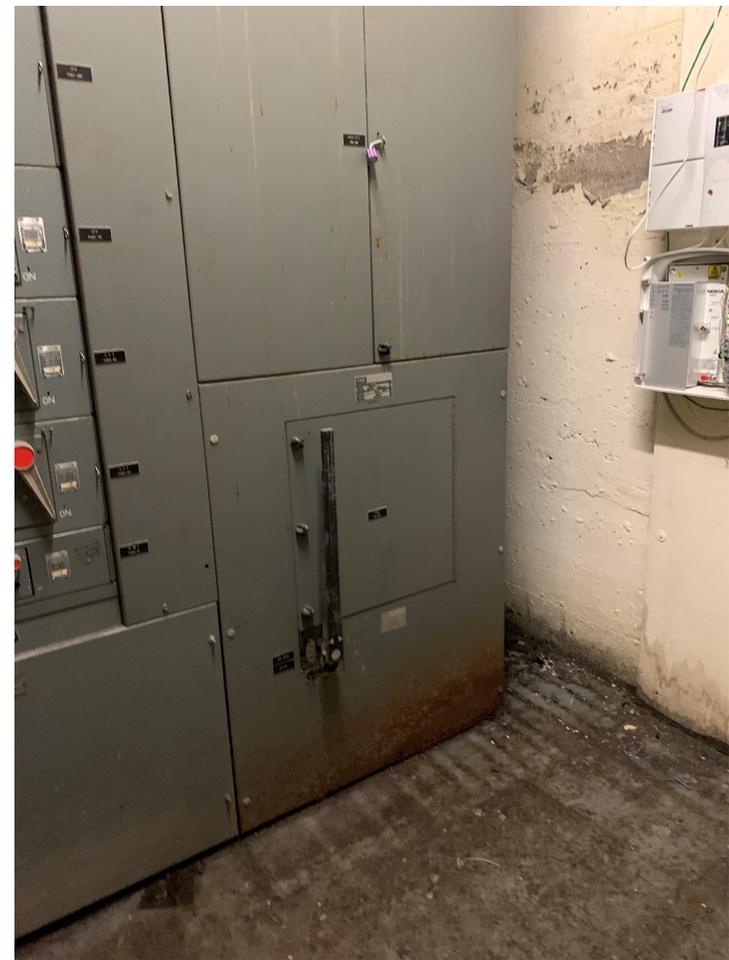
### Category 101: Electrical Distribution Systems

Existing switchboard assembly is past its useful life with possible water damage from previous flooding. Existing panels are approximately 50 years old and require replacement.
