**2020 BUILDING
CONDITION SURVEY
REPORT**

CORNWALL CENTRAL
SCHOOL DISTRICT

Central
Administration

CSArch Project #204-1901

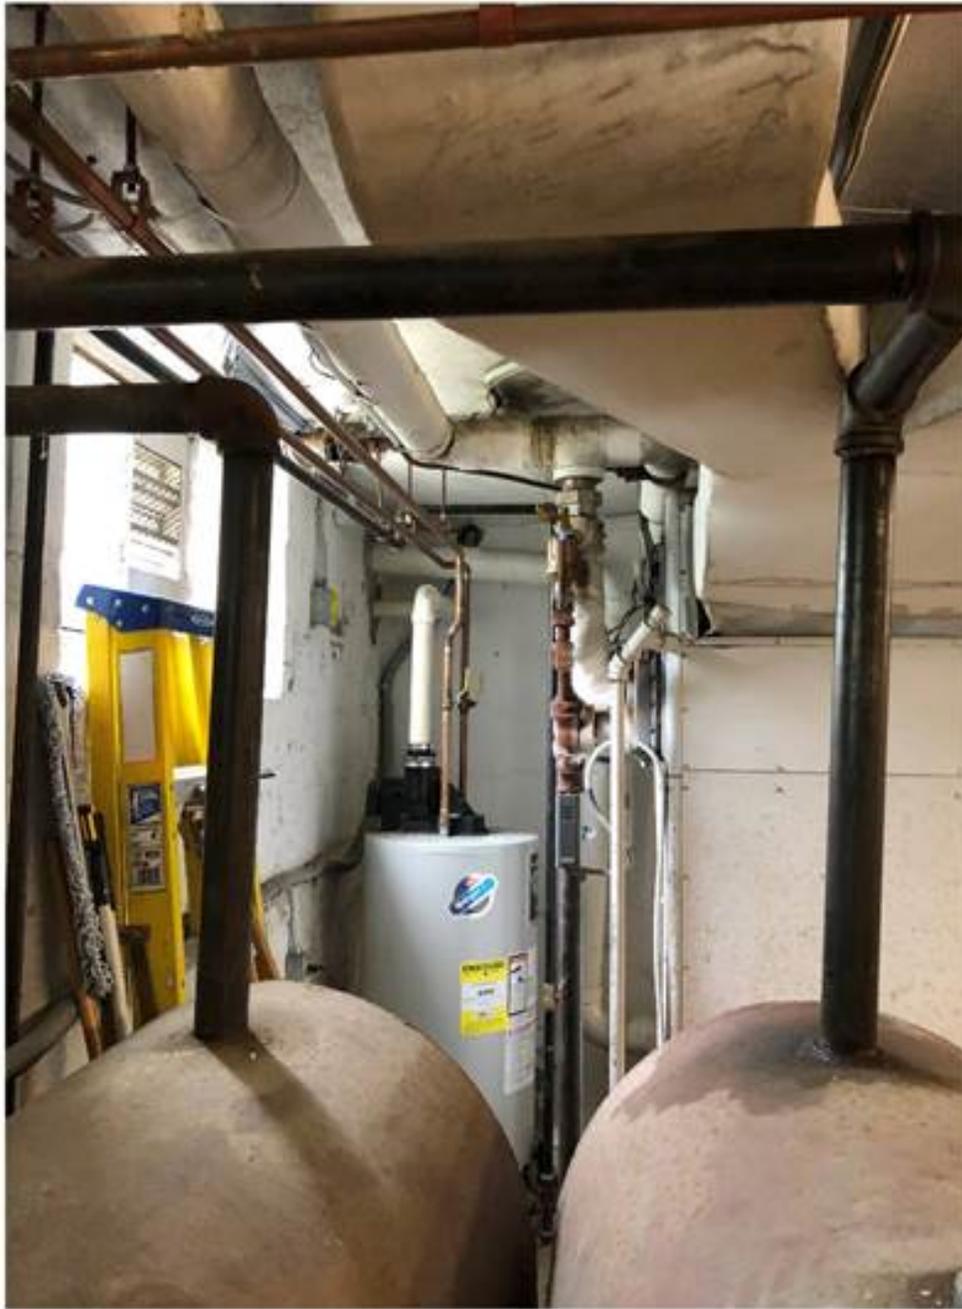
CA-01

Category 42: Site Fuel Oil

Pressure test fuel tanks to check for leaks.

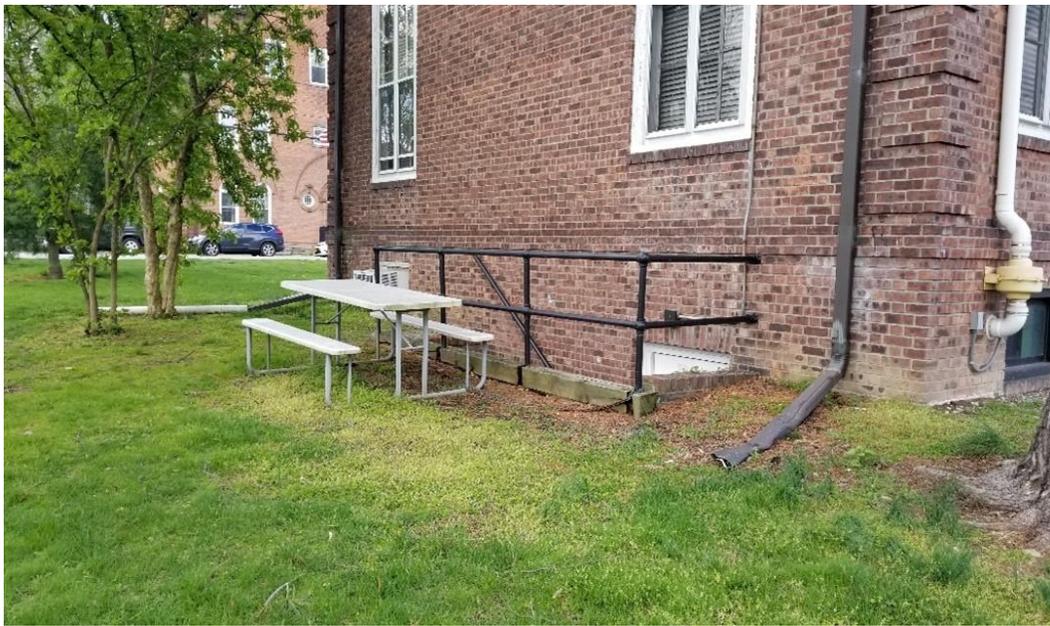
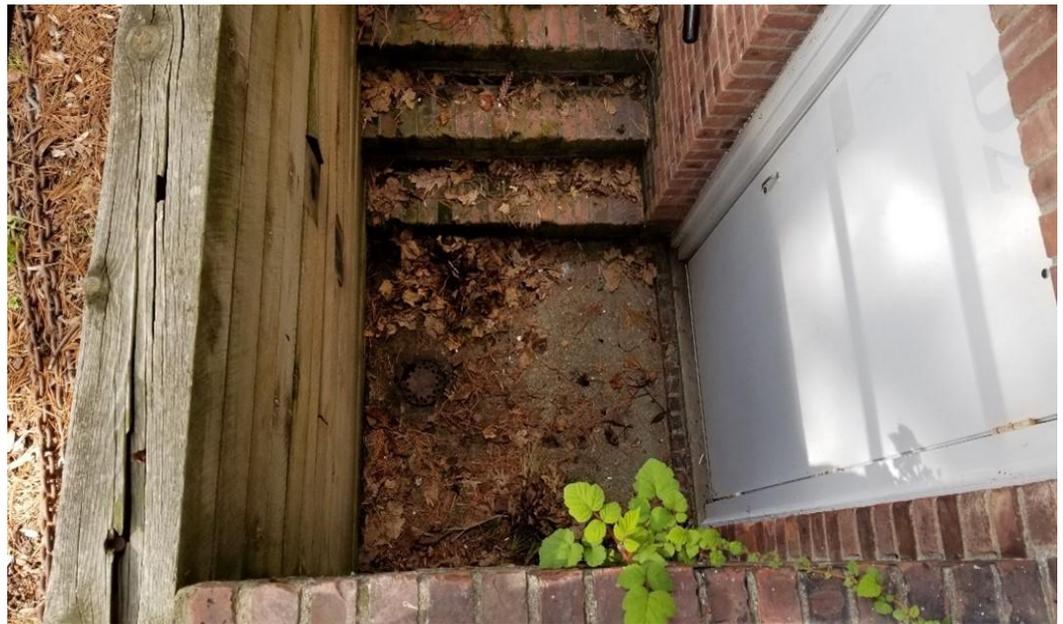
CA-03

Category 44: Closed Drainage Pipe Stormwater Management System

Properly route roof leaders. Determine drain discharge location and confirm no connection to sanitary sewer.

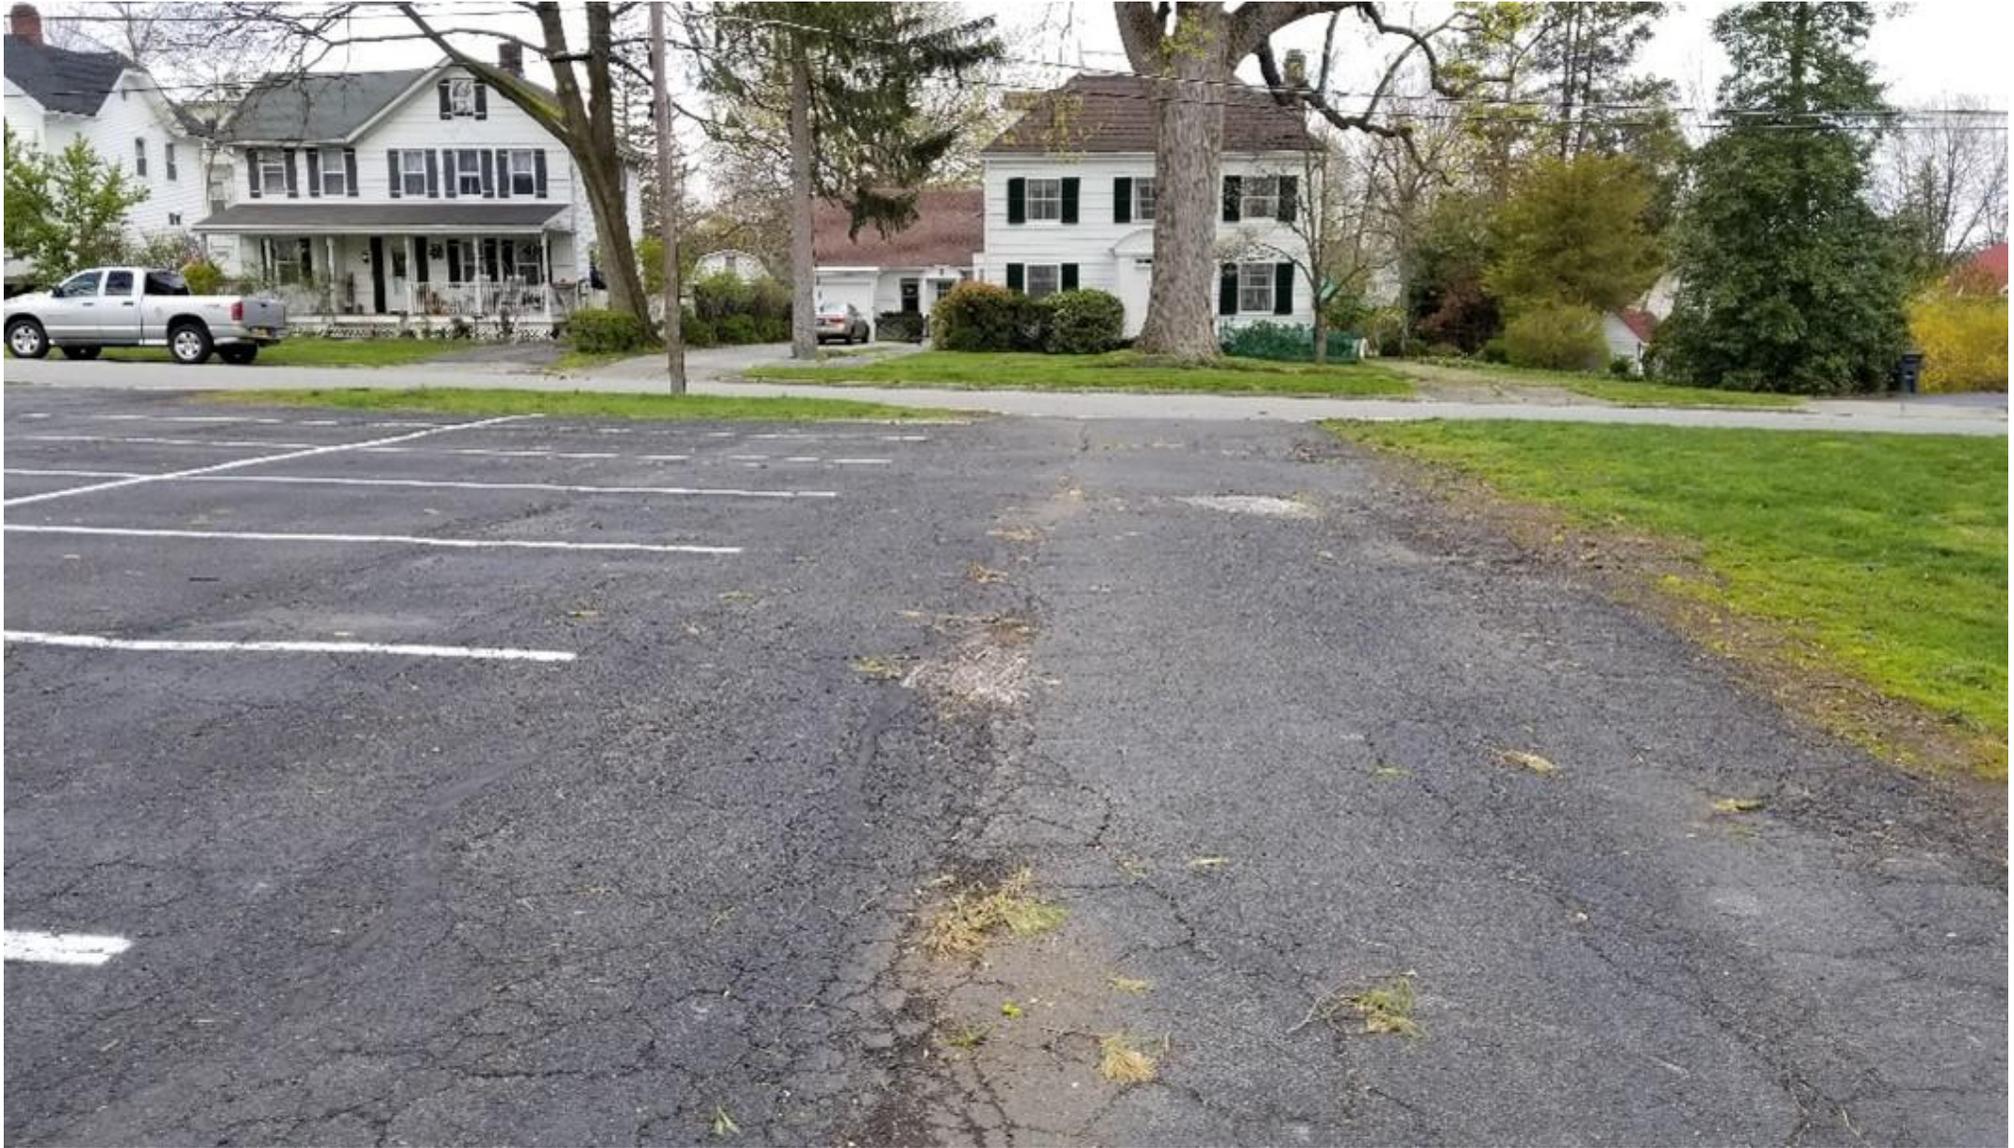
CA-04

Category 55: Pavement

Replace parking lot and driveway pavement. Pavement is at end of useful life.

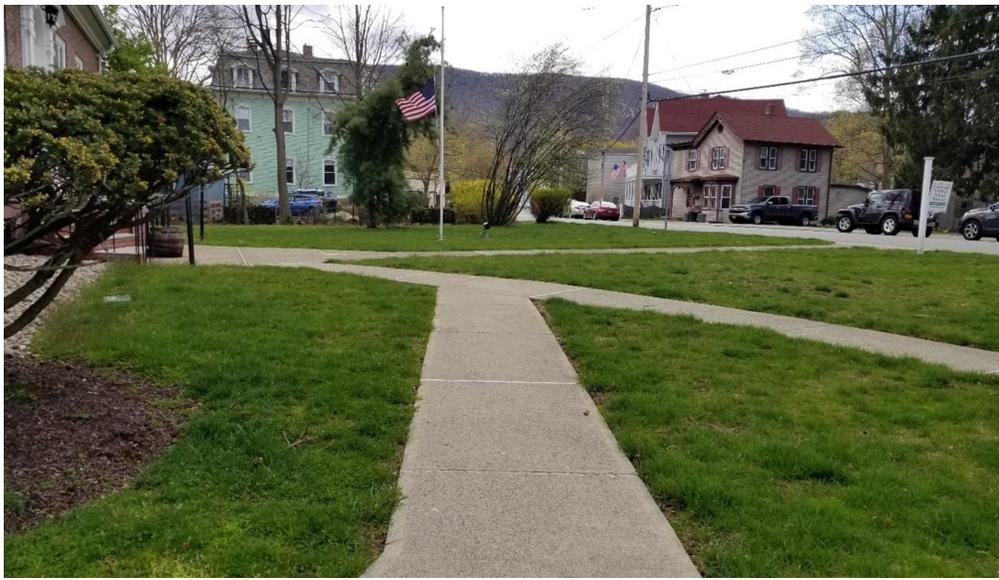
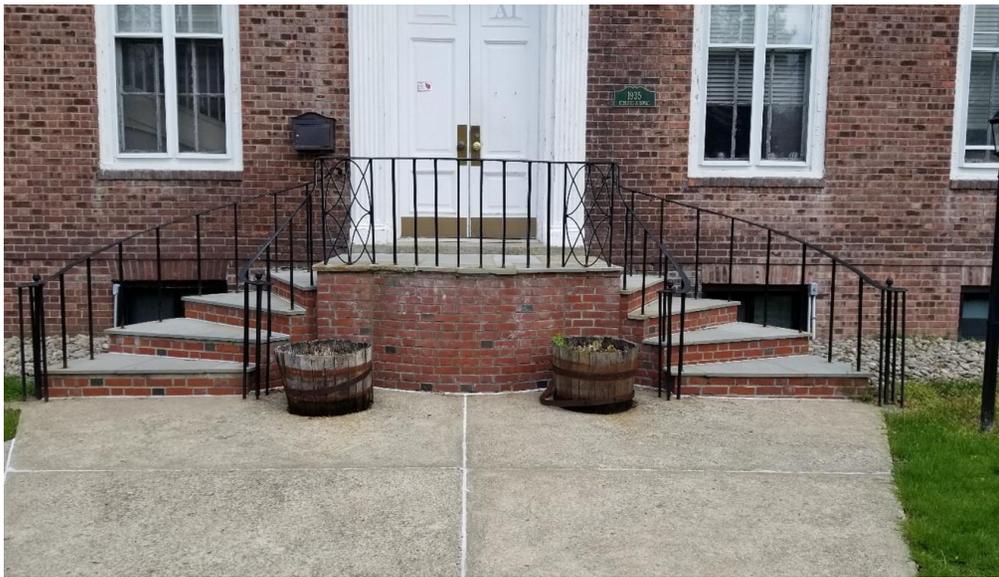
CA-06

Category 56: Sidewalks

Walkways in fair condition, but not wide enough to meet ADA requirements. Replace with ADA compliant concrete sidewalks. Building lacks ADA accessible entrance. Install ramp at main entrance to access the building.

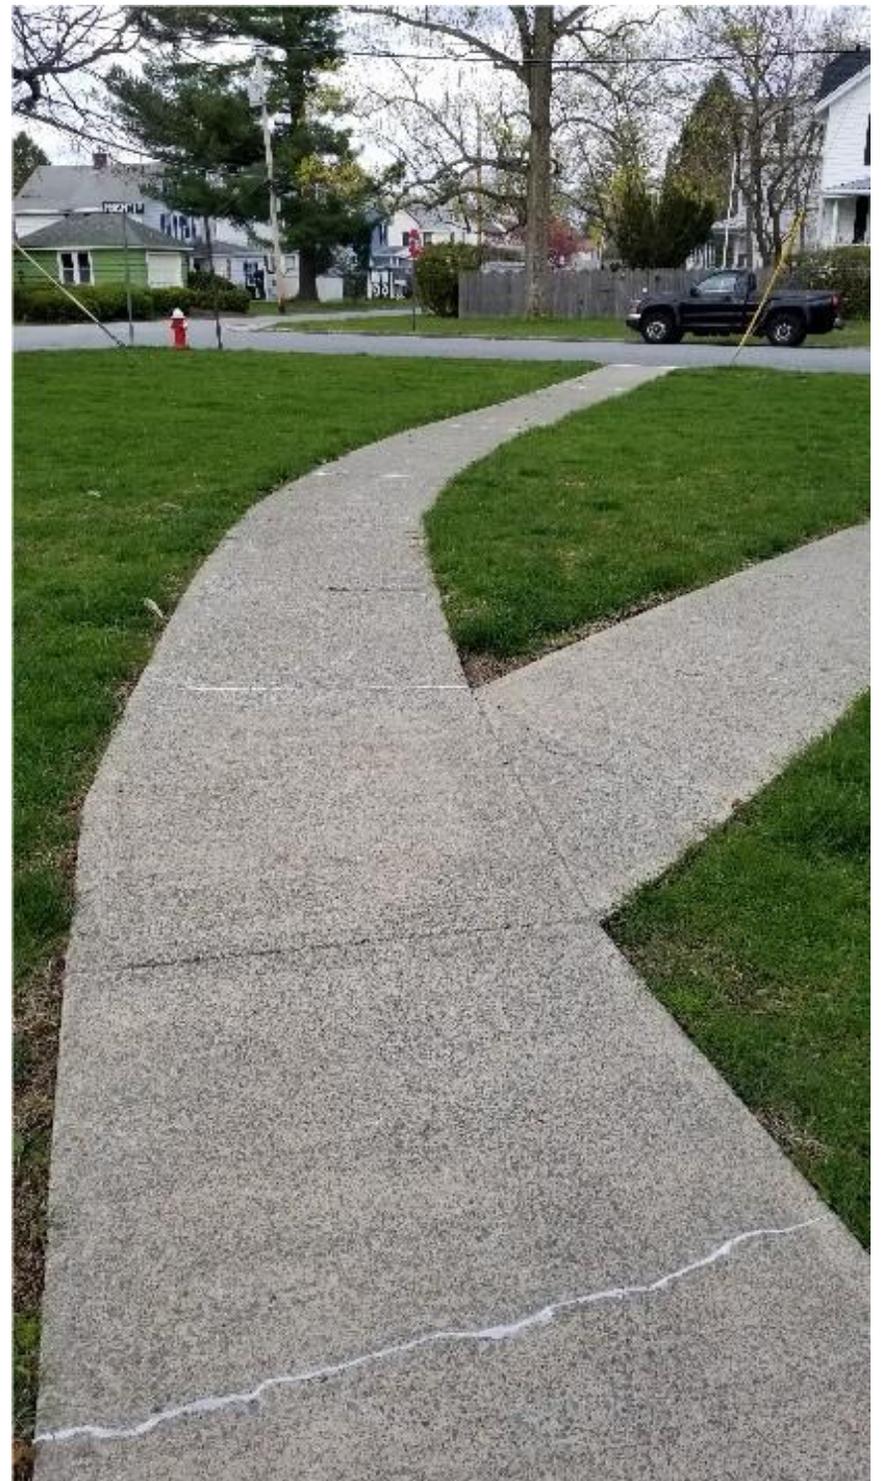
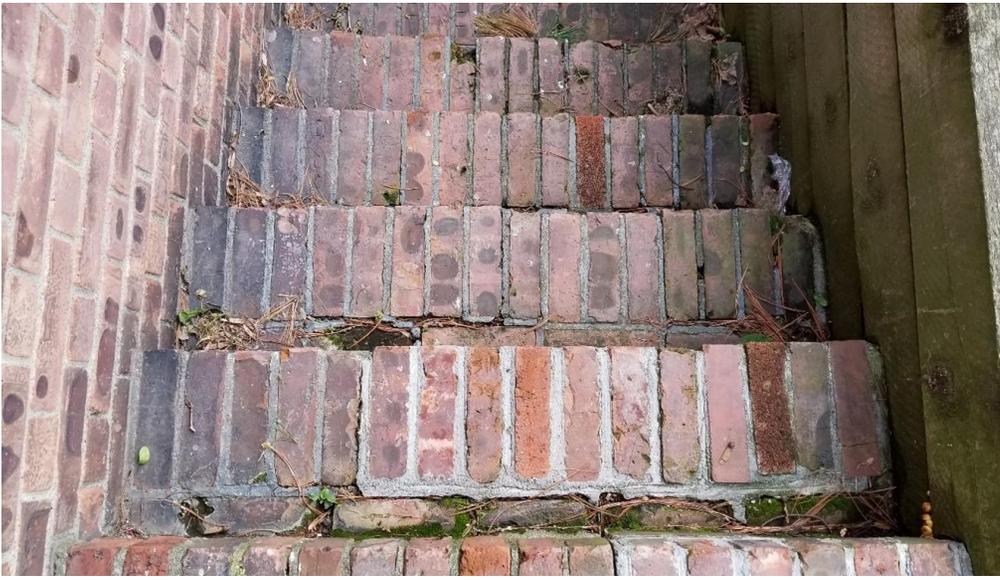
CA-08

Category 56: Sidewalks

Replace/repair masonry stairs and timber retaining wall.
Stair/retaining wall in poor condition.

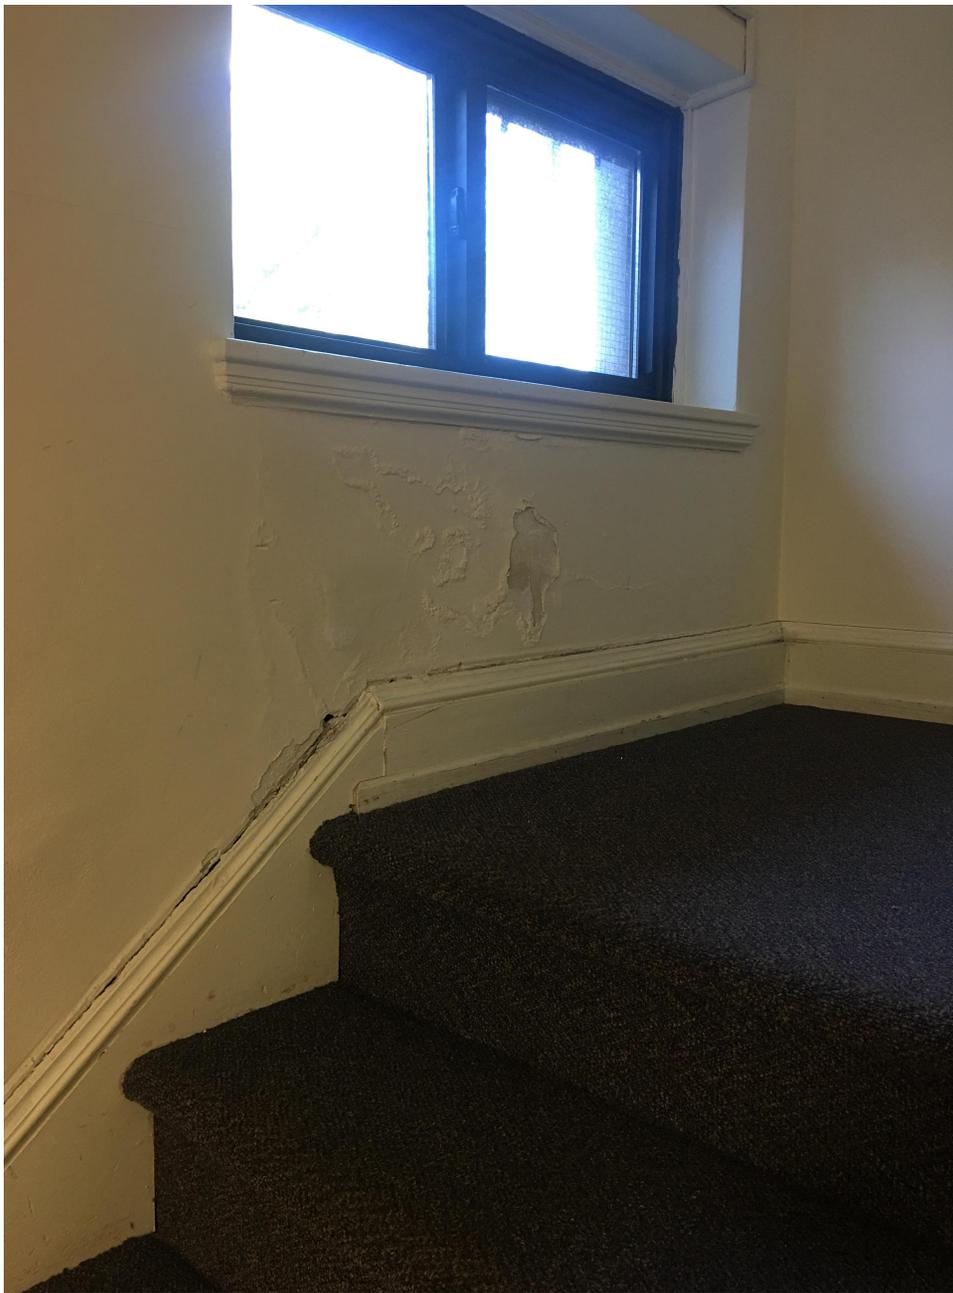
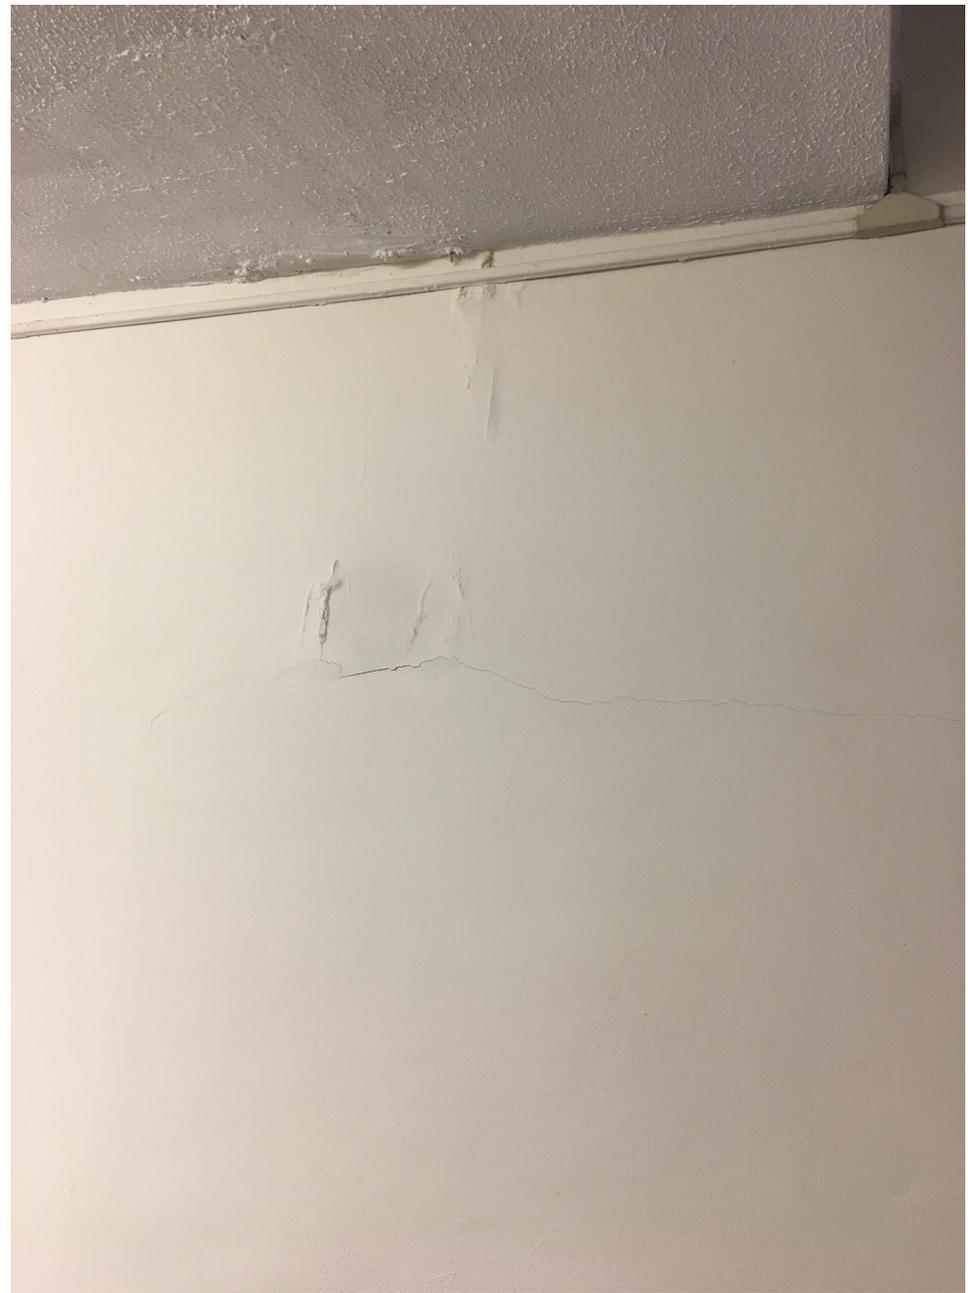
CA-11

Category 61: Foundation

Category 65: Structural Floors

Repair wood decay on existing structural members.

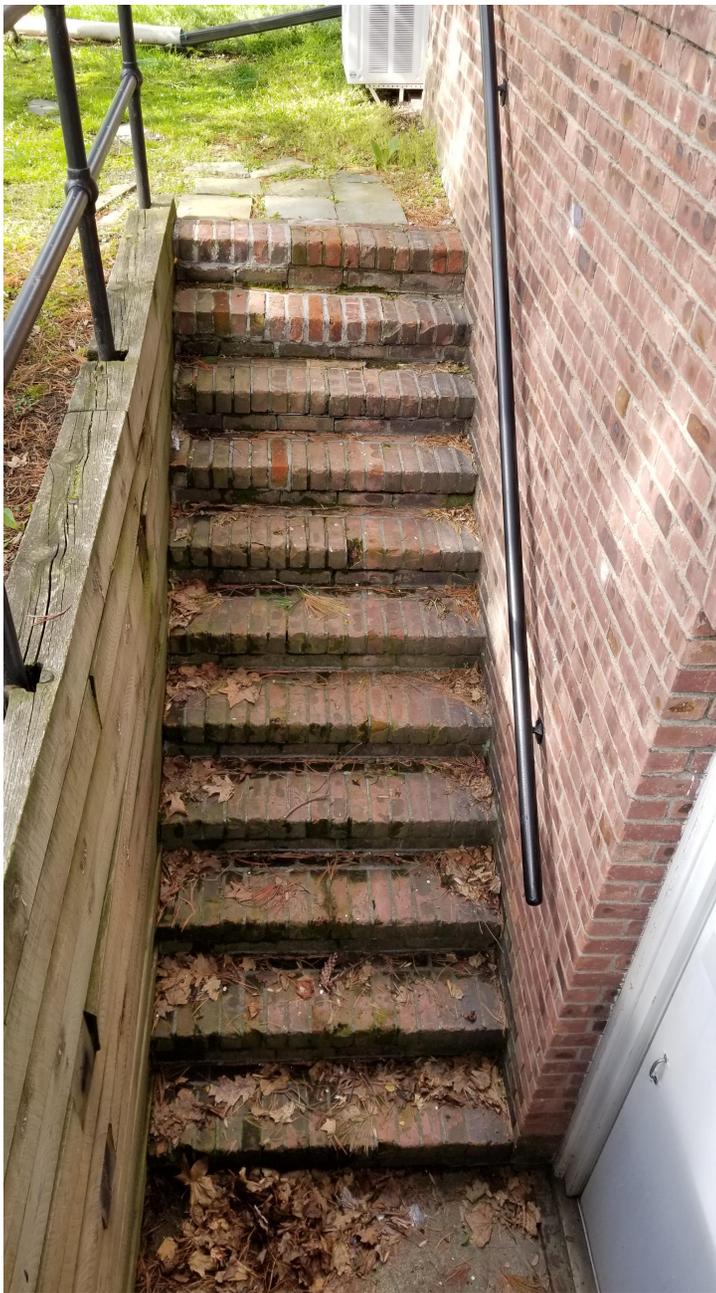
CA-11

Category 70: Exterior Steps, Stairs, Ramps

Replace masonry stairs going to basement, clean brick/slate at main entry. Consider replacement for main entry system.

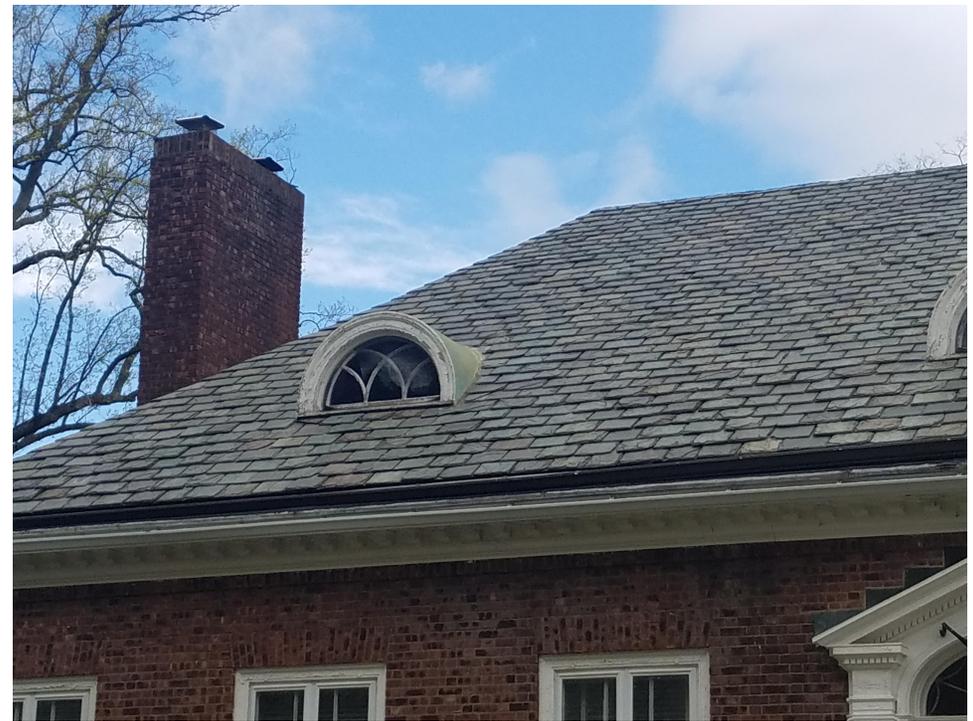
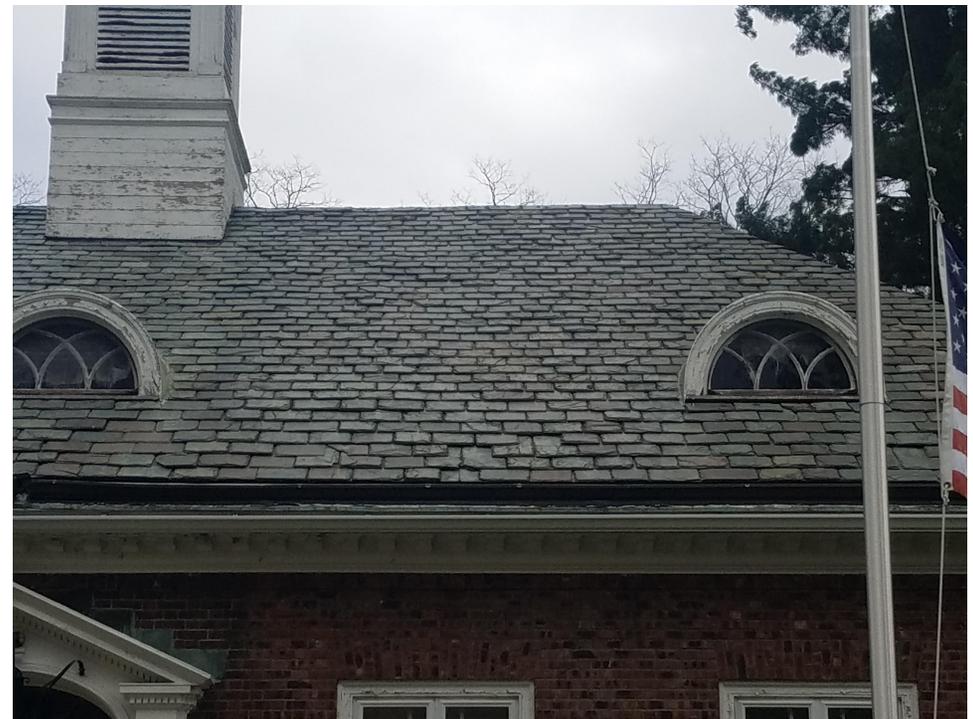
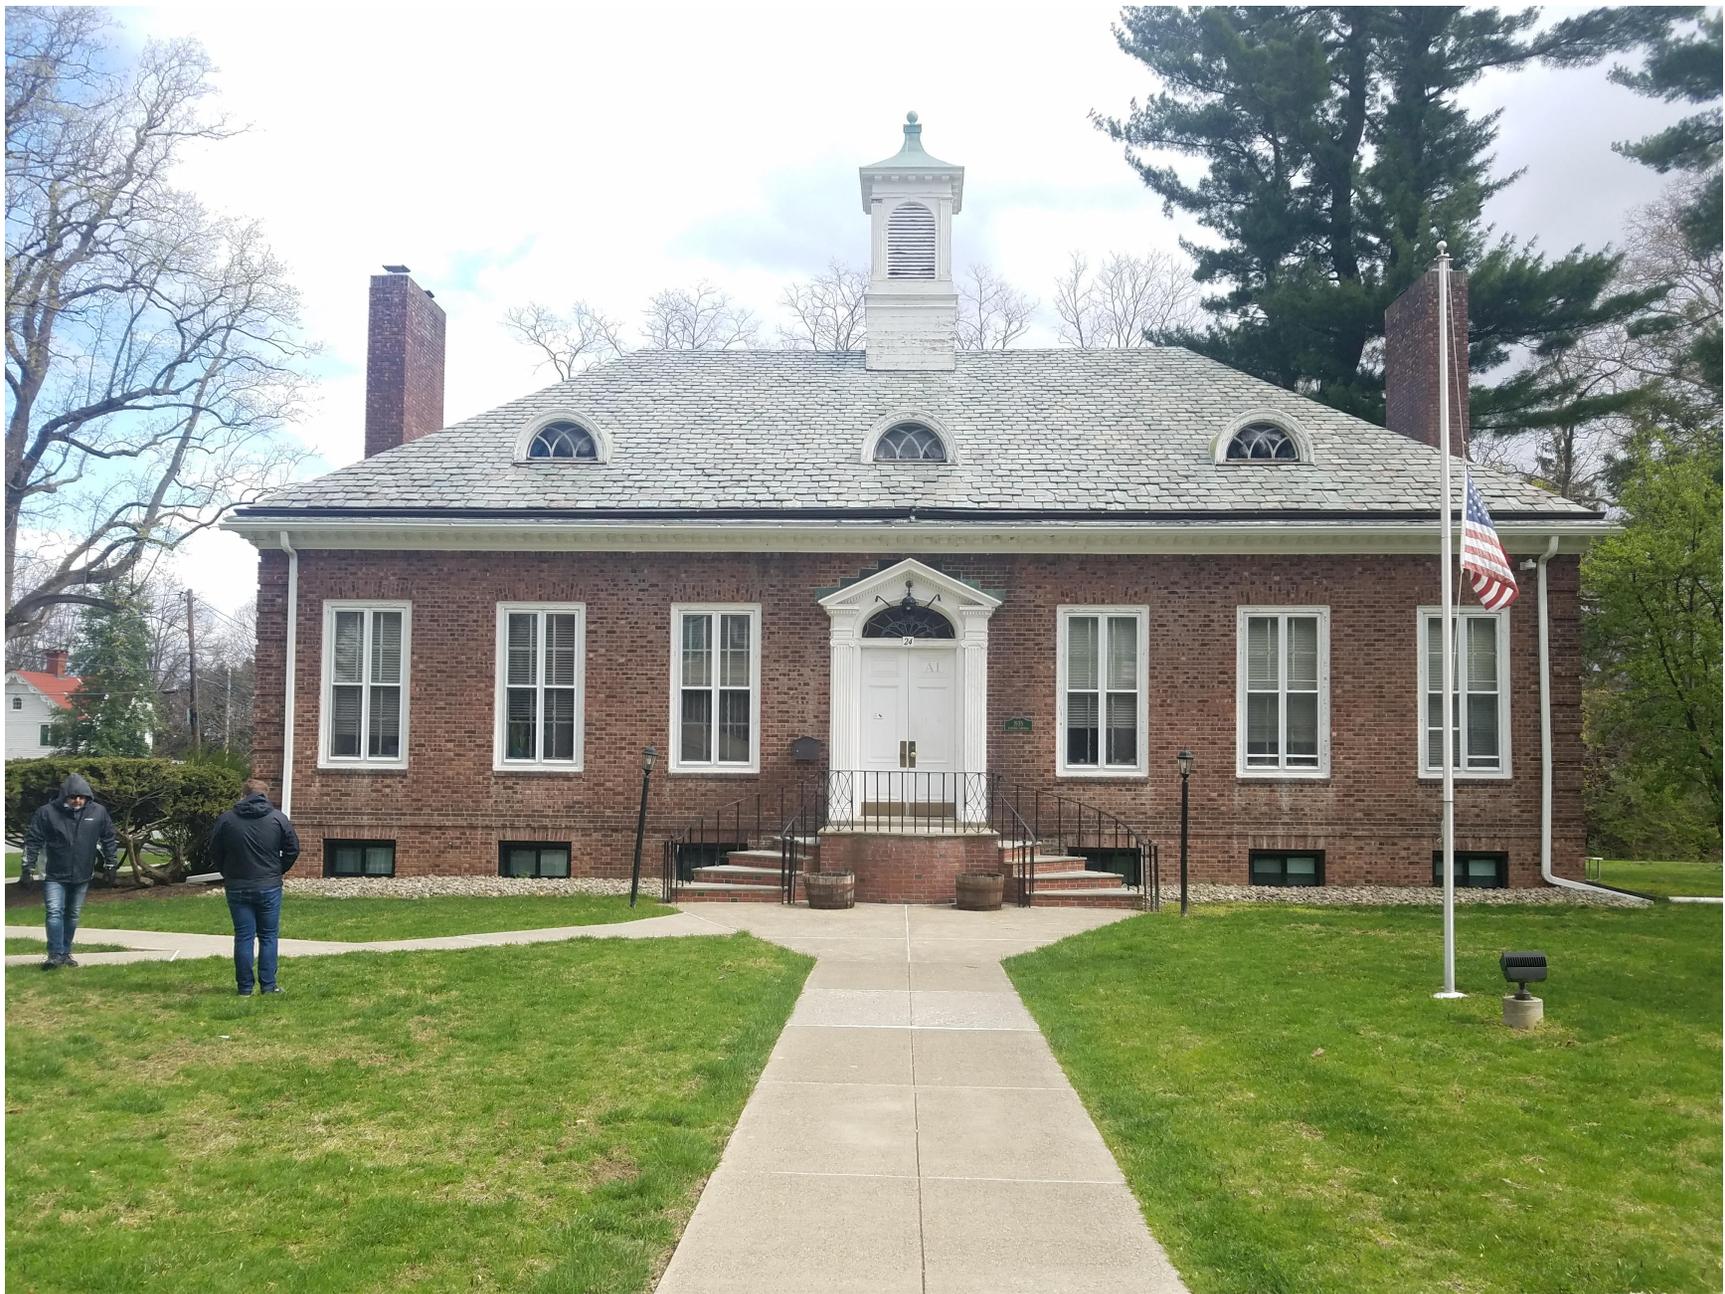
CA-17

Category 112: Exterior Accessible Route

The building site is flat and barrier free, but the building is not accessible because the main floor is raised above the grade. Given the building vintage, the state historic preservation laws should be reviewed before planning building improvements, once thoroughly investigated, one potential solution would include providing an exterior rated lift at the rear of the building.

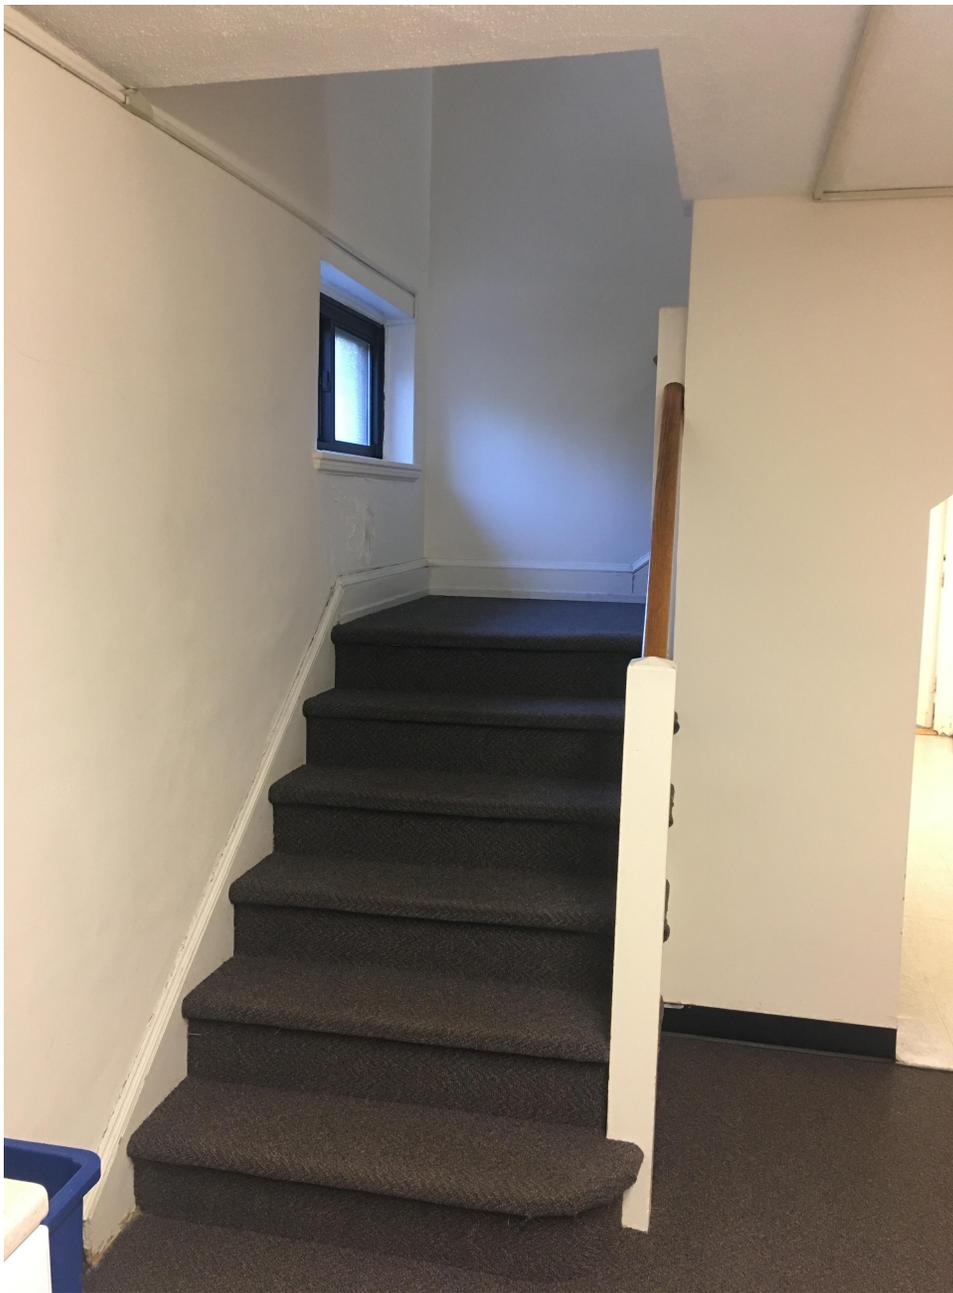
CA-18

Category 115: Interior Accessible Route

The building interior is not accessible, one potential solution would include providing a lift inside of building with an enclosed shaft. Refer to Category 112 for additional information.

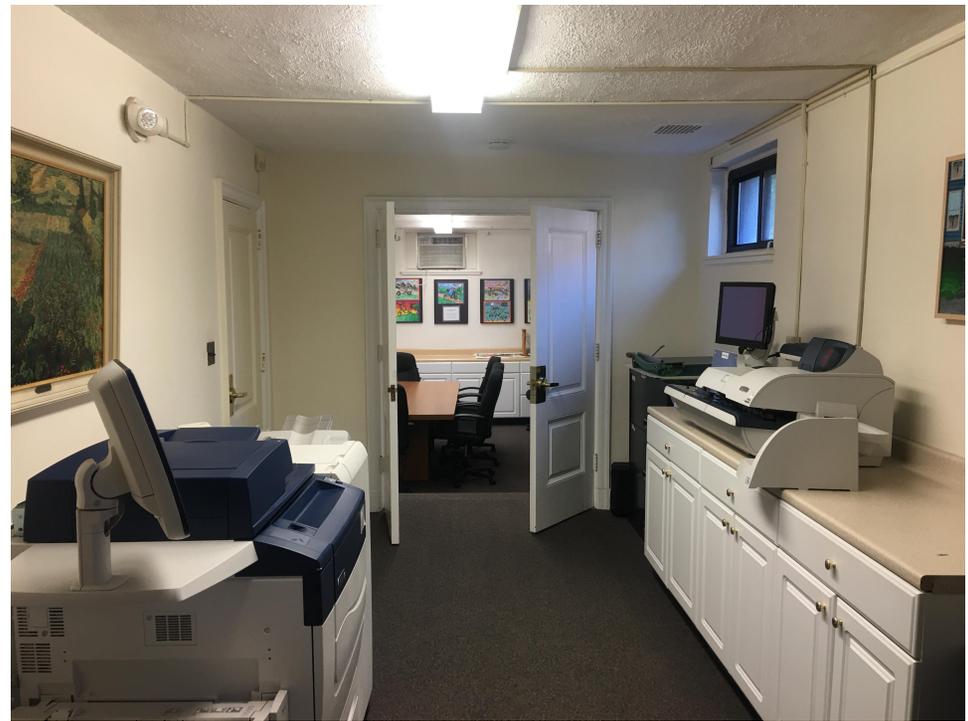
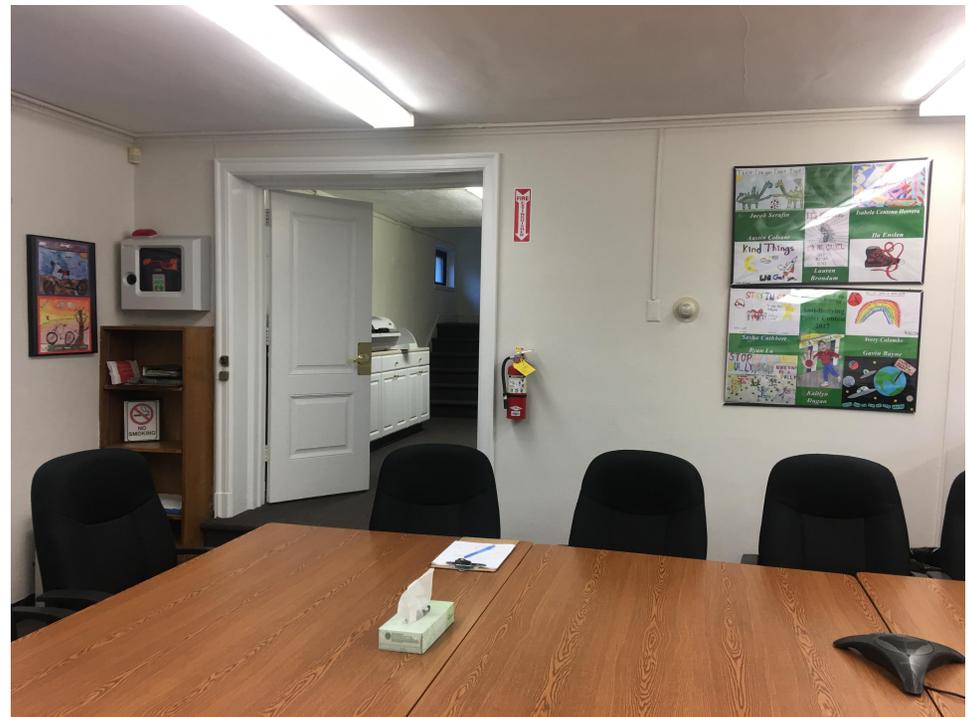
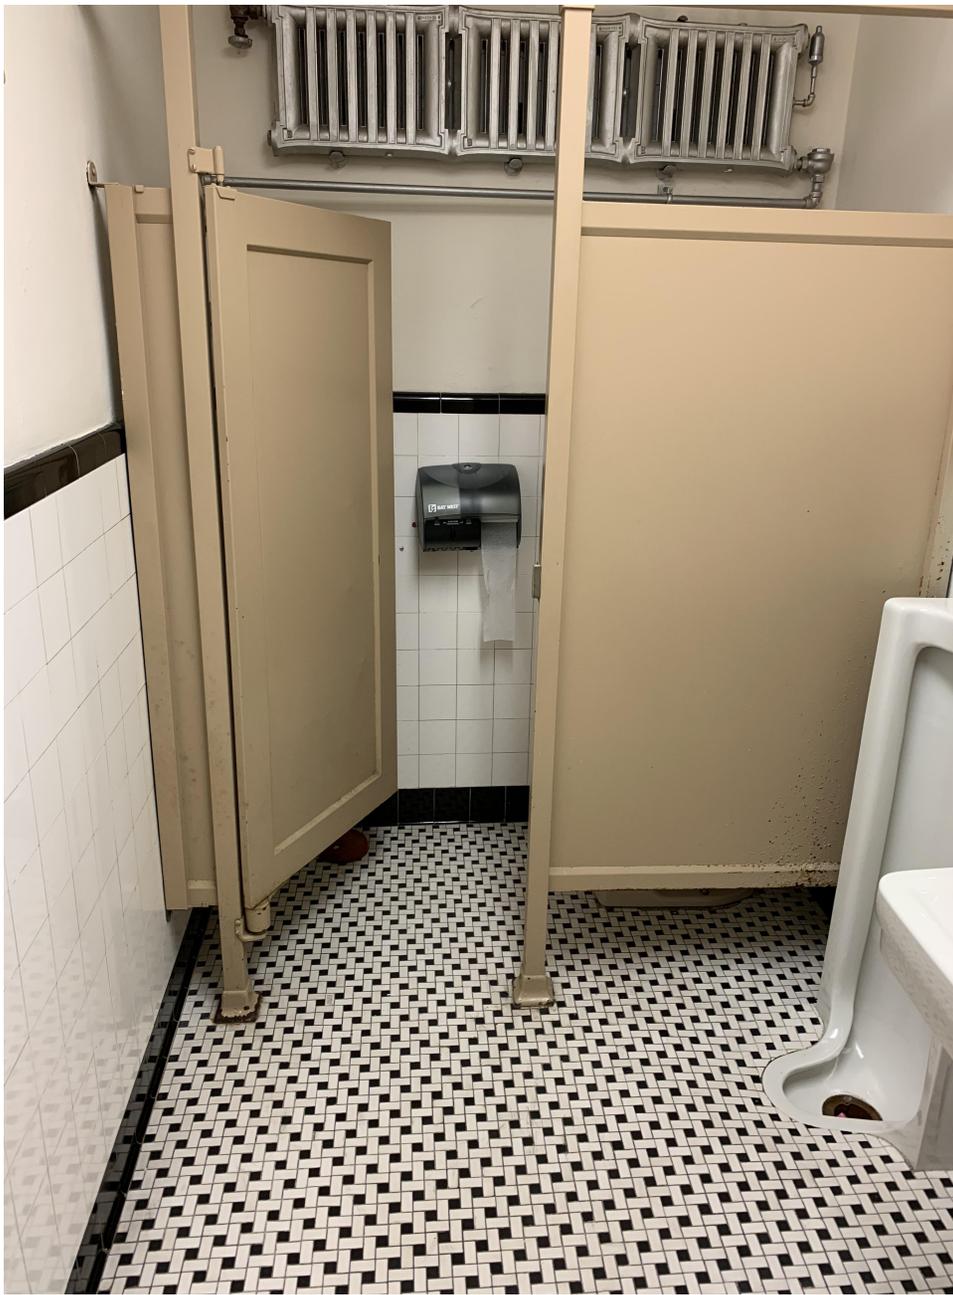
CA-21

Category 116: Interior Spaces

Interior spaces not accessible, toilet rooms and conference room located on basement level, offices located on the main level; provide toilet room renovations and miscellaneous upgrades. Refer to Category 112 for additional information.
