**2020 BUILDING
CONDITION SURVEY
REPORT**

CORNWALL CENTRAL
SCHOOL DISTRICT

Central
Middle School

January 2021

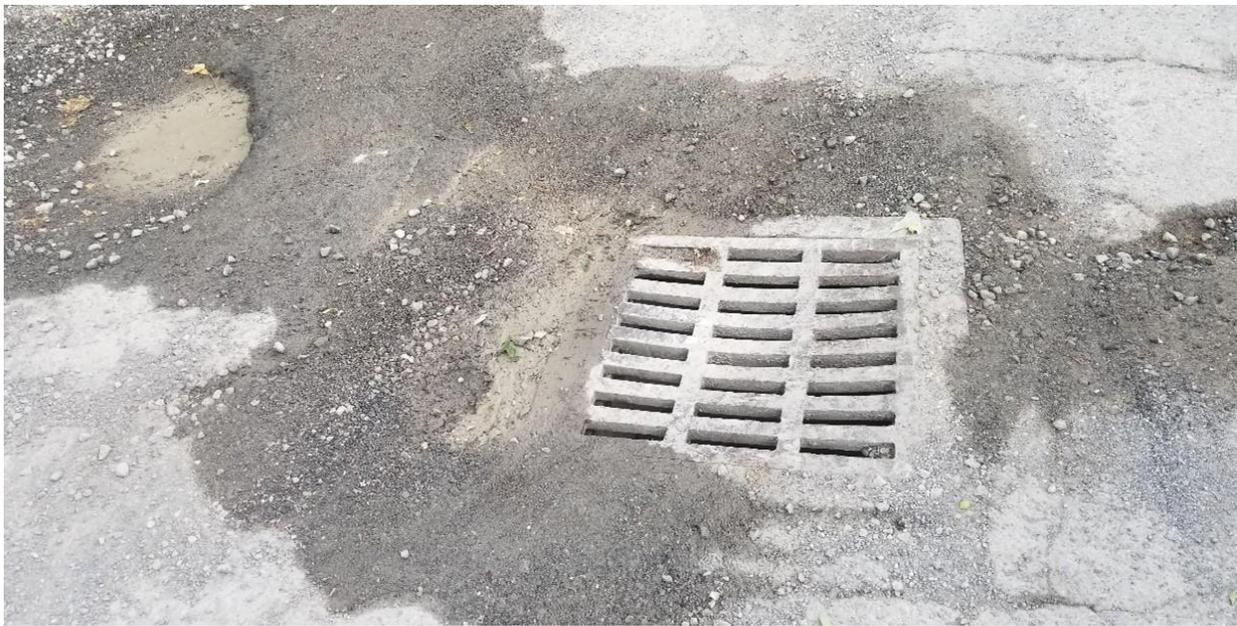
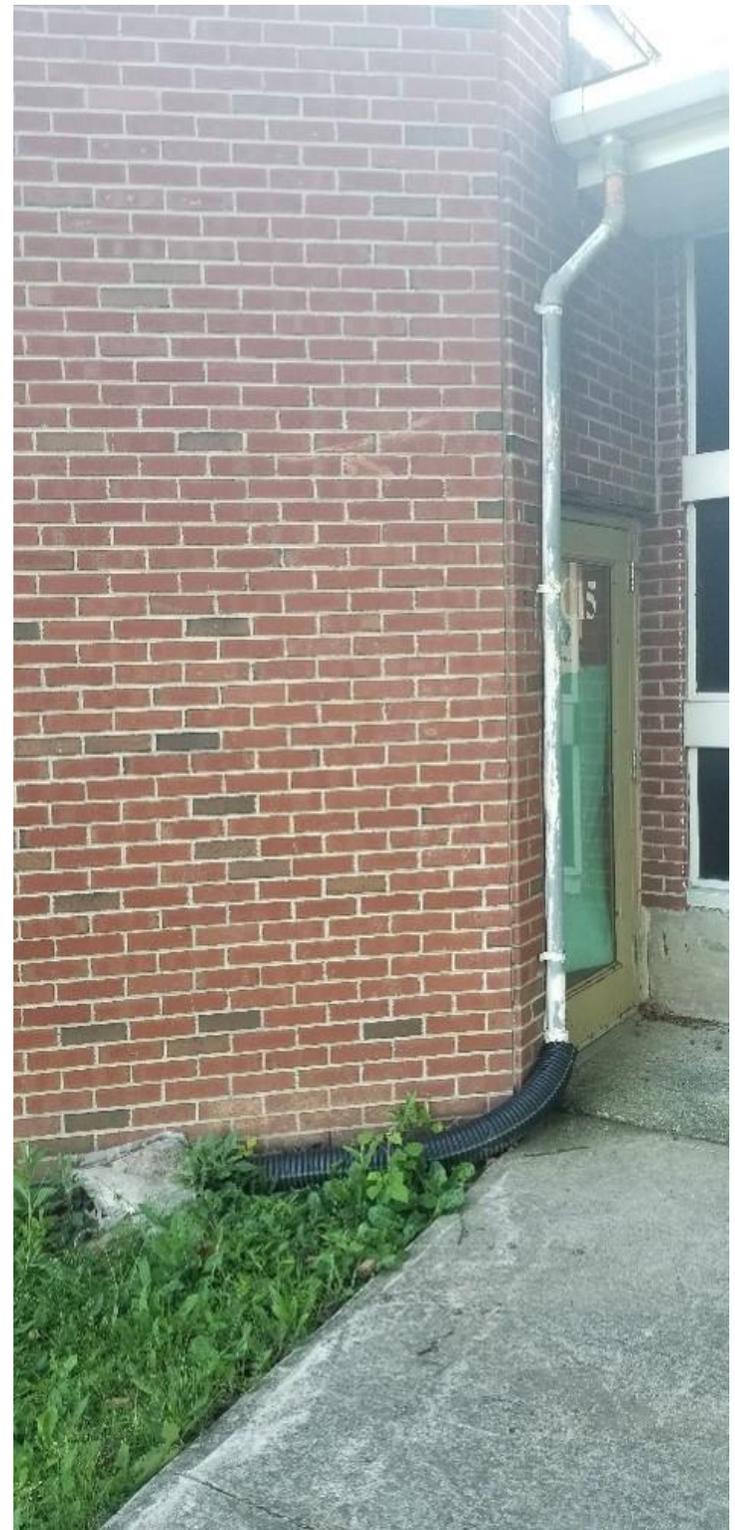
MS-02

Category 44: Closed Drainage Pipe Stormwater Management System
Need additional catch basins in parking lot and in driveways in front of the building.

44f. Comments: Install drainage at downspout locations to direct stormwater away from building foundation

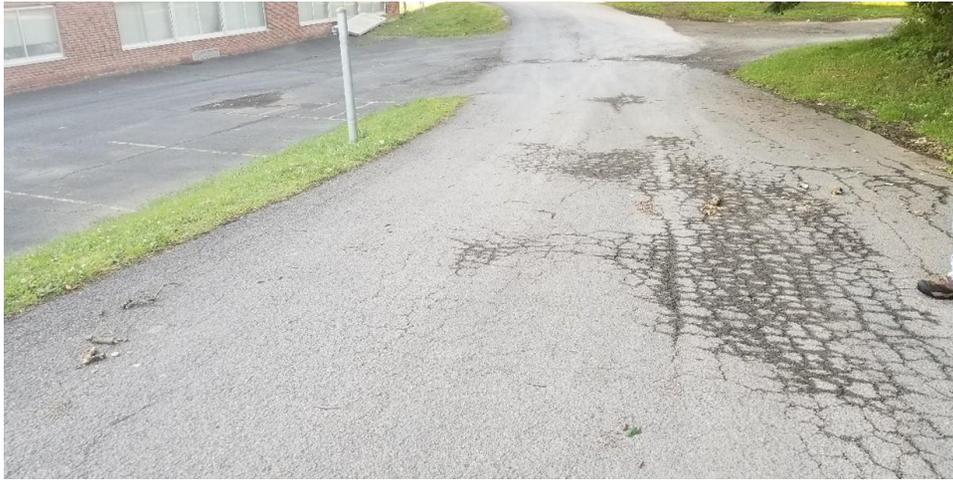
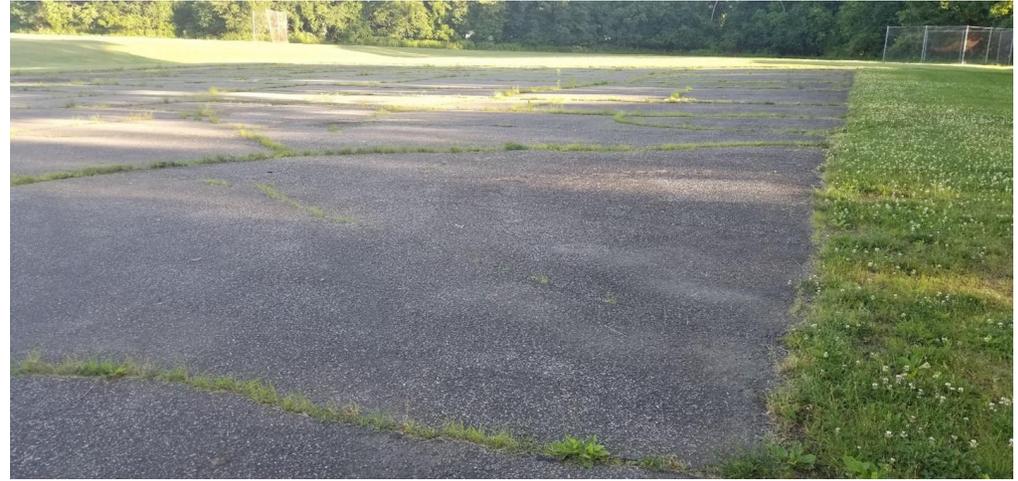
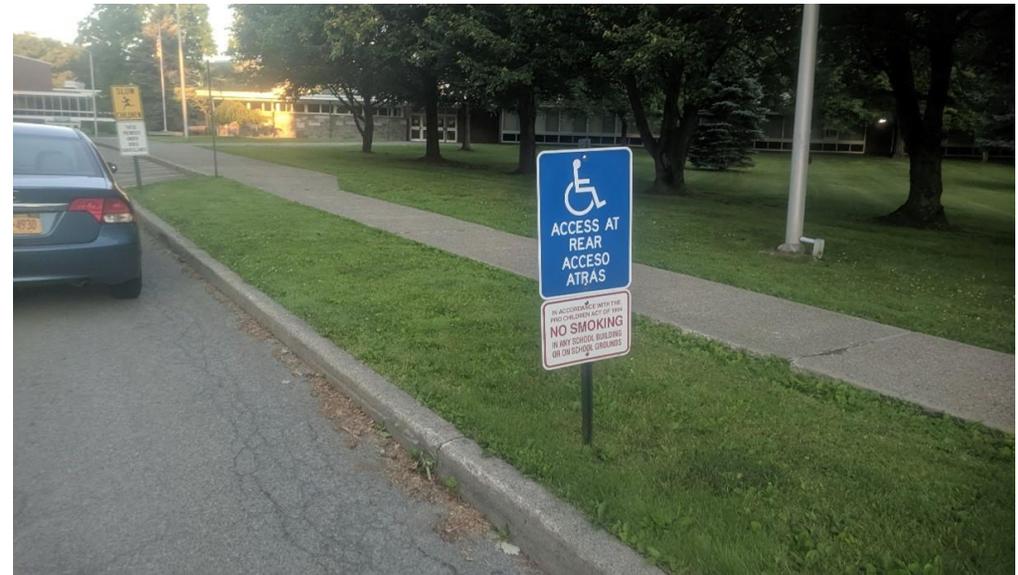
Category 55: Pavement (Roadways and Parking Lots)

Replace driveway and curbing at front of building. Install safety fence/guide rail along edge of pavement at top of hill near playground slides. Barrier needed for safety of vehicles accessing pavement in rear, and for safety of students playing on/around the slide.

55f. Comments: Replace parking lot and driveway pavement, pavement at end of useful life; replace pavement

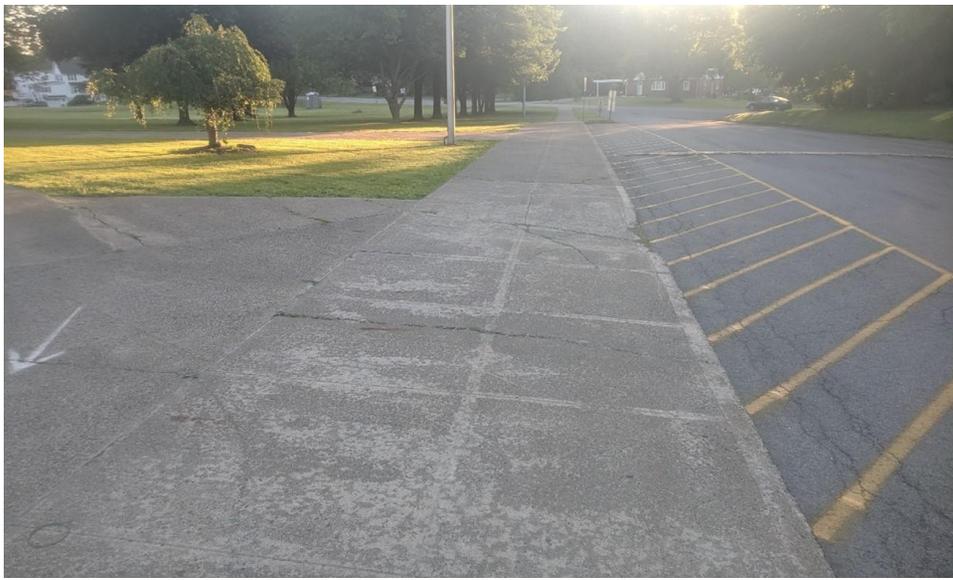
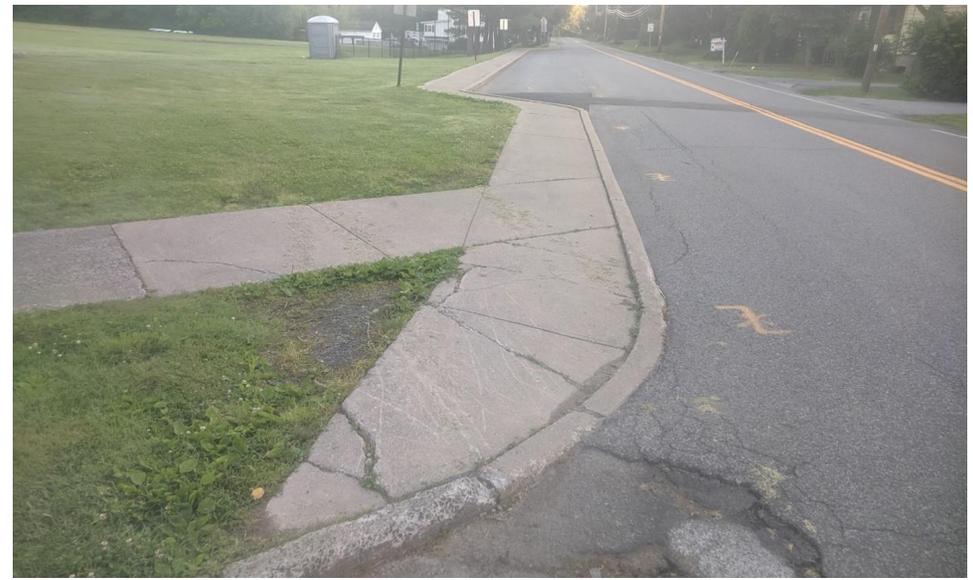
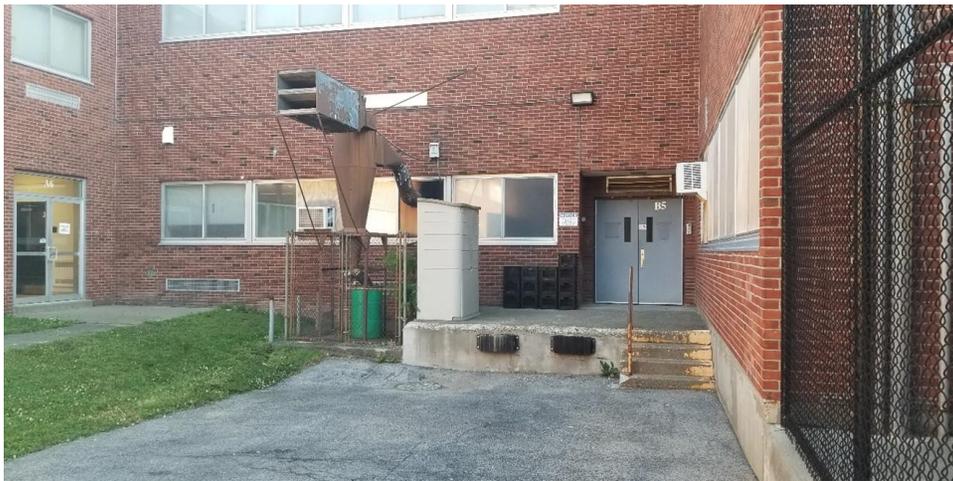
Category 56: Sidewalks

Replace concrete sidewalk. Icing/ponding hazard (too flat).
Replace concrete stair. Stair treads worn, surface uneven, and several large cracks throughout.

- The concrete sidewalks are in unsatisfactory condition. The concrete sidewalks along the driveway in front of the building and at the south building entrance are at the end of their useful life and need to be replaced.

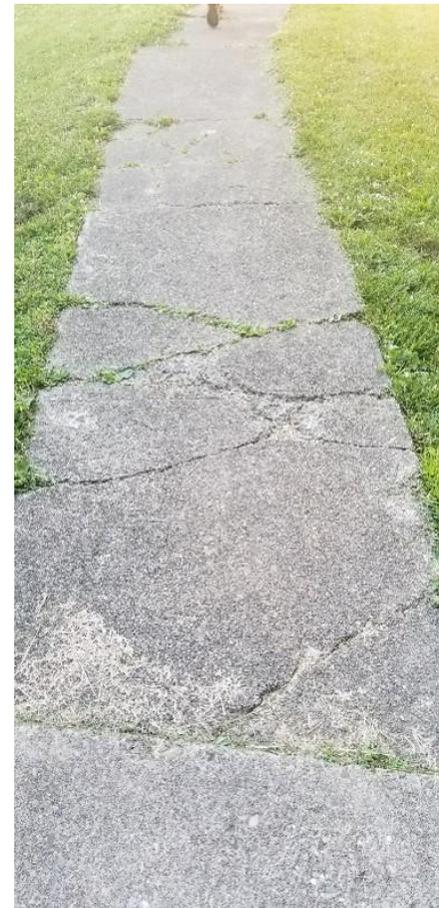
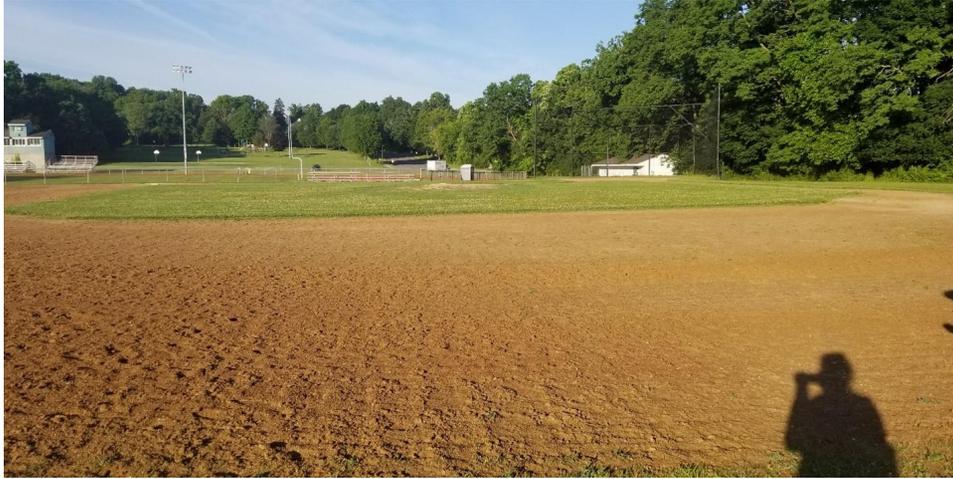
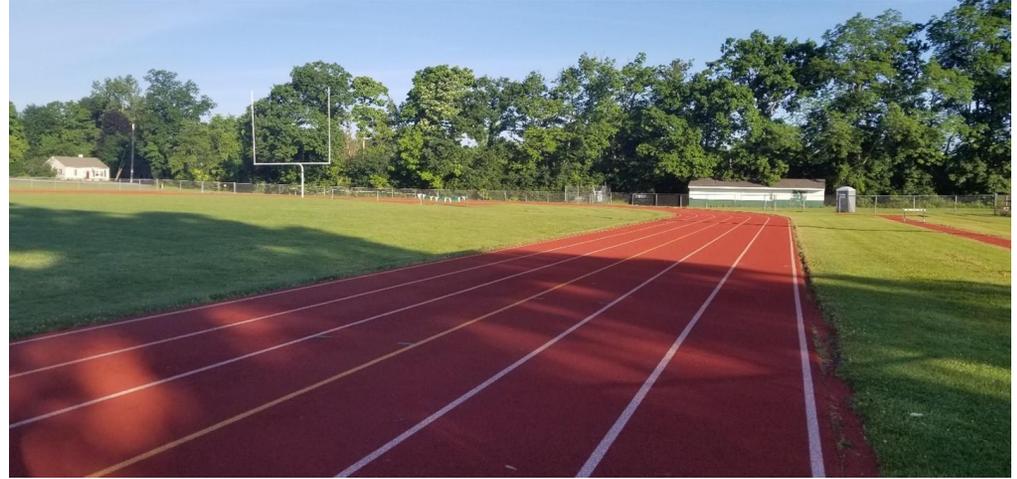
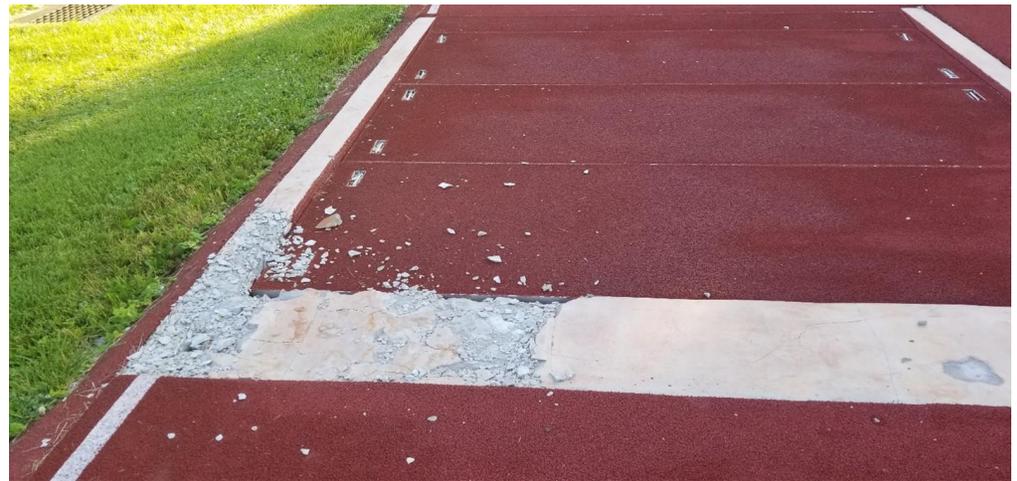
Category 58: Athletic Fields and Play Fields

Repair/replace drainage at baseball fields. Visible ponding of water.

- Press box and bleachers at track and field need replacement.
- Football and soccer field, goal posts and nets are in good condition.
- The athletic fields located behind the school building needs proper grading and drainage.

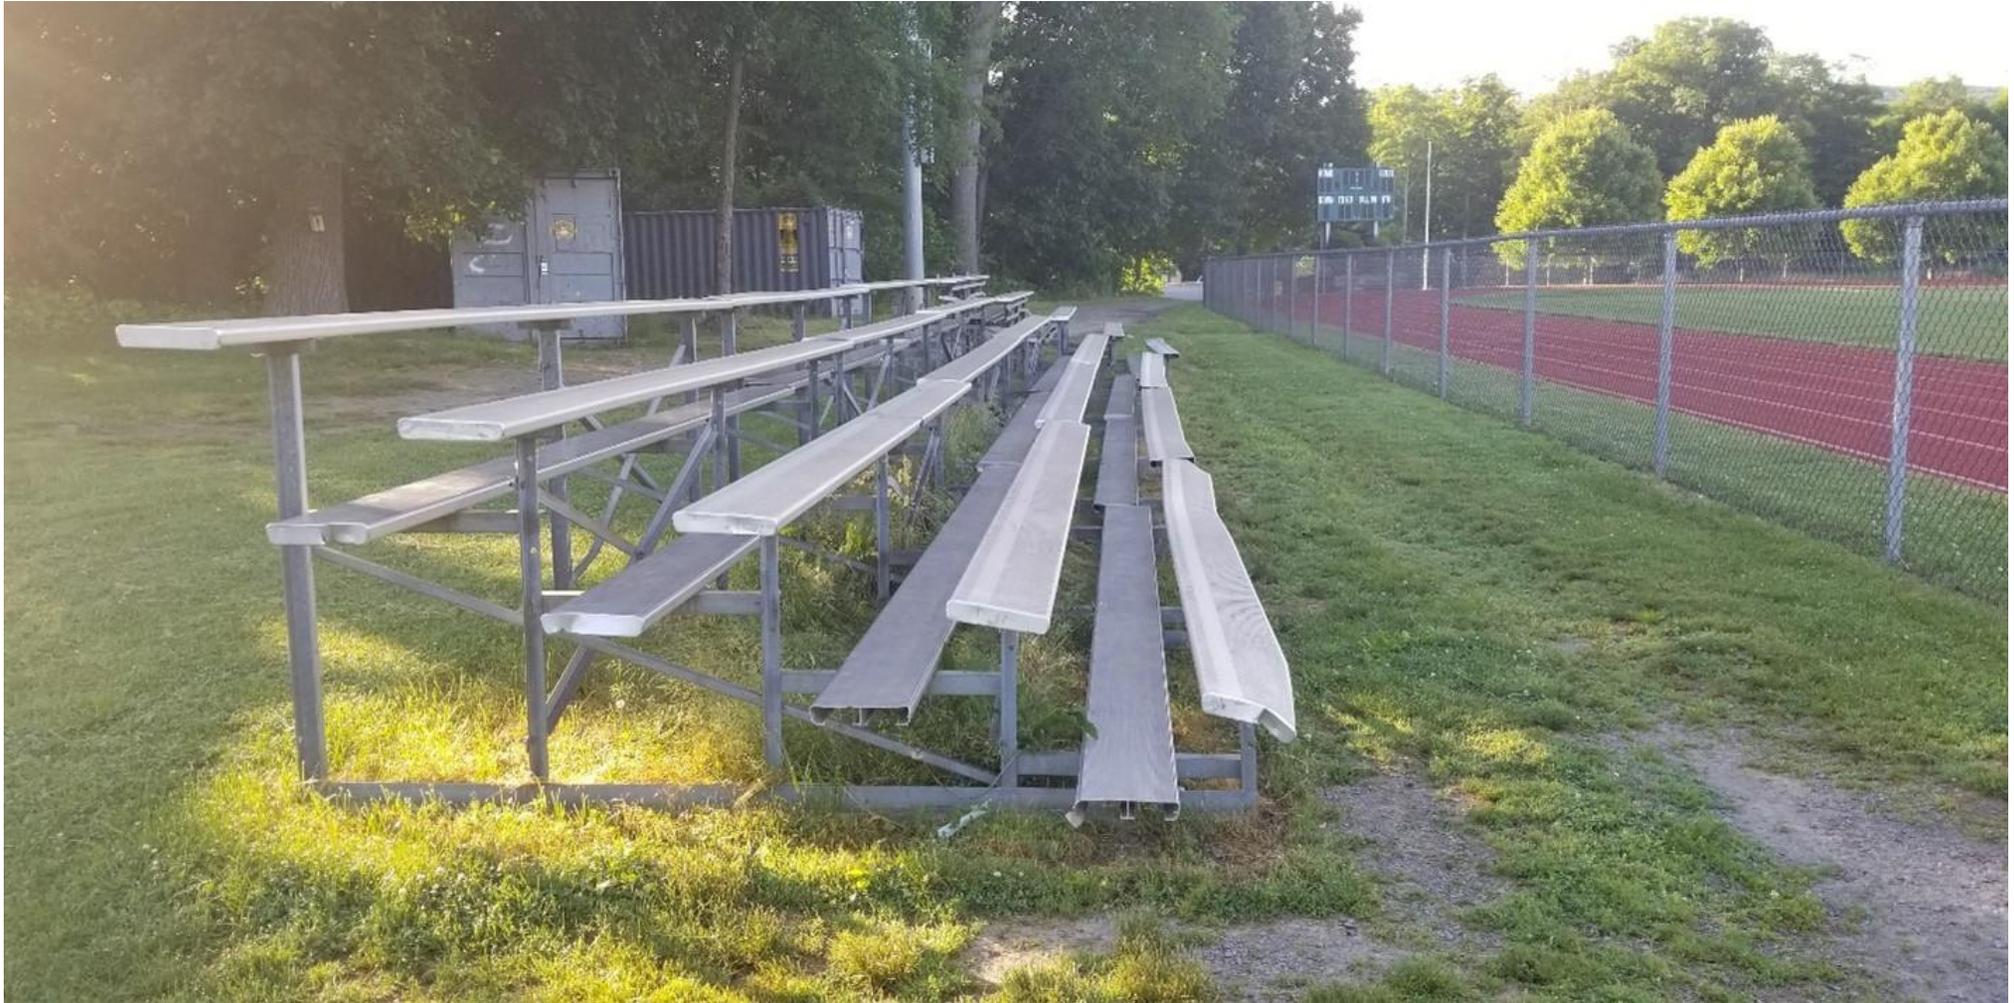
MS-14

Category 59: Bleachers

Replace damaged visitors bleachers. First two rows are unusable for seating.

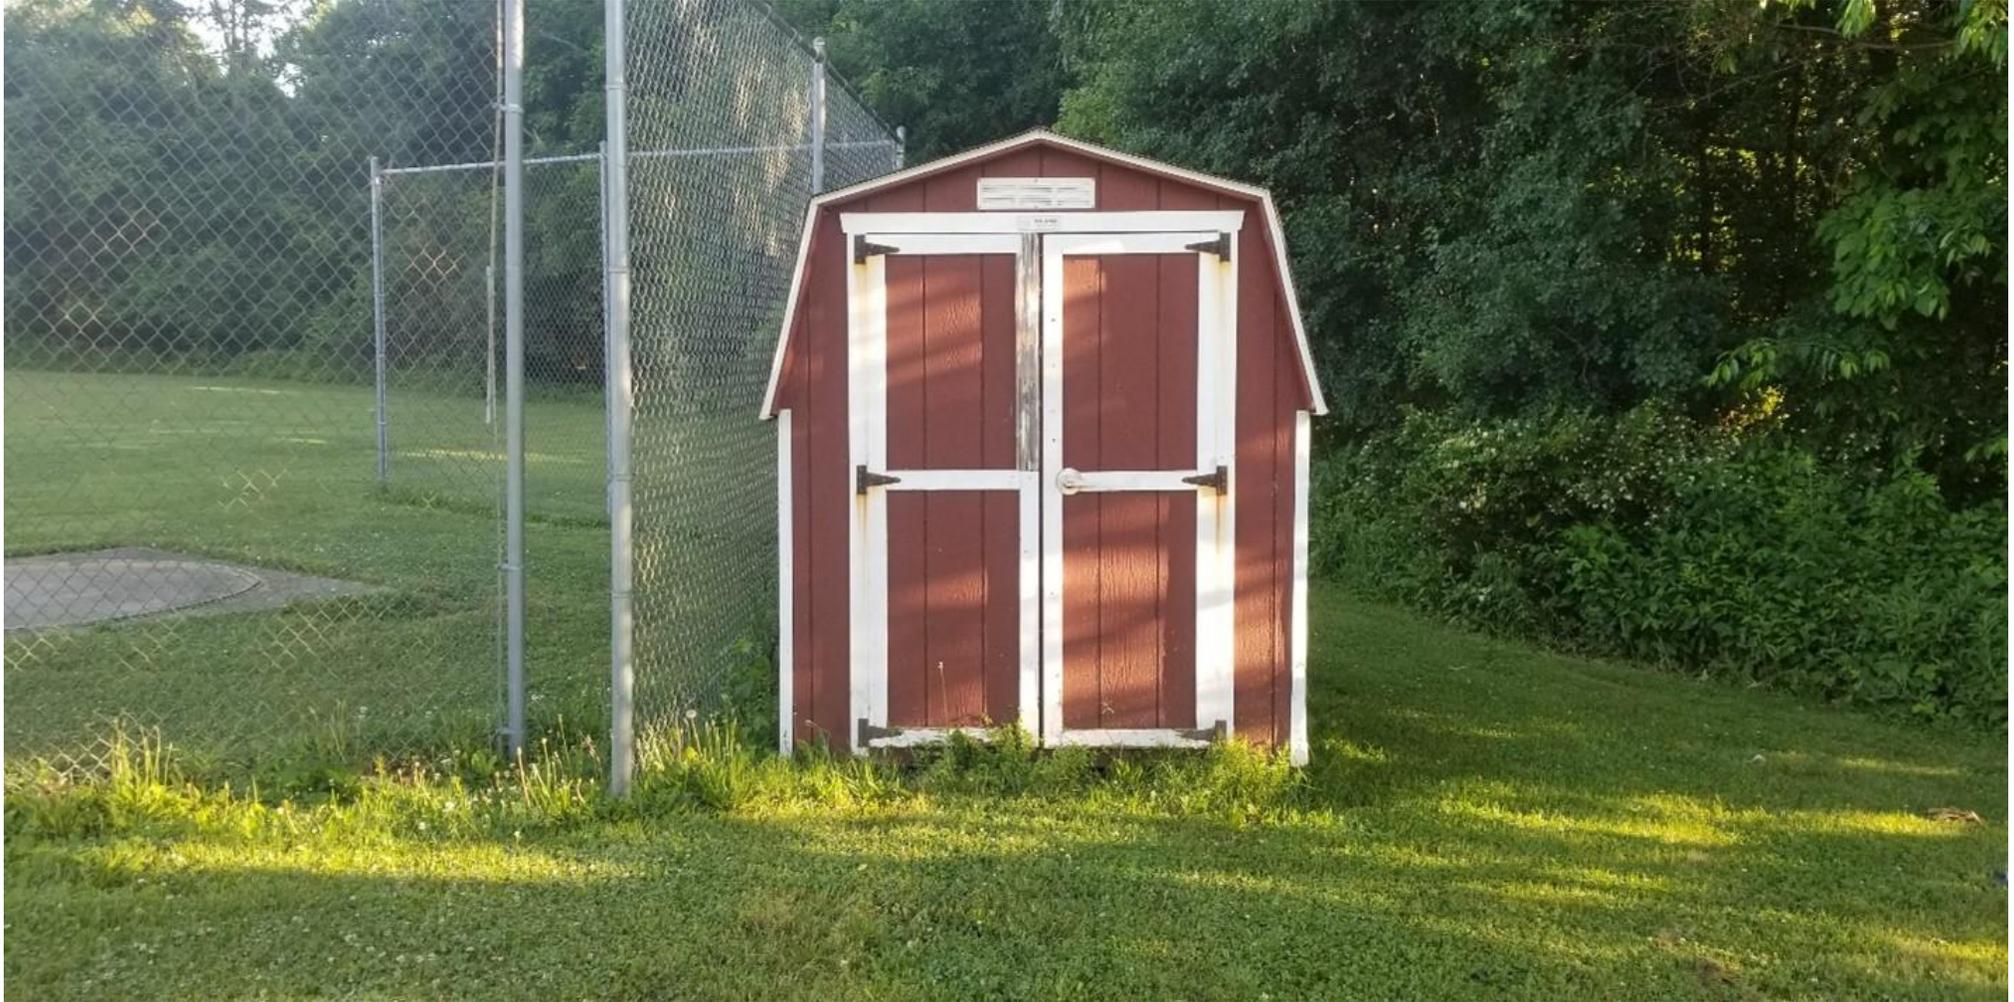
MS-15

Category 60: Other Structures

Replace existing storage building which is in poor condition.

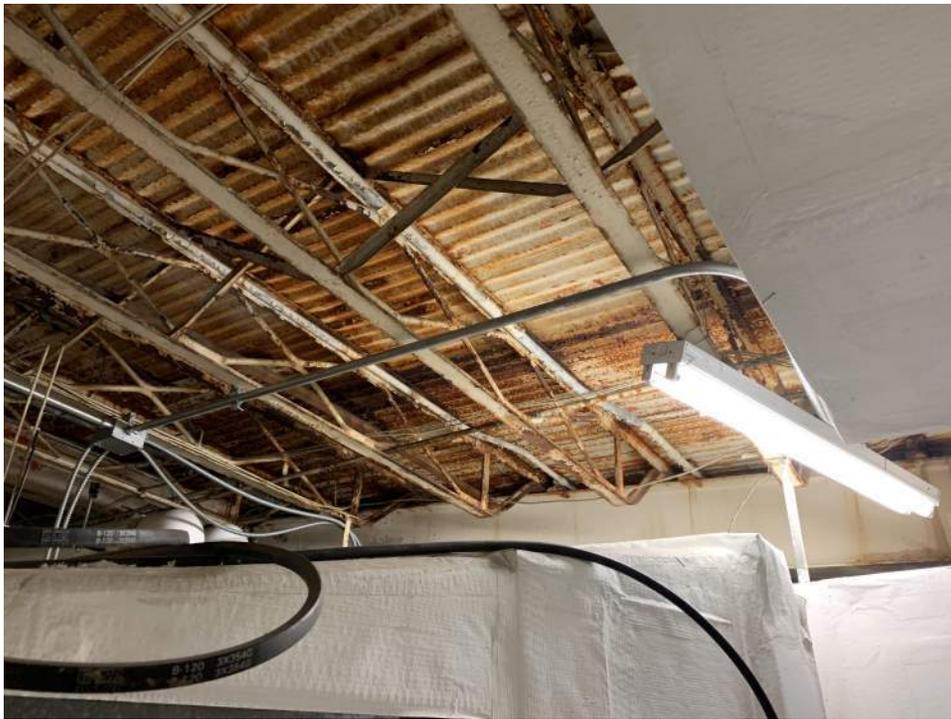
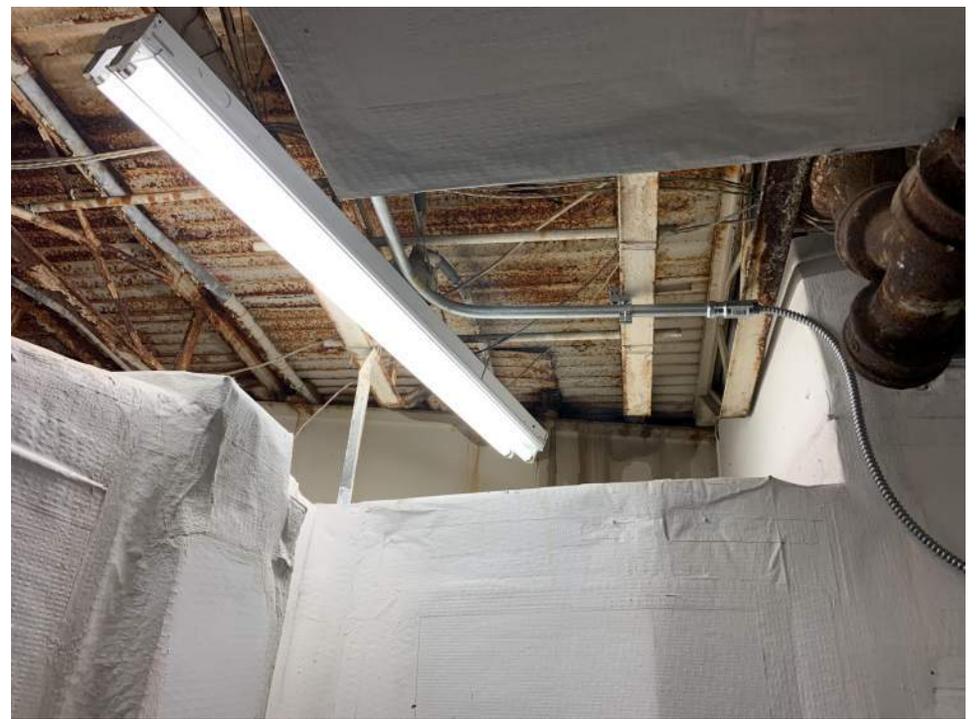
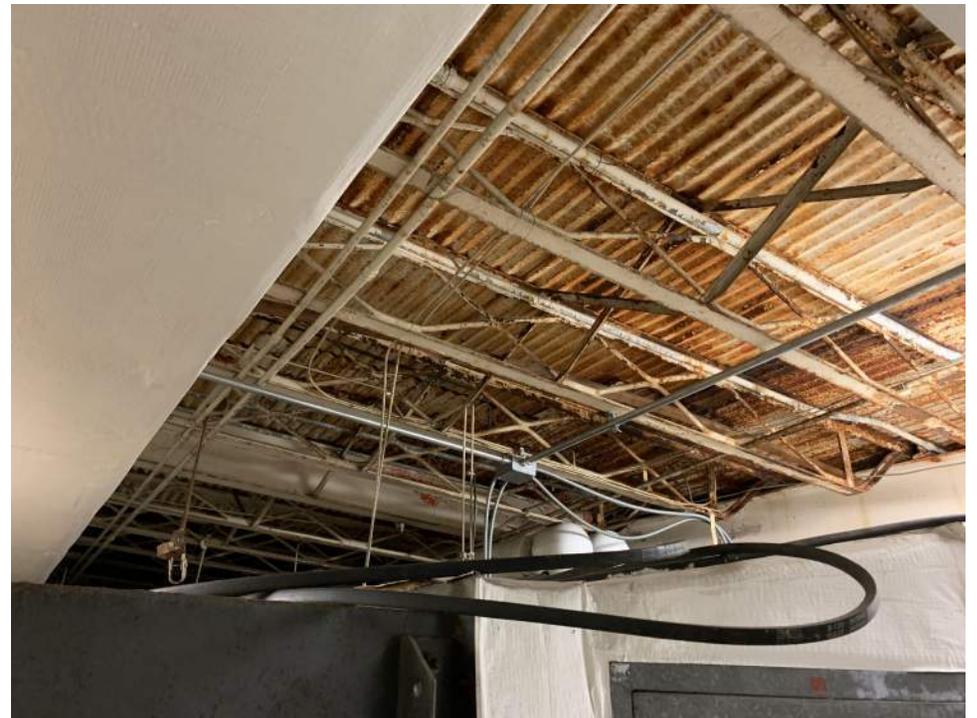
Category 65: Structural Floors

Severe Rusting on metal deck found in mechanical room below auditorium. Recommend structural engineer to study the condition.

- Though the foundations and footings could not be directly observed while on site, no apparent signs of significant movement that would indicate excessive settlement were observed. There was no evidence of heaving, jacking, decay, corrosion, water penetration, or unsupported areas.
- The metal deck supporting the auditorium concrete slab has severe rust and corrosion.

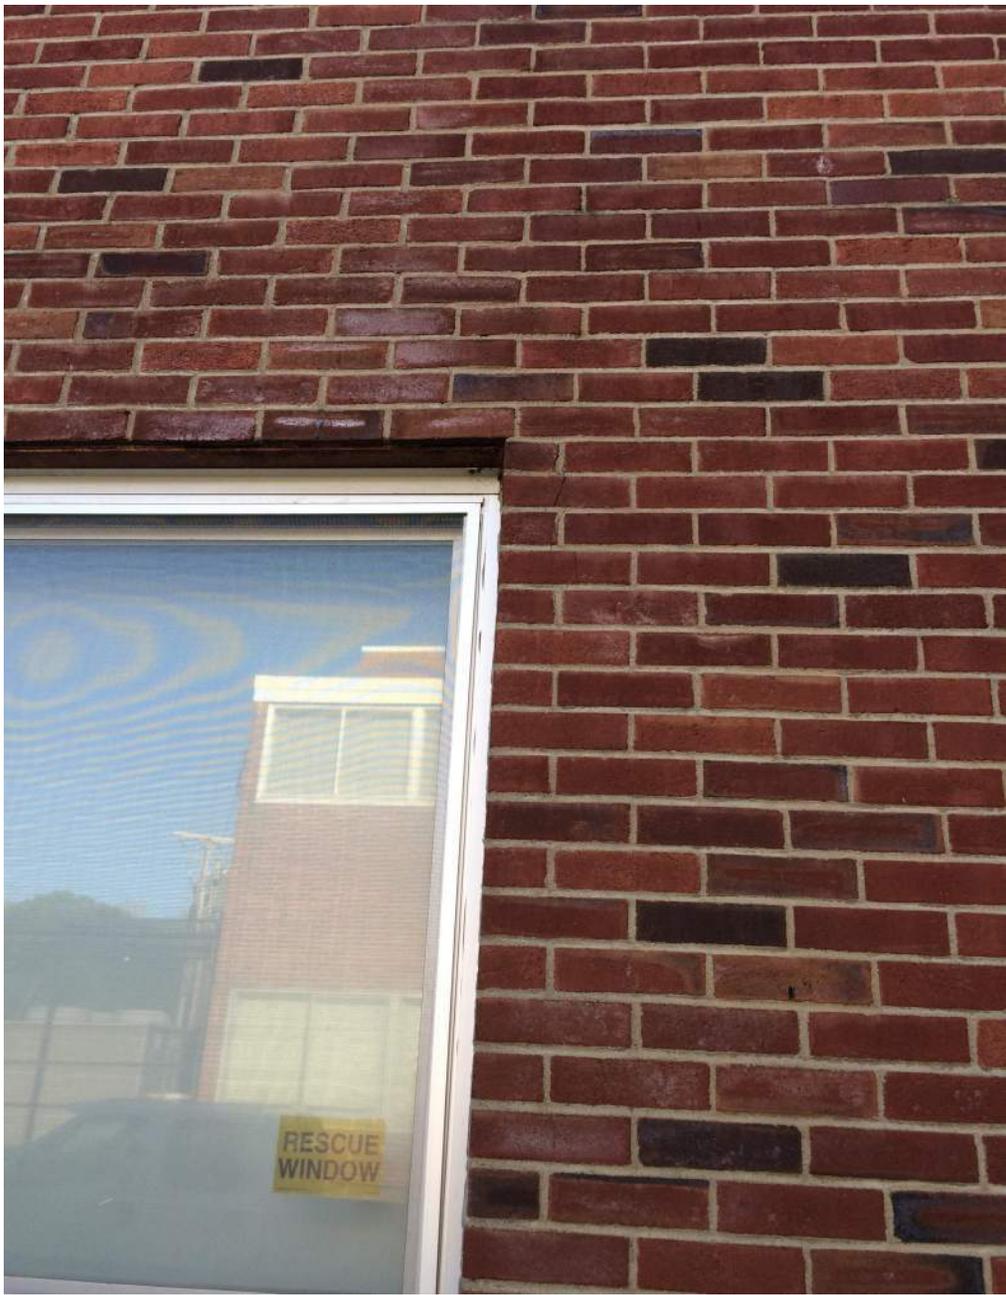
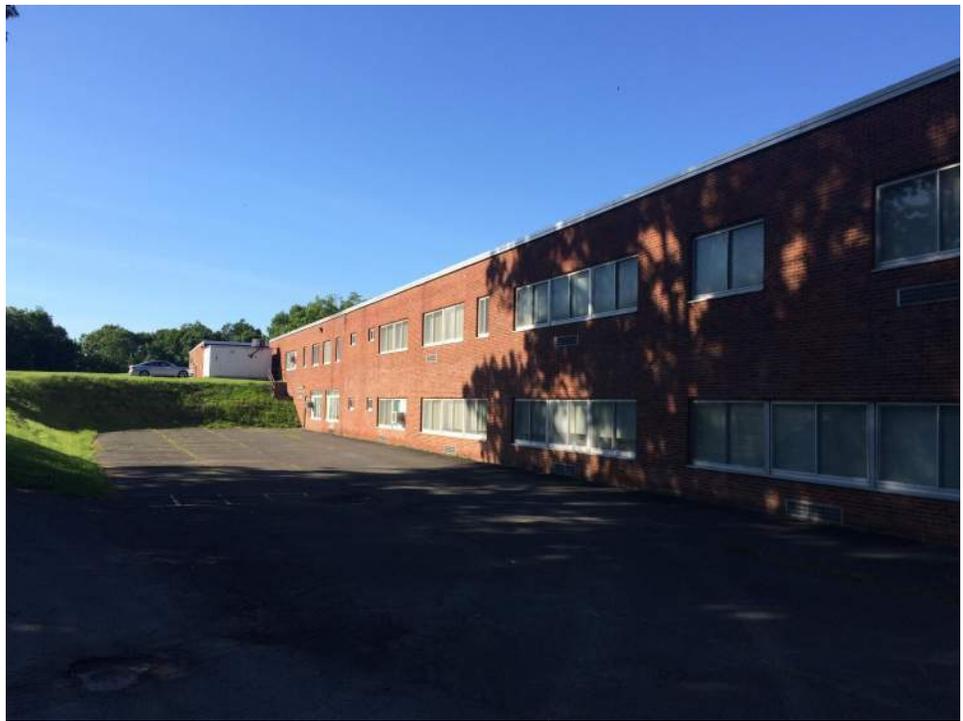
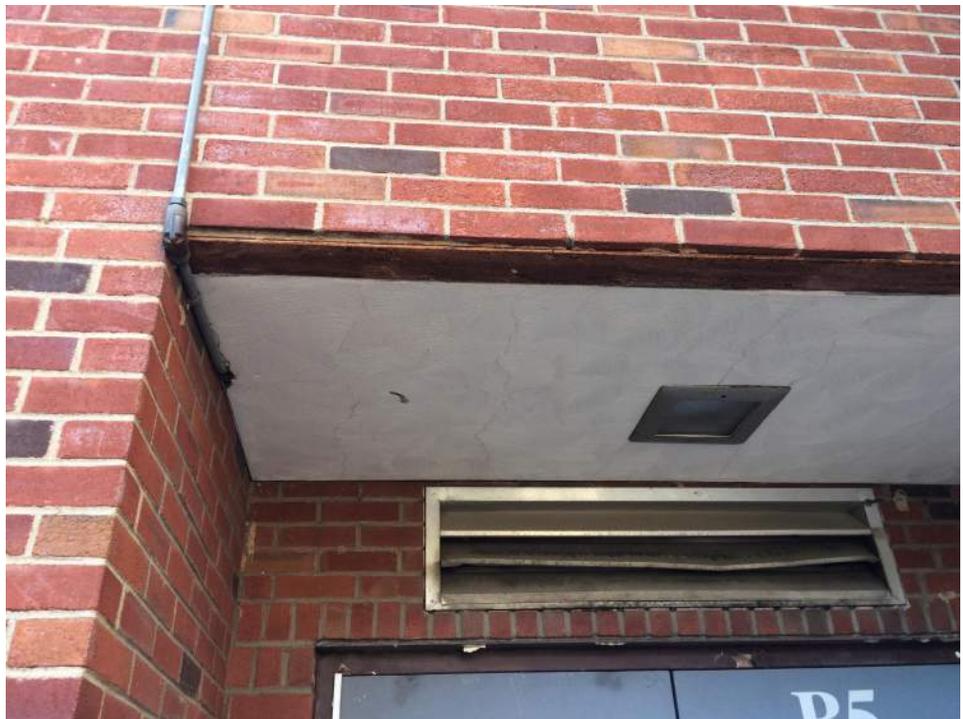
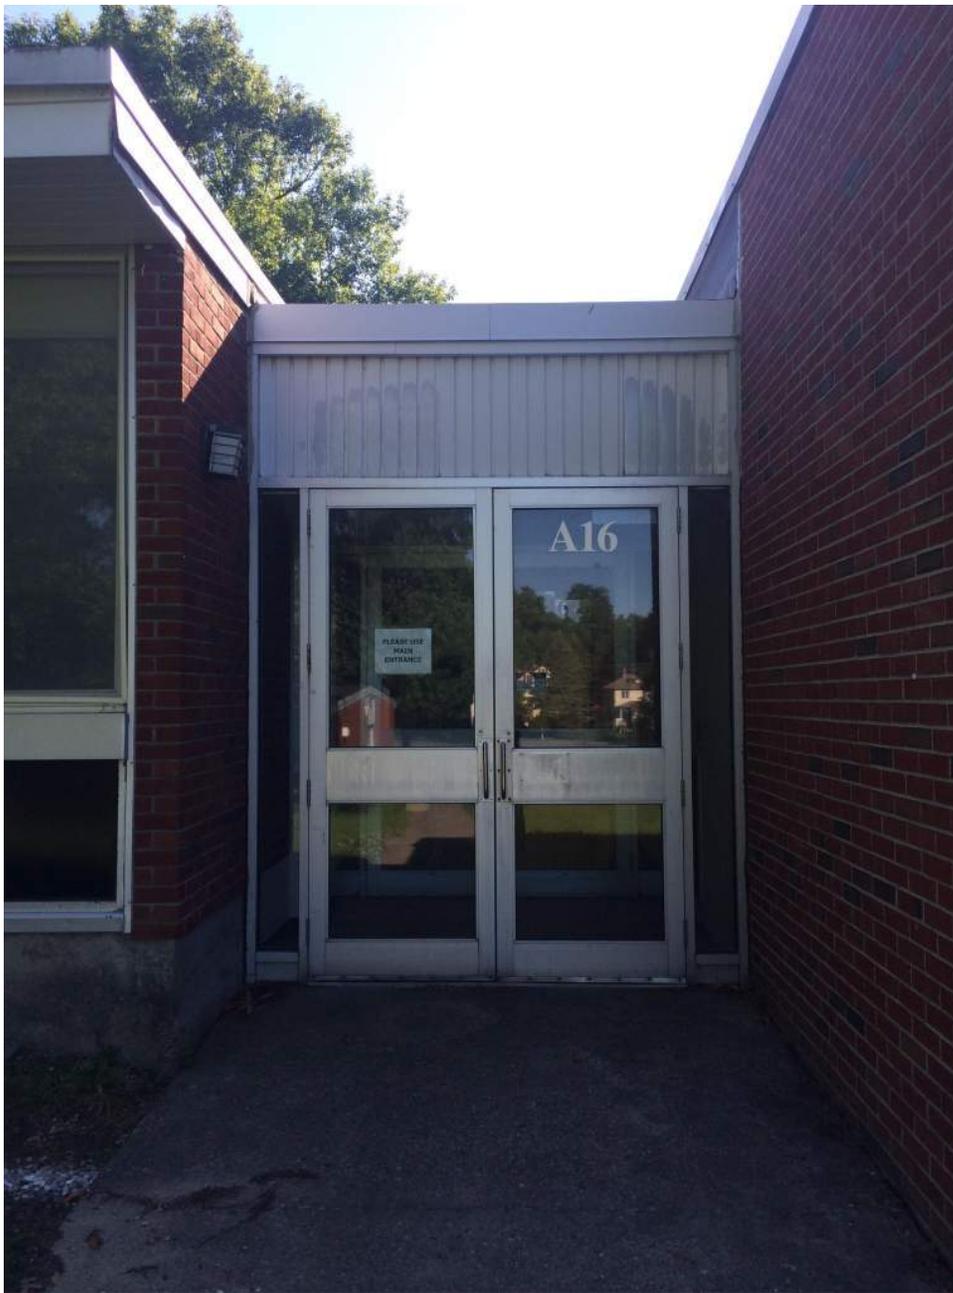
Category 68: Exterior Walls and Columns
Repair cracked masonry along south classroom wing.
Recoat lintels, correct rust jacking, and clean masonry.

- Exterior Walls and Columns (S) – 'Unsatisfactory'
 - Repair cracked unit masonry along the south classroom wing
 - Install control joints where necessary
- Roof and Skylights (S) – 'Unsatisfactory'
 - Replace roof area of south classroom wing
 - Repair 'stretched' perimeter condition for existing membrane
- Heat Generating Systems (H) – 'Unsatisfactory'
 - Gymnasium blower coiler units
- Ventilation System (H)- 'Unsatisfactory'
 - Locker room systems only
- Plumbing Fixtures (H)- 'Unsatisfactory'
 - Renovate eight (8) toilet rooms to repair concealed galvanized drainage lines
 - Replace valves on the domestic water line

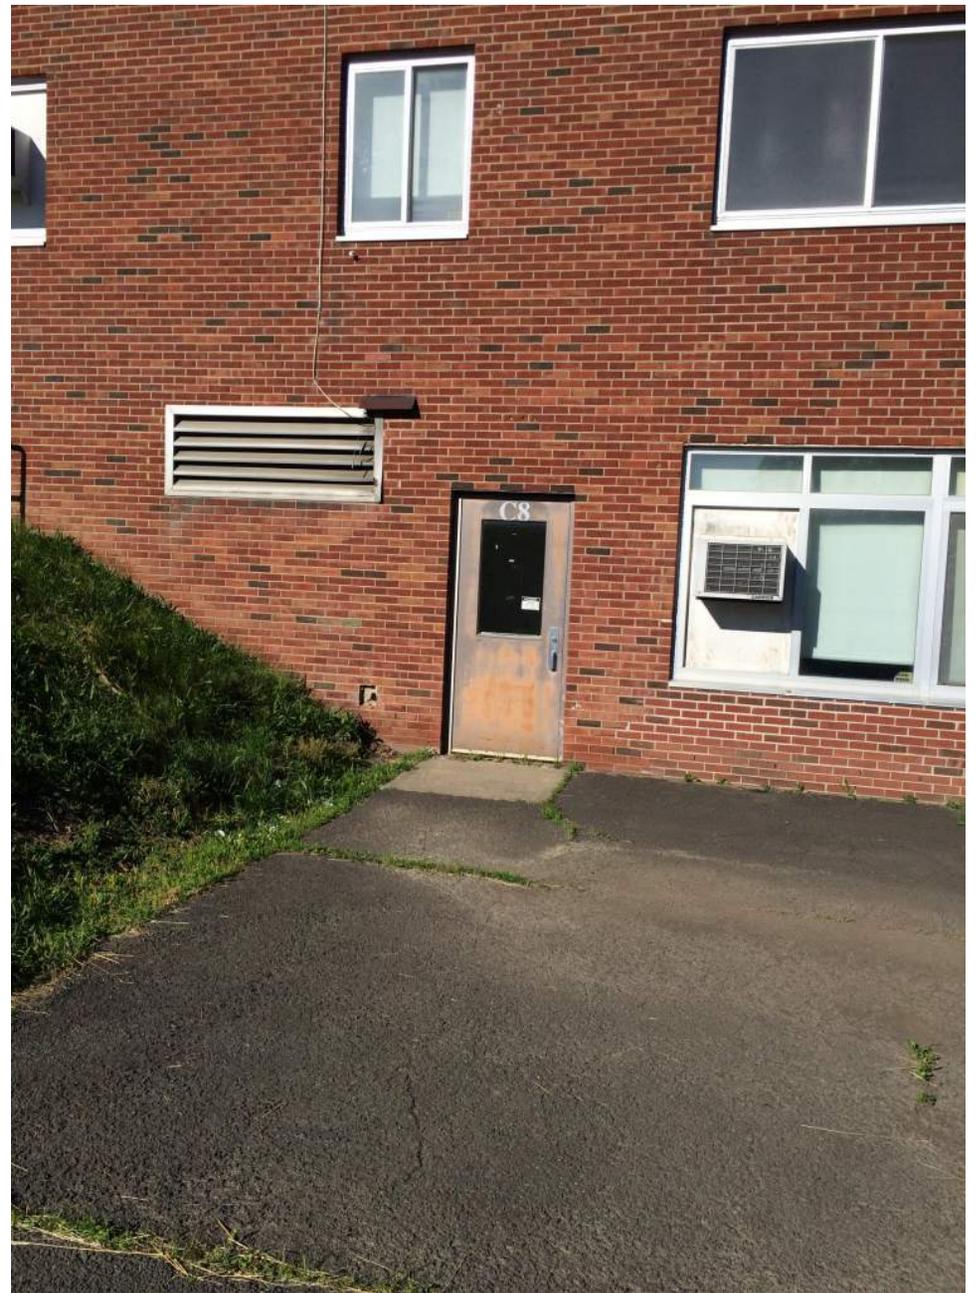
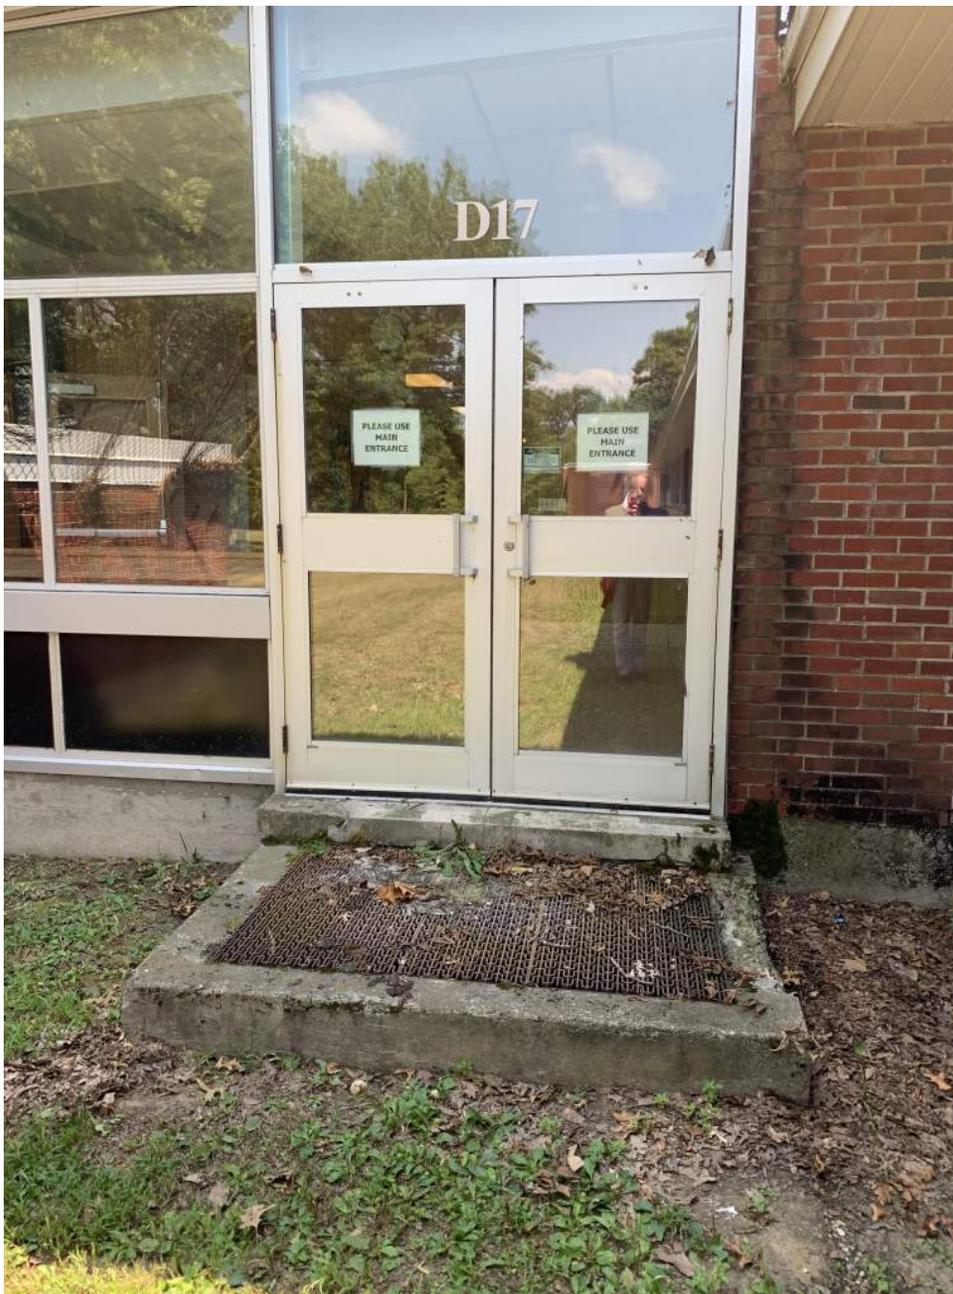
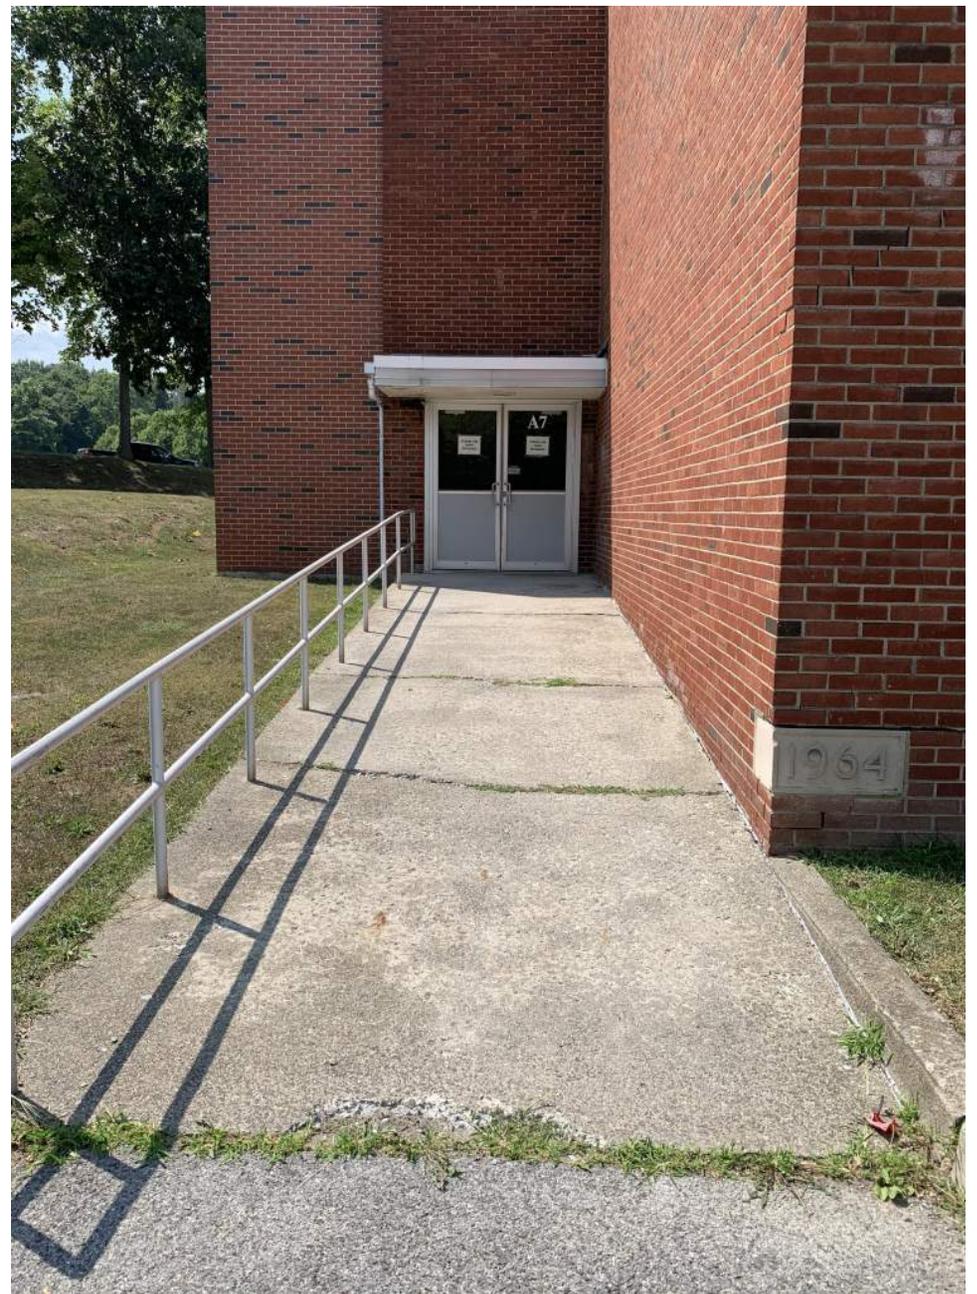
Category 69: Exterior Doors

Replace exterior doors and frames (hollow metal and aluminum).

- Like the storefront systems, the hollow metal doors and frames are old and not considered energy-efficient, it is recommended to replace the hollow metal doors and frames with new doors and frames.

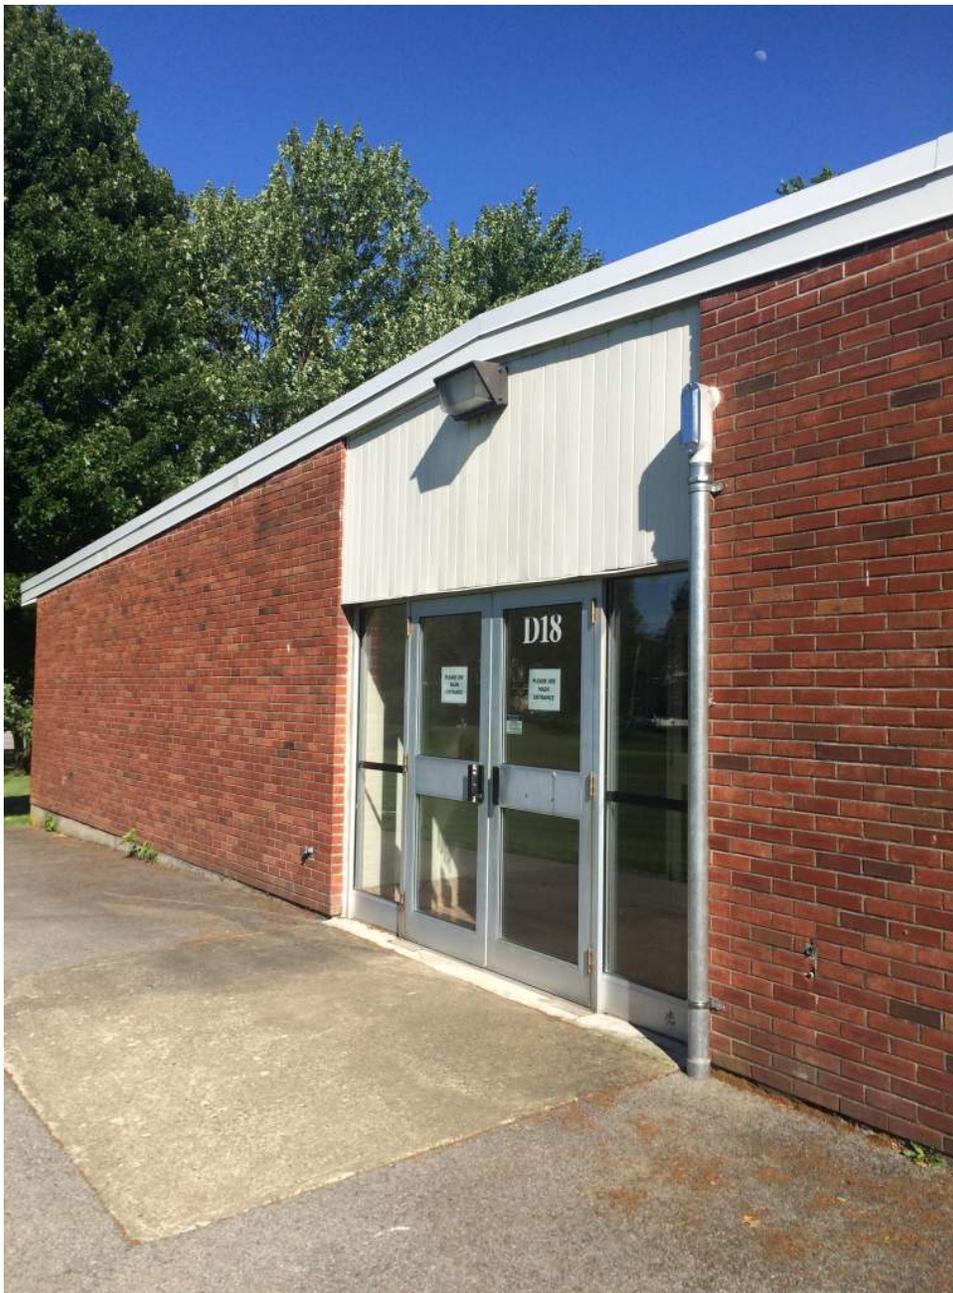
MS-26

Category 70: Exterior Steps, Stairs, & Ramps

Ramp near elevator tower has several large cracks and spalled concrete. Concrete step with door D17 is beyond repair and should be replaced.

- The concrete ramp near the south entrance of the 1964 addition has several large cracks and some spalled concrete, replace as required.
- Concrete step and landing with grate near door D17 are in disrepair and should be replaced; asphalt 'ramped' walk in courtyard leading to door A16 is in good condition.
- Repair cracked unit masonry (brick) along south classroom D & E wing; recoat lintels, correct rust jacking; cut expansion joints in the existing masonry at the building corners; masonry cleaning required building wide.
