**2020 BUILDING
CONDITION SURVEY
REPORT**

CORNWALL CENTRAL
SCHOOL DISTRICT

Central
Middle School

January 2021

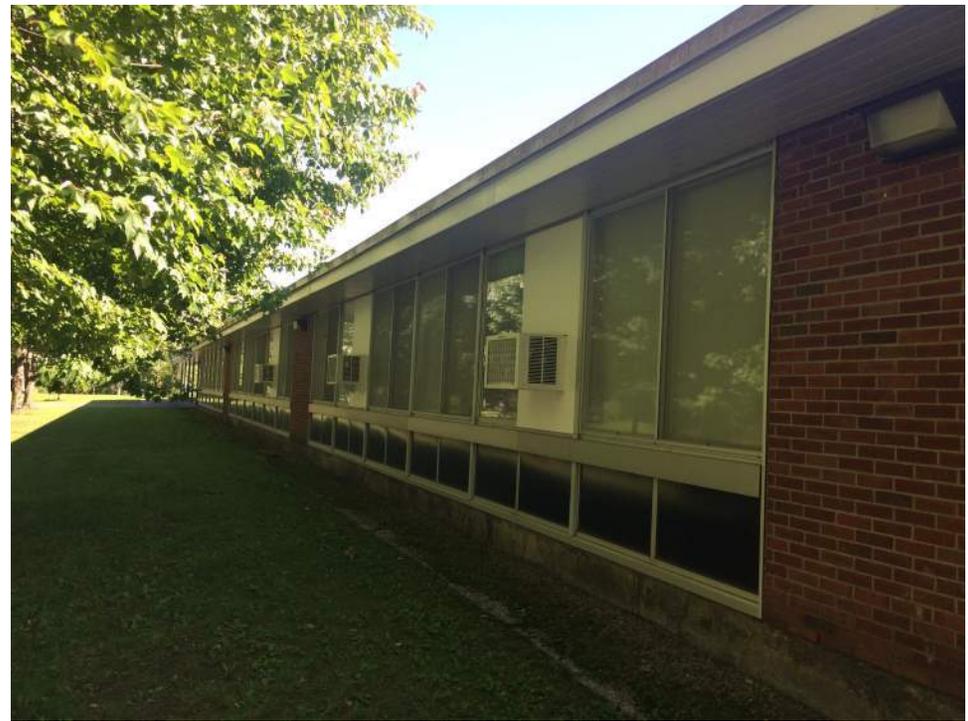
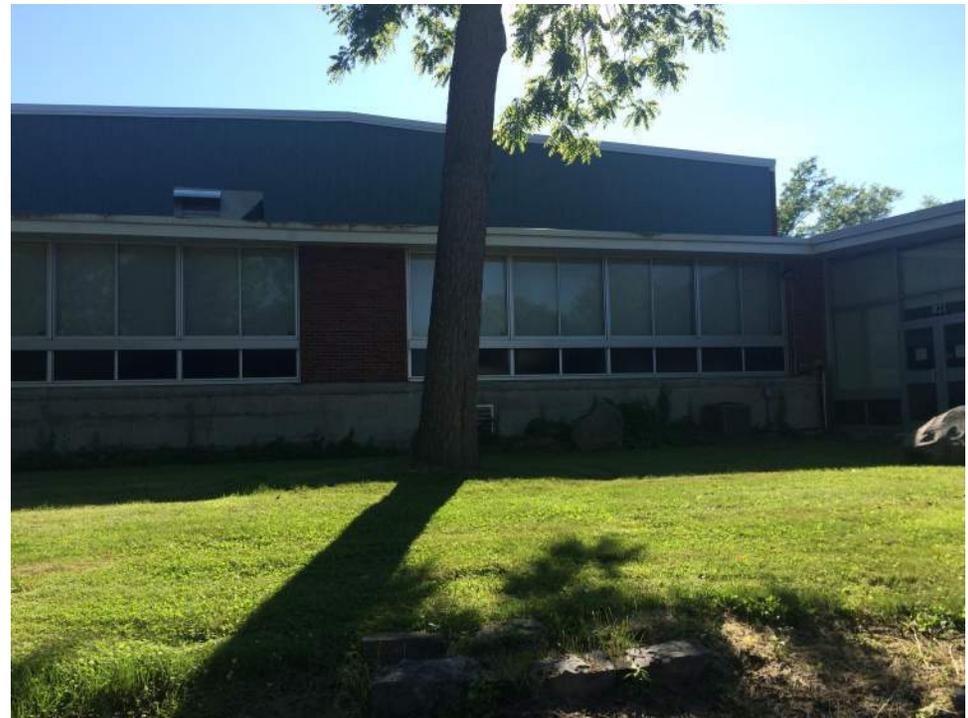
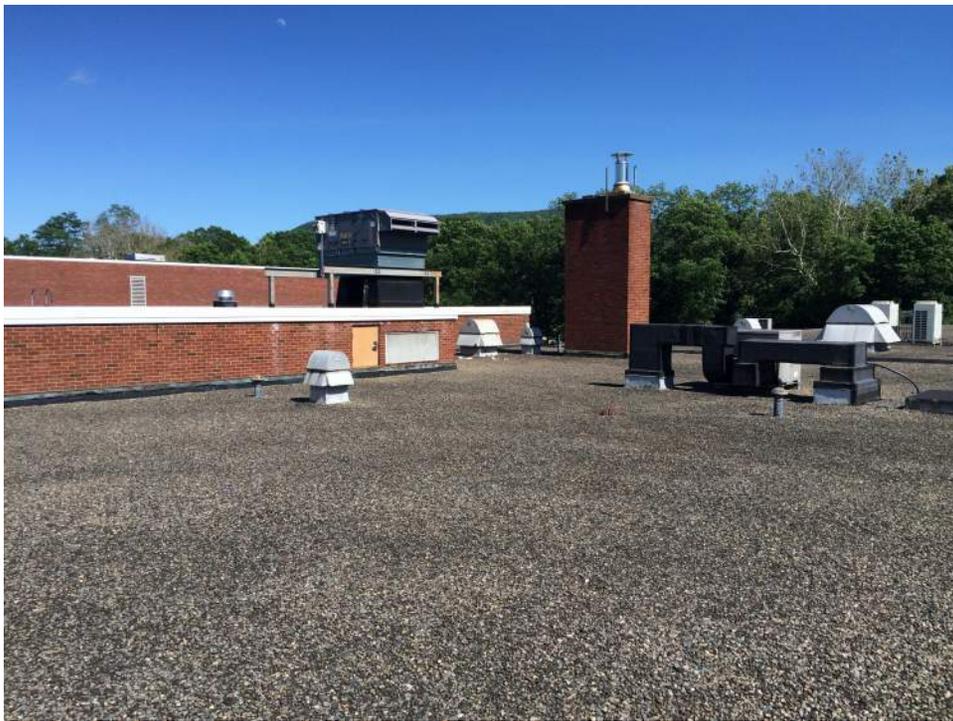
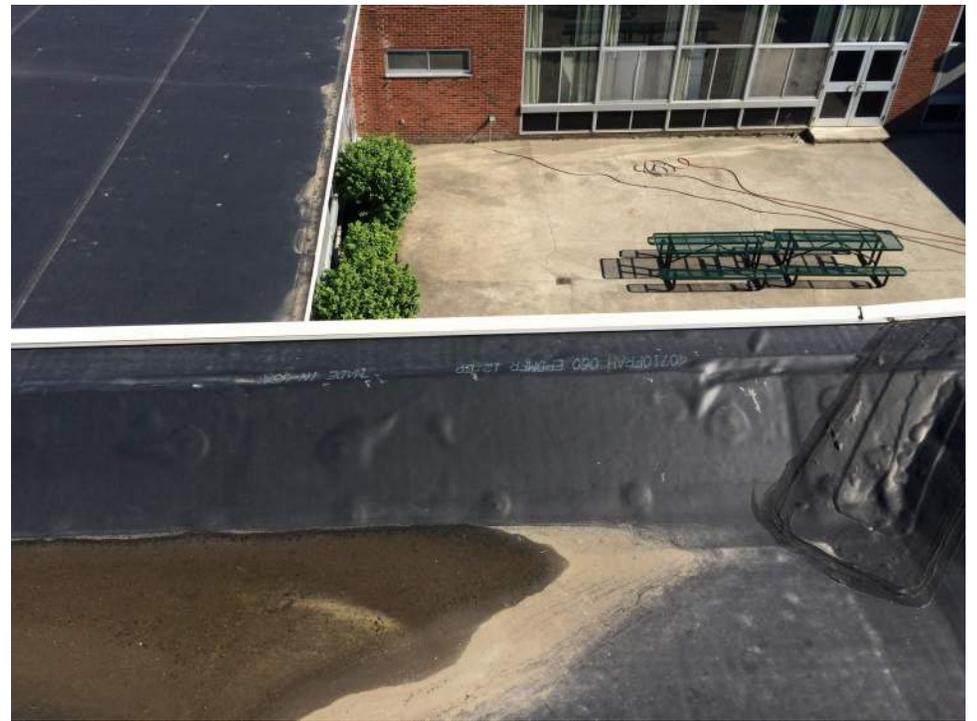
Category 72- Windows:

Replace building aluminum storefront system and adjacent doors and frames. Replace aluminum storefront systems at classrooms and office areas.

- Since the existing storefront systems are original to the building and not considered an energy-efficient building envelope system, it is recommended to replace the storefront and doors / frames with a modern, energy-efficient storefront system; consider selecting a thermally broken metal frame system with insulated glazing units.

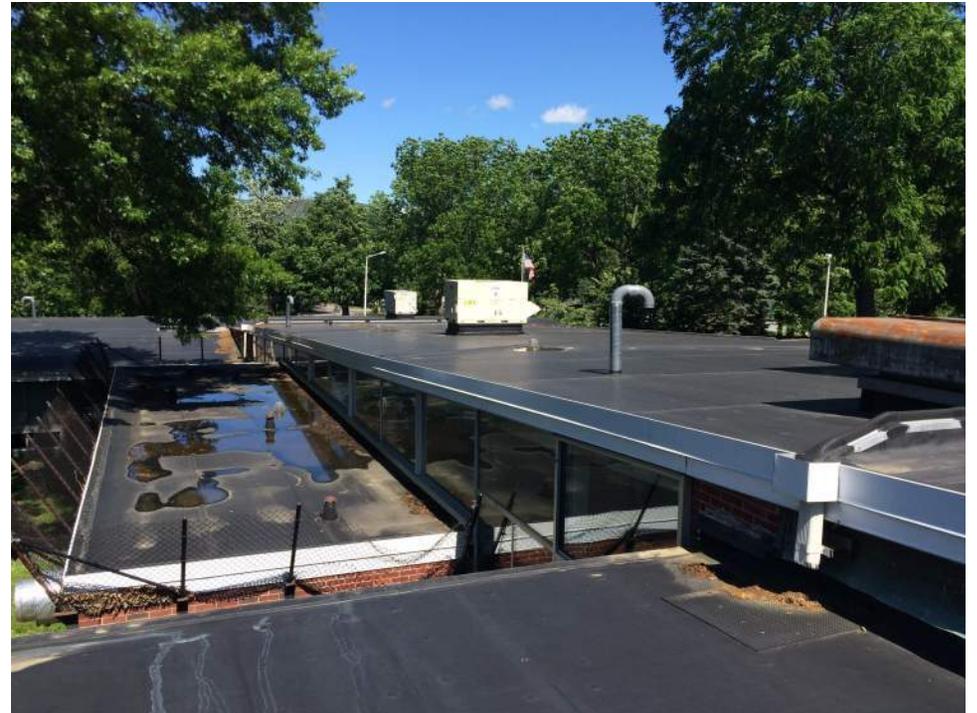
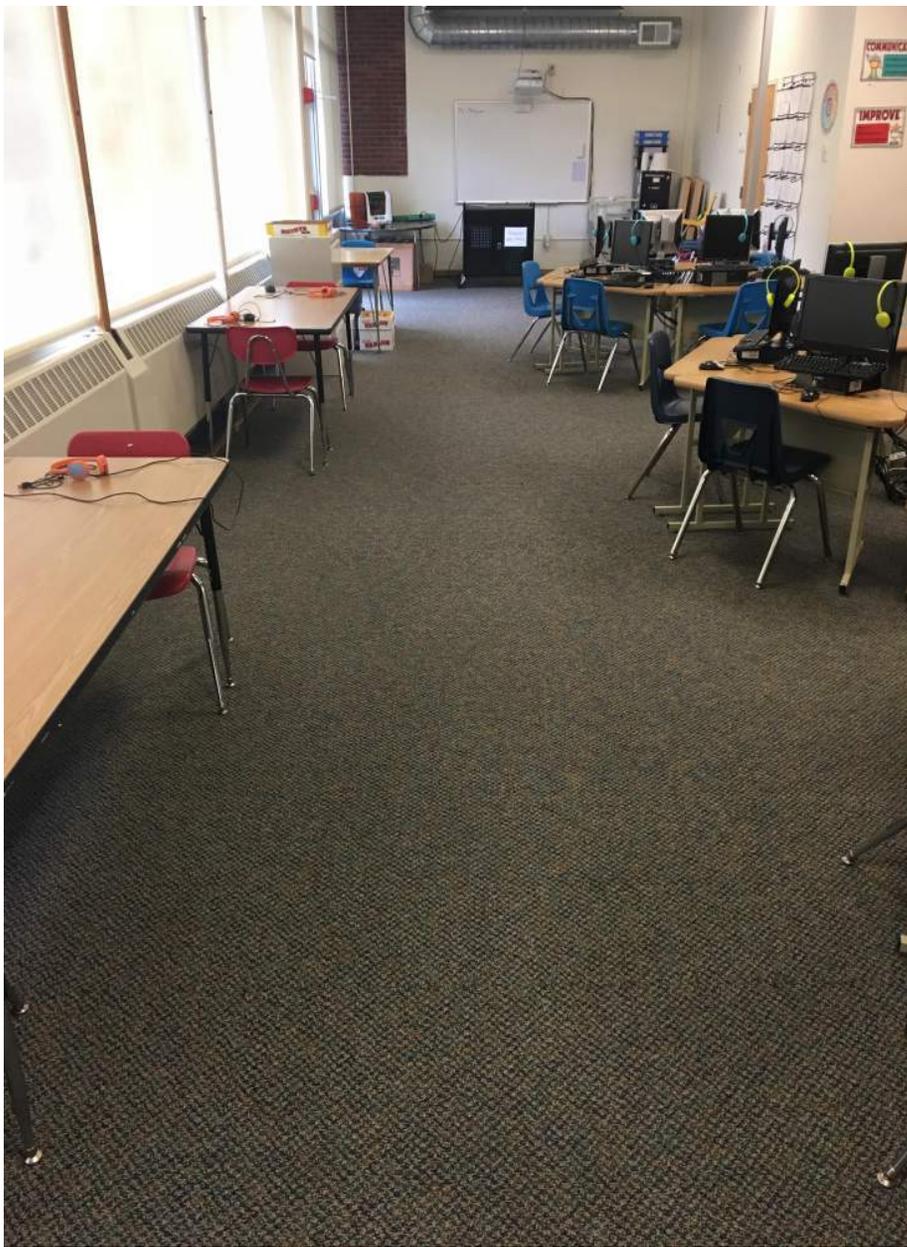
Category 73: Roofs & Skylights

Replace existing ballasted built-up roof (Area 'A') and repair billowed EPDM membrane along roof perimeters (3 areas). Replace metal edge and reattach metal termination bar for base flashing in one area.

- At D & E wing, the existing built-up roof system with stone ballast is beyond its expected useful life and is not a reliable building envelope system; replace the roof system, including the insulation, flashings and roof metal edge.

- During a roof walk-through, several EPDM roof areas were observed having a delaminated section along the roof perimeter, these areas should be repaired to maintain the integrity of the roof membrane.

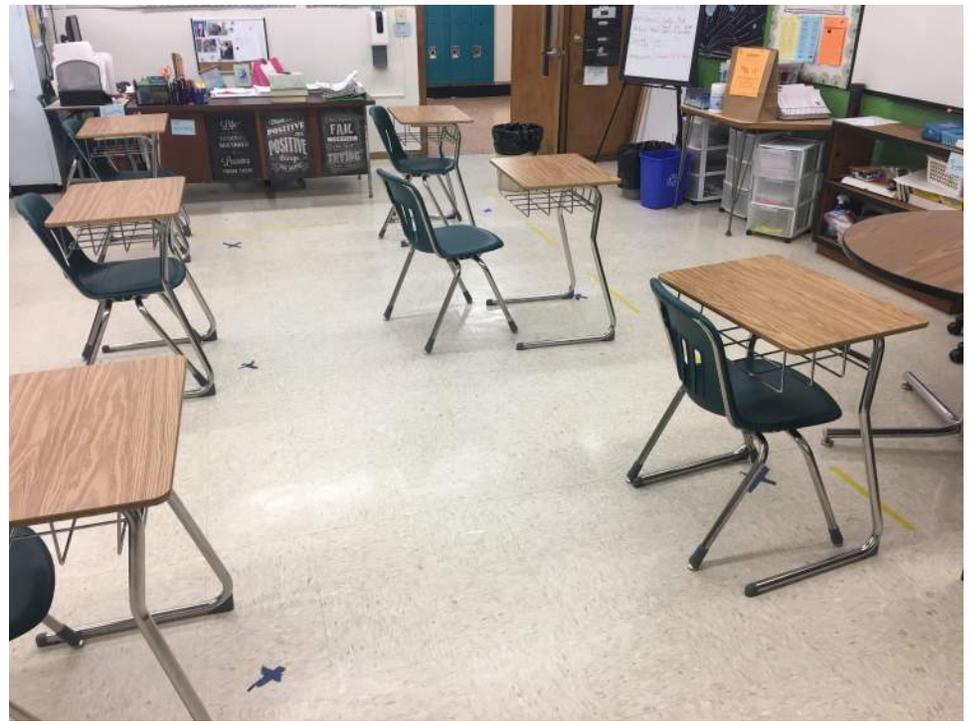
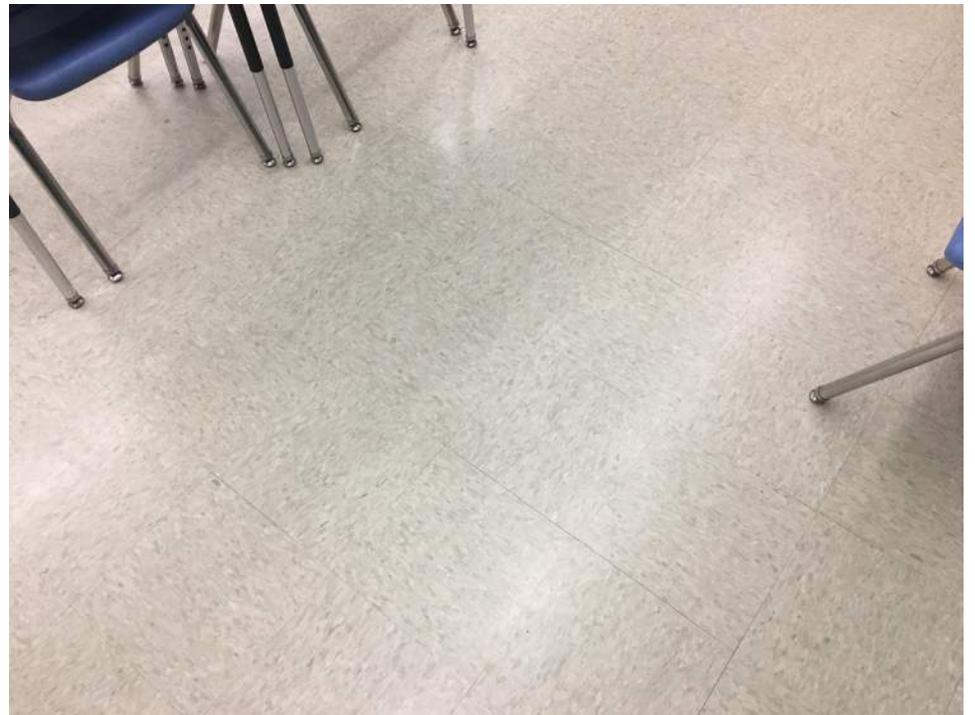
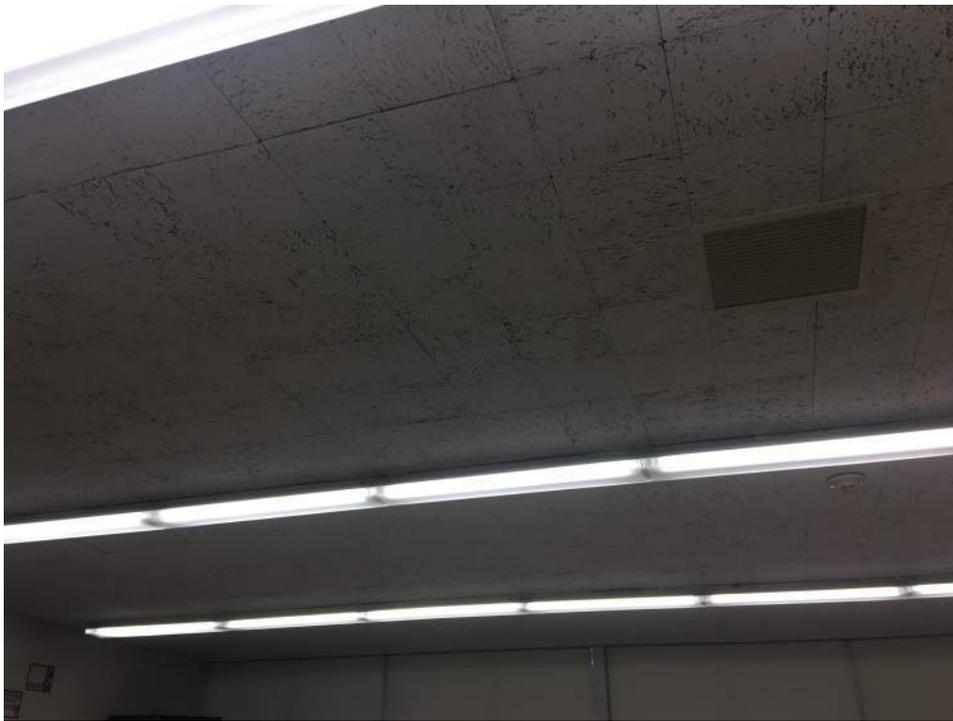
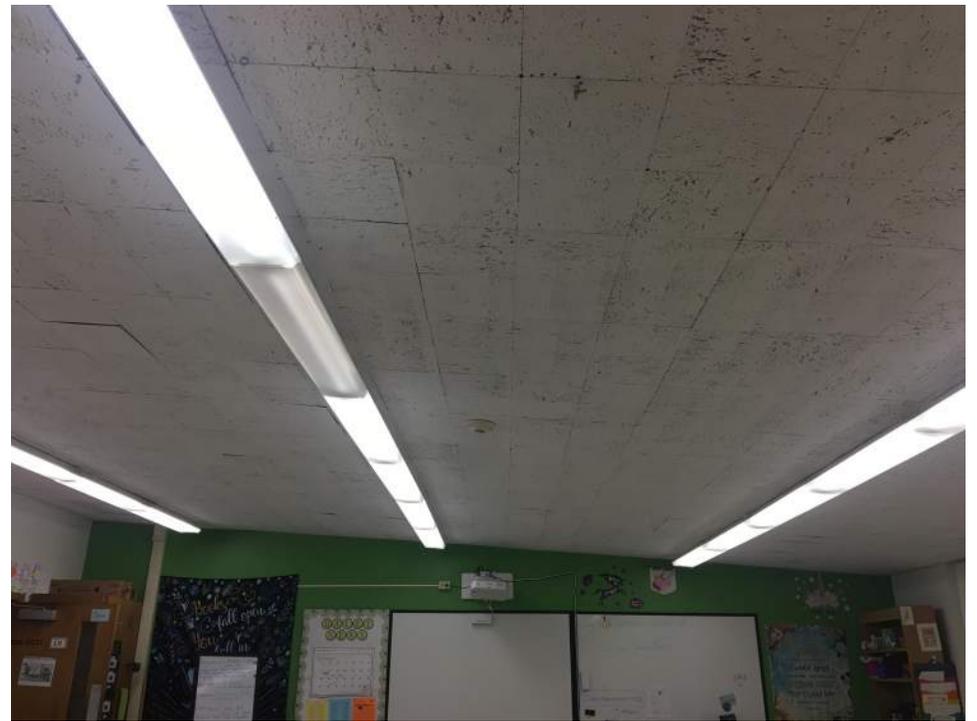
Category 77: Resilient Tiles & Sheet Flooring
Replace existing resilient floor tile in classrooms.

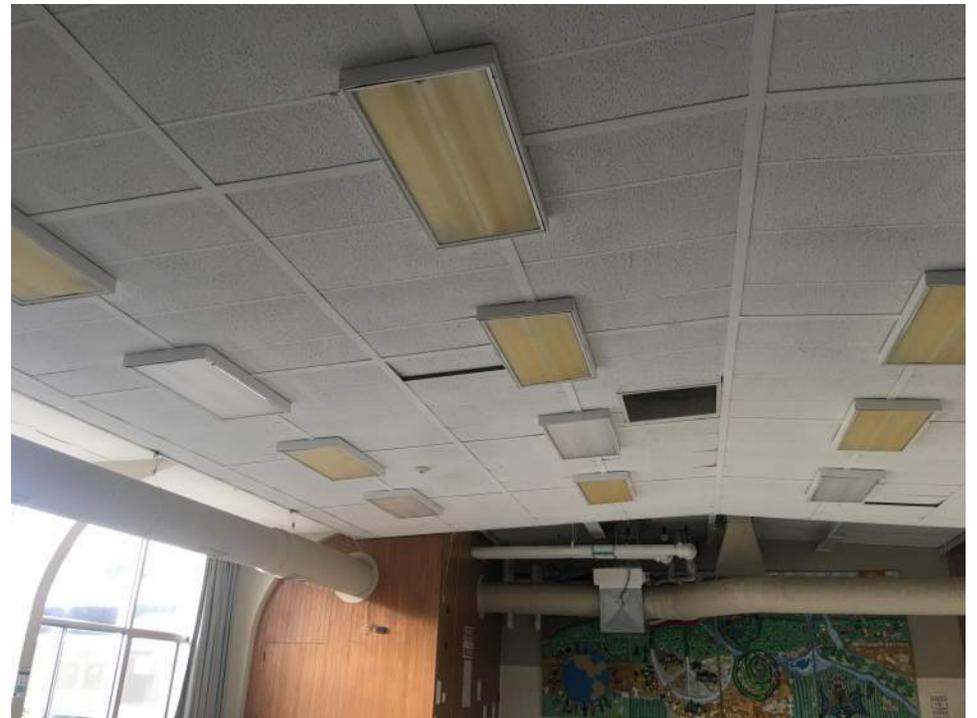
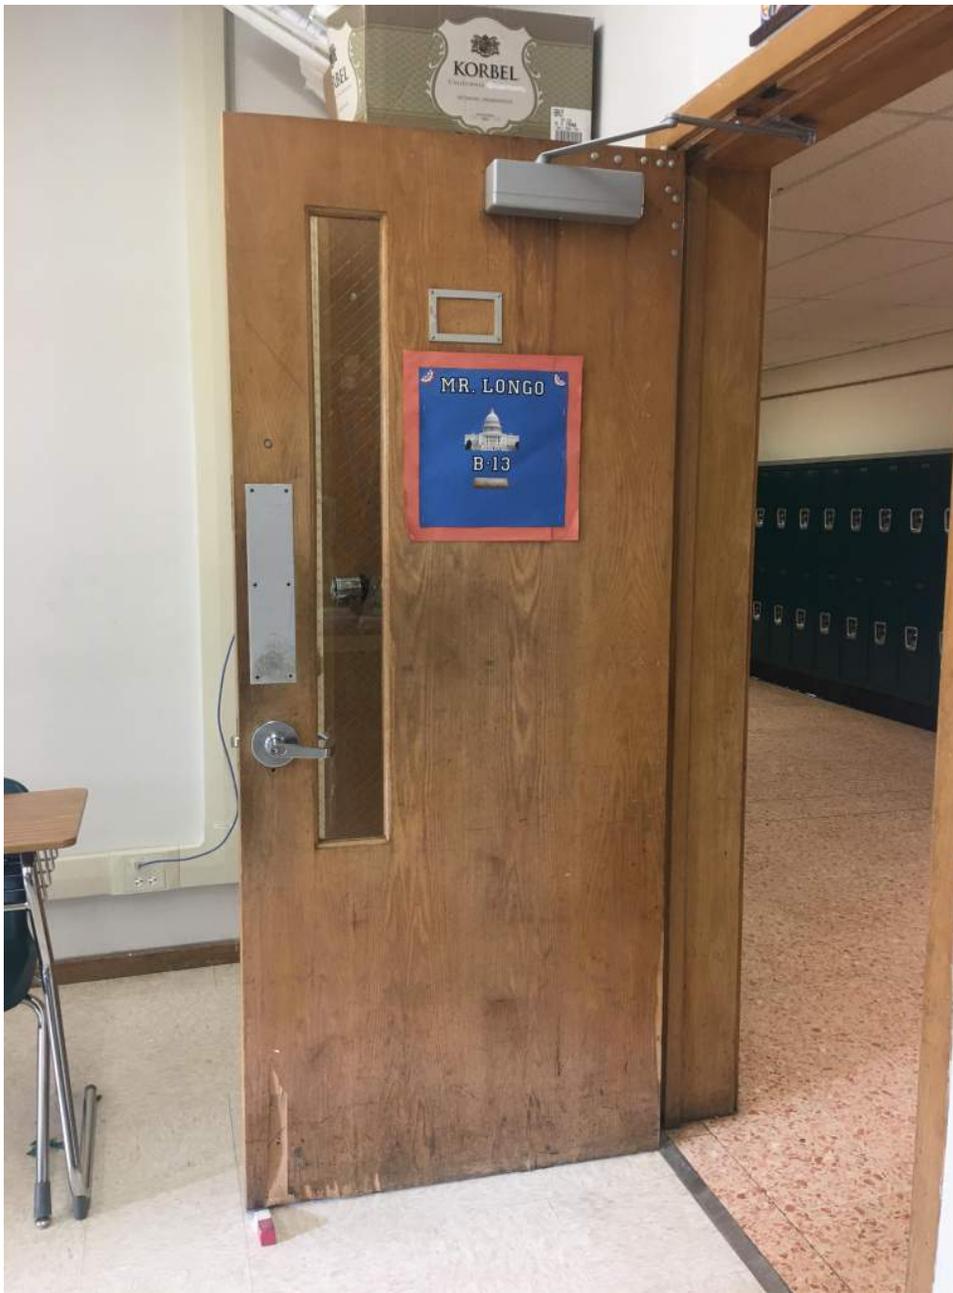
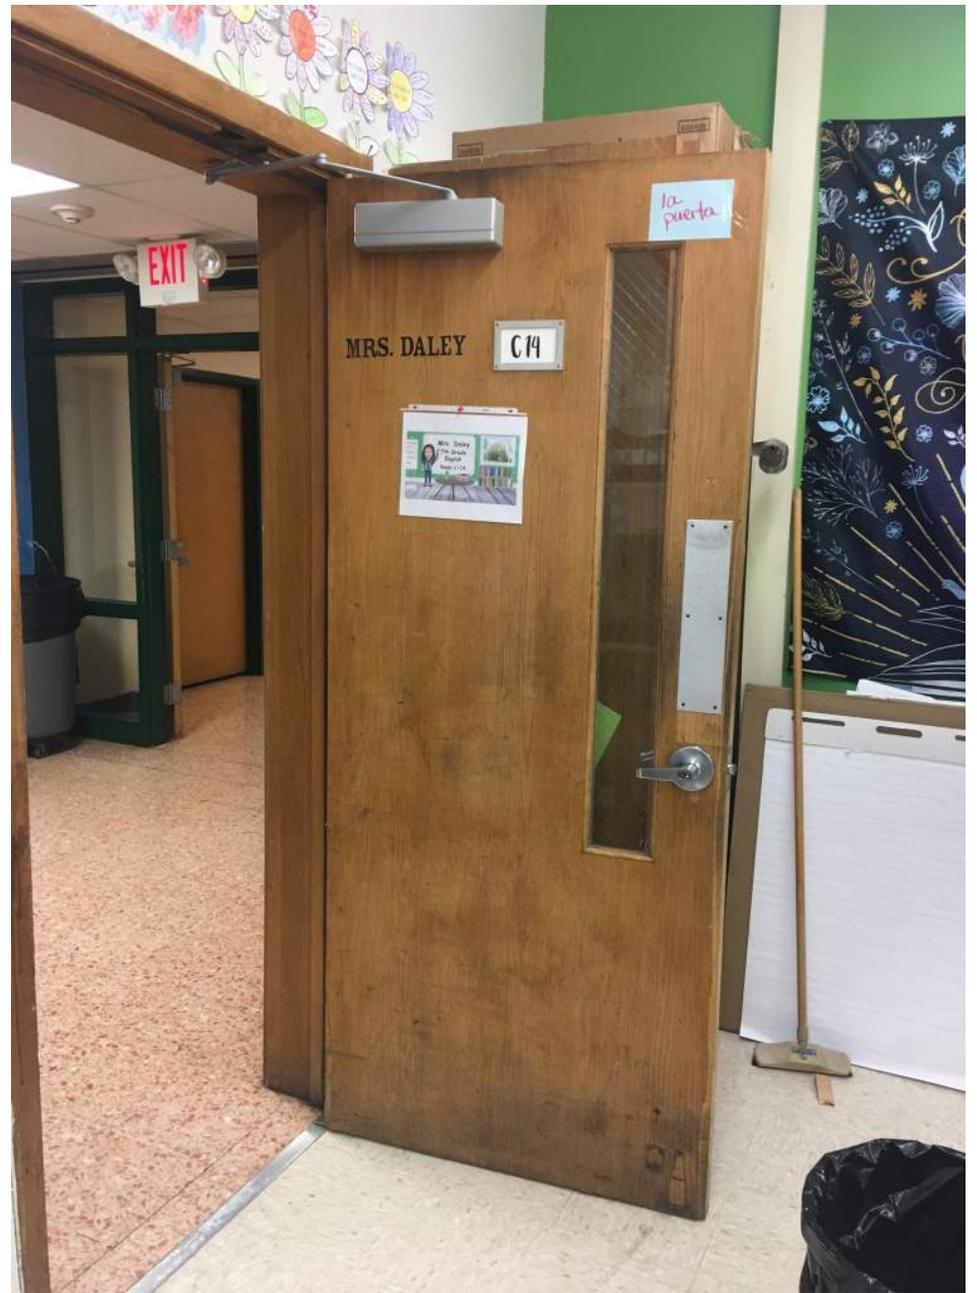
Category 80: Ceilings

Replace classroom ceilings in B & C Wings. Consider replacing ceilings in cafeteria.

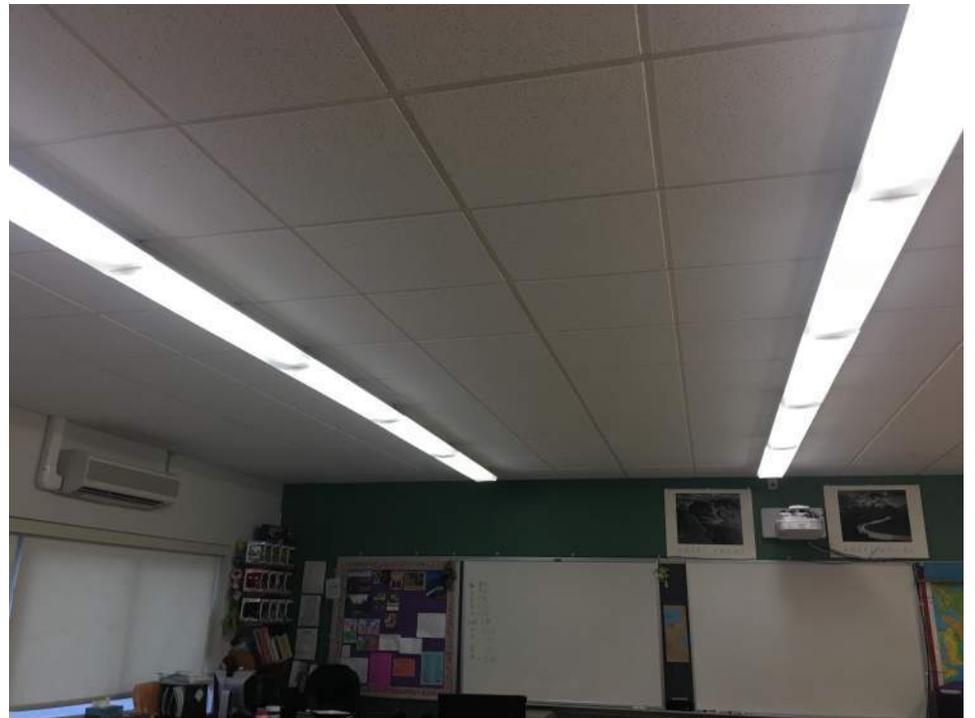
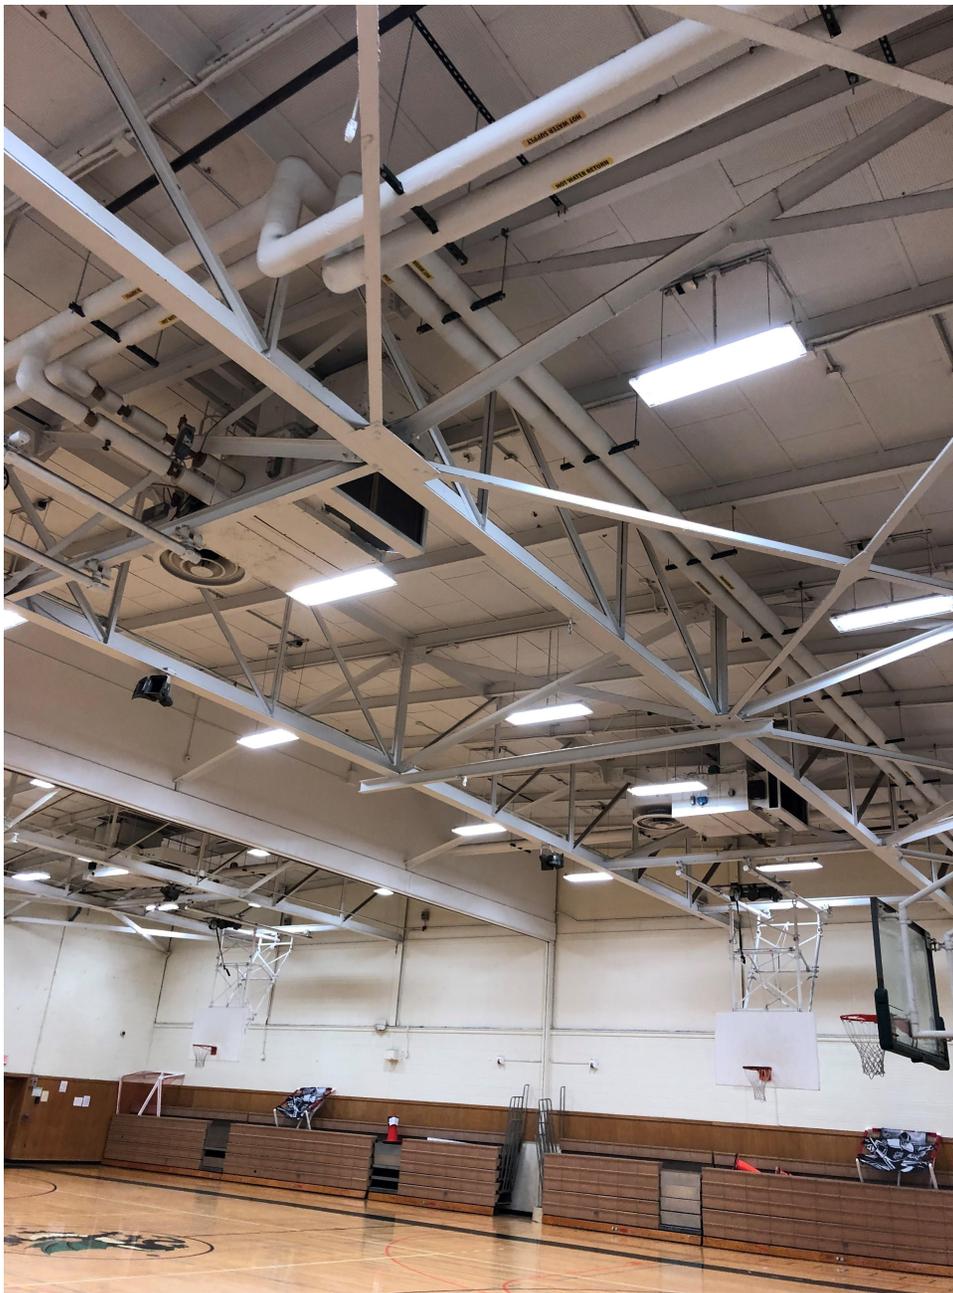
Category 102: Lighting Fixtures
Replace lighting in cafeteria and classrooms throughout building and associated controls.

Existing Classroom and Cafeteria recessed fluorescent interior lighting fixtures and associated controls are in fair to poor condition. Illumination levels appear to be deficient in certain areas.

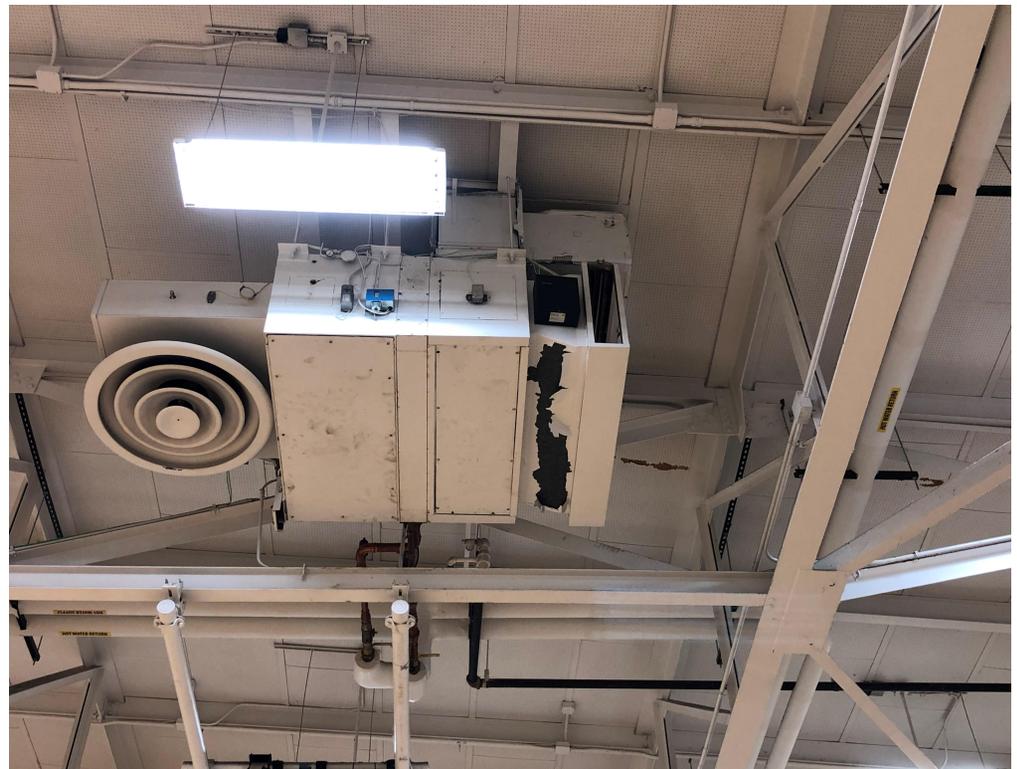
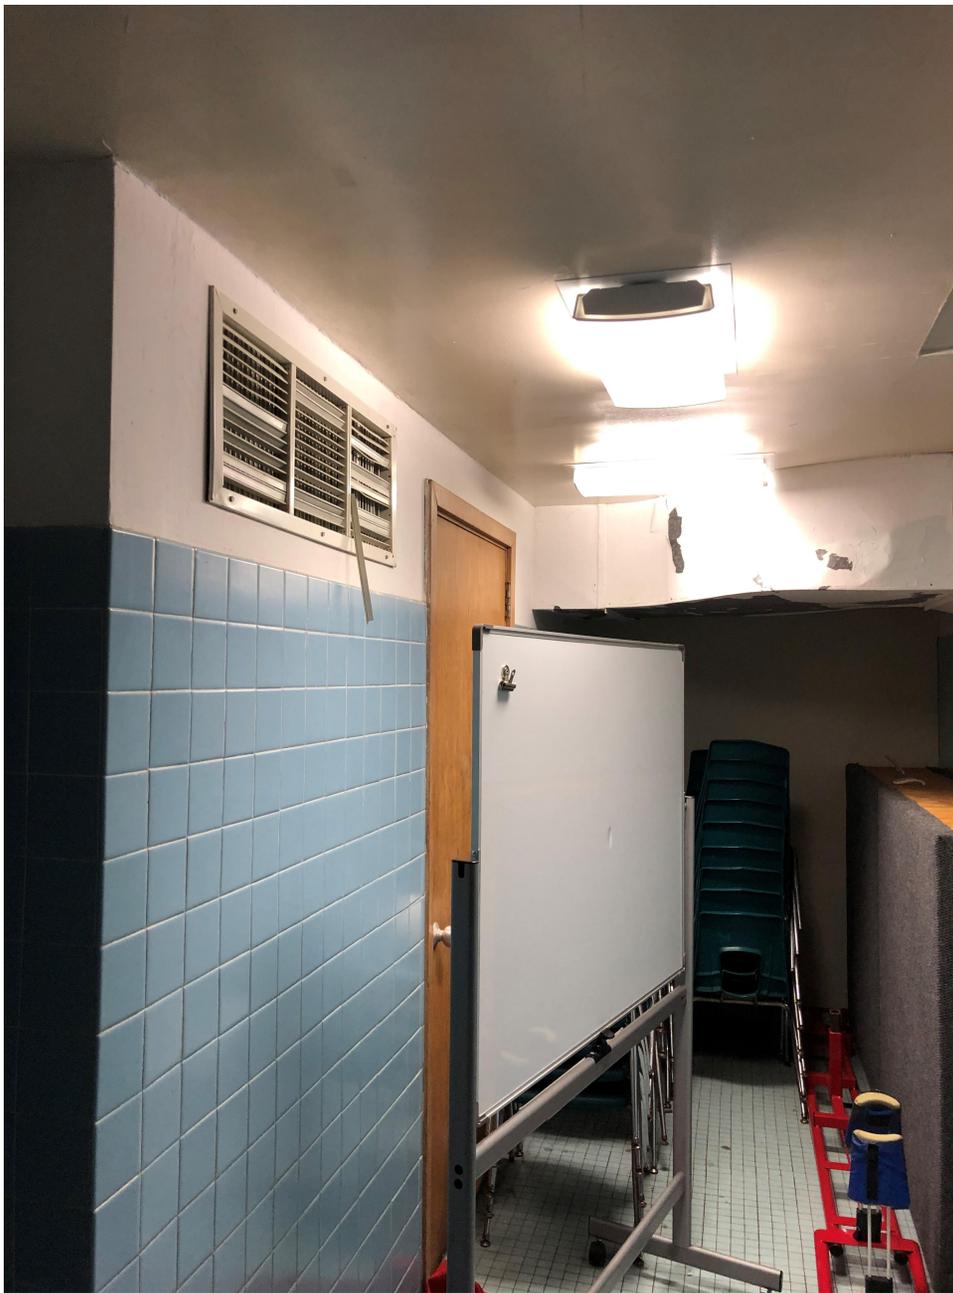
Category 87: Heat Generating Systems

Replace the two (2) blower coils in the gymnasium that are not functioning.

- Replace two (2) blower coil units in the Gymnasium that are not running. Also, the remaining two (2) blower coil units are near to its useful service life and require to be replaced within the next five years.
- Replace two (2) horizontal unit ventilators in the Locker Rooms that are in poor condition and generate loud noise.
- The unit ventilators are near to its useful service life and require to be replaced within the next three years.
- The HVAC controls are in good condition.
- The boilers are in good condition.
- The present preventive maintenance policy should continue.

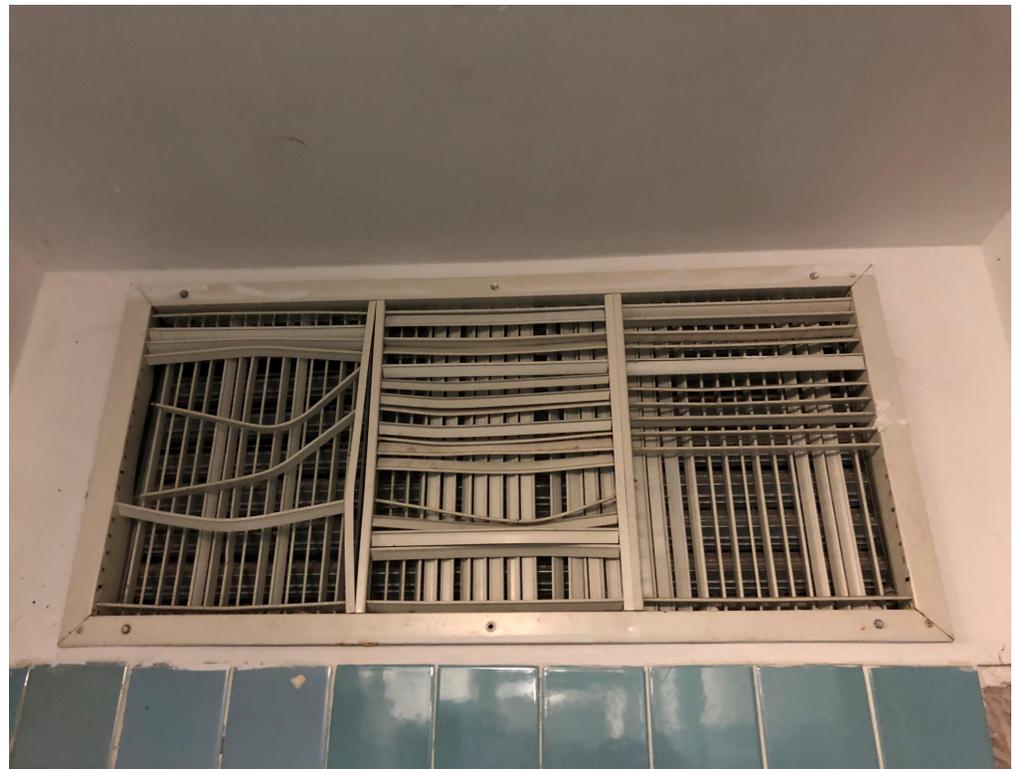
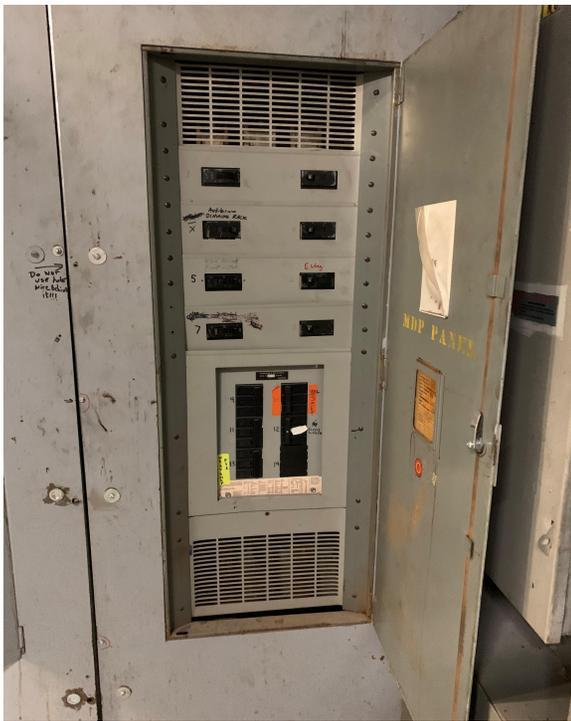
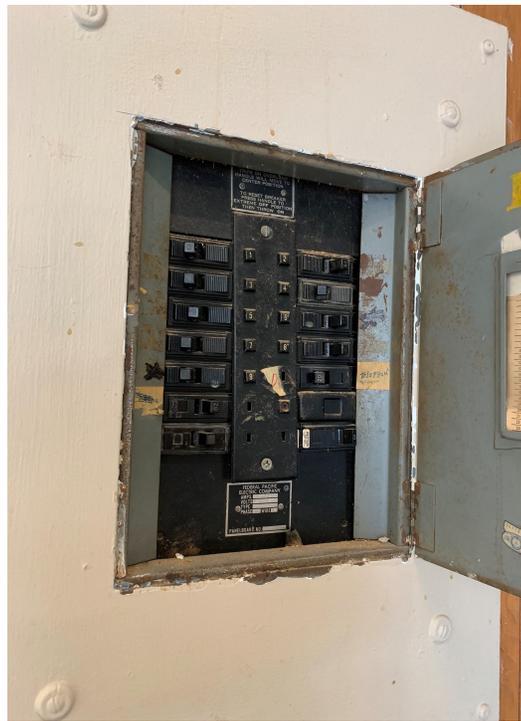
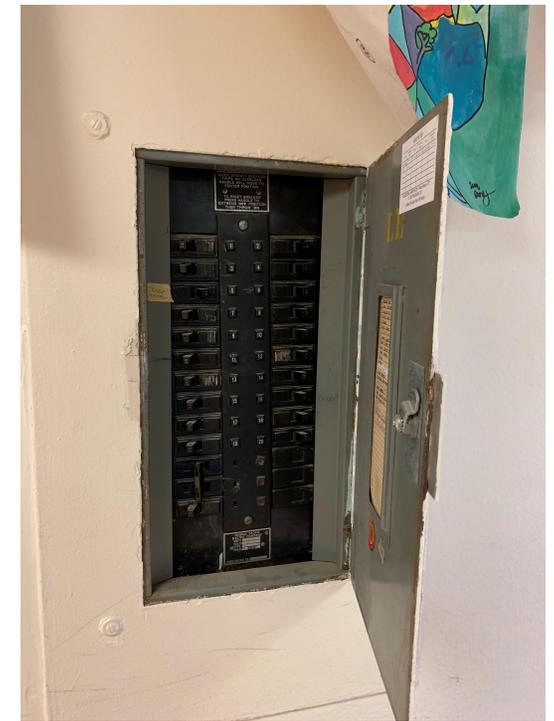
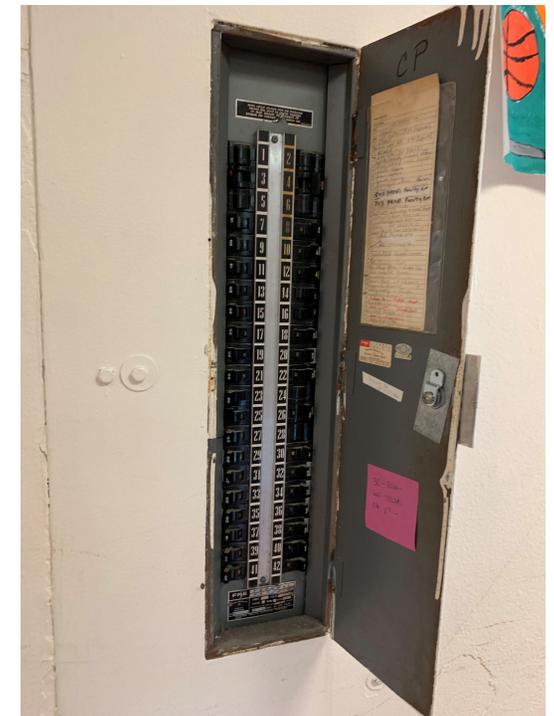
Category 88: Ventilation Systems

Locker room HV units are in poor condition. Replace with horizontal unit ventilator.
