**2020 BUILDING  
CONDITION SURVEY  
REPORT**

CORNWALL CENTRAL  
SCHOOL DISTRICT

Central  
High School

CSArch Project #204-1901

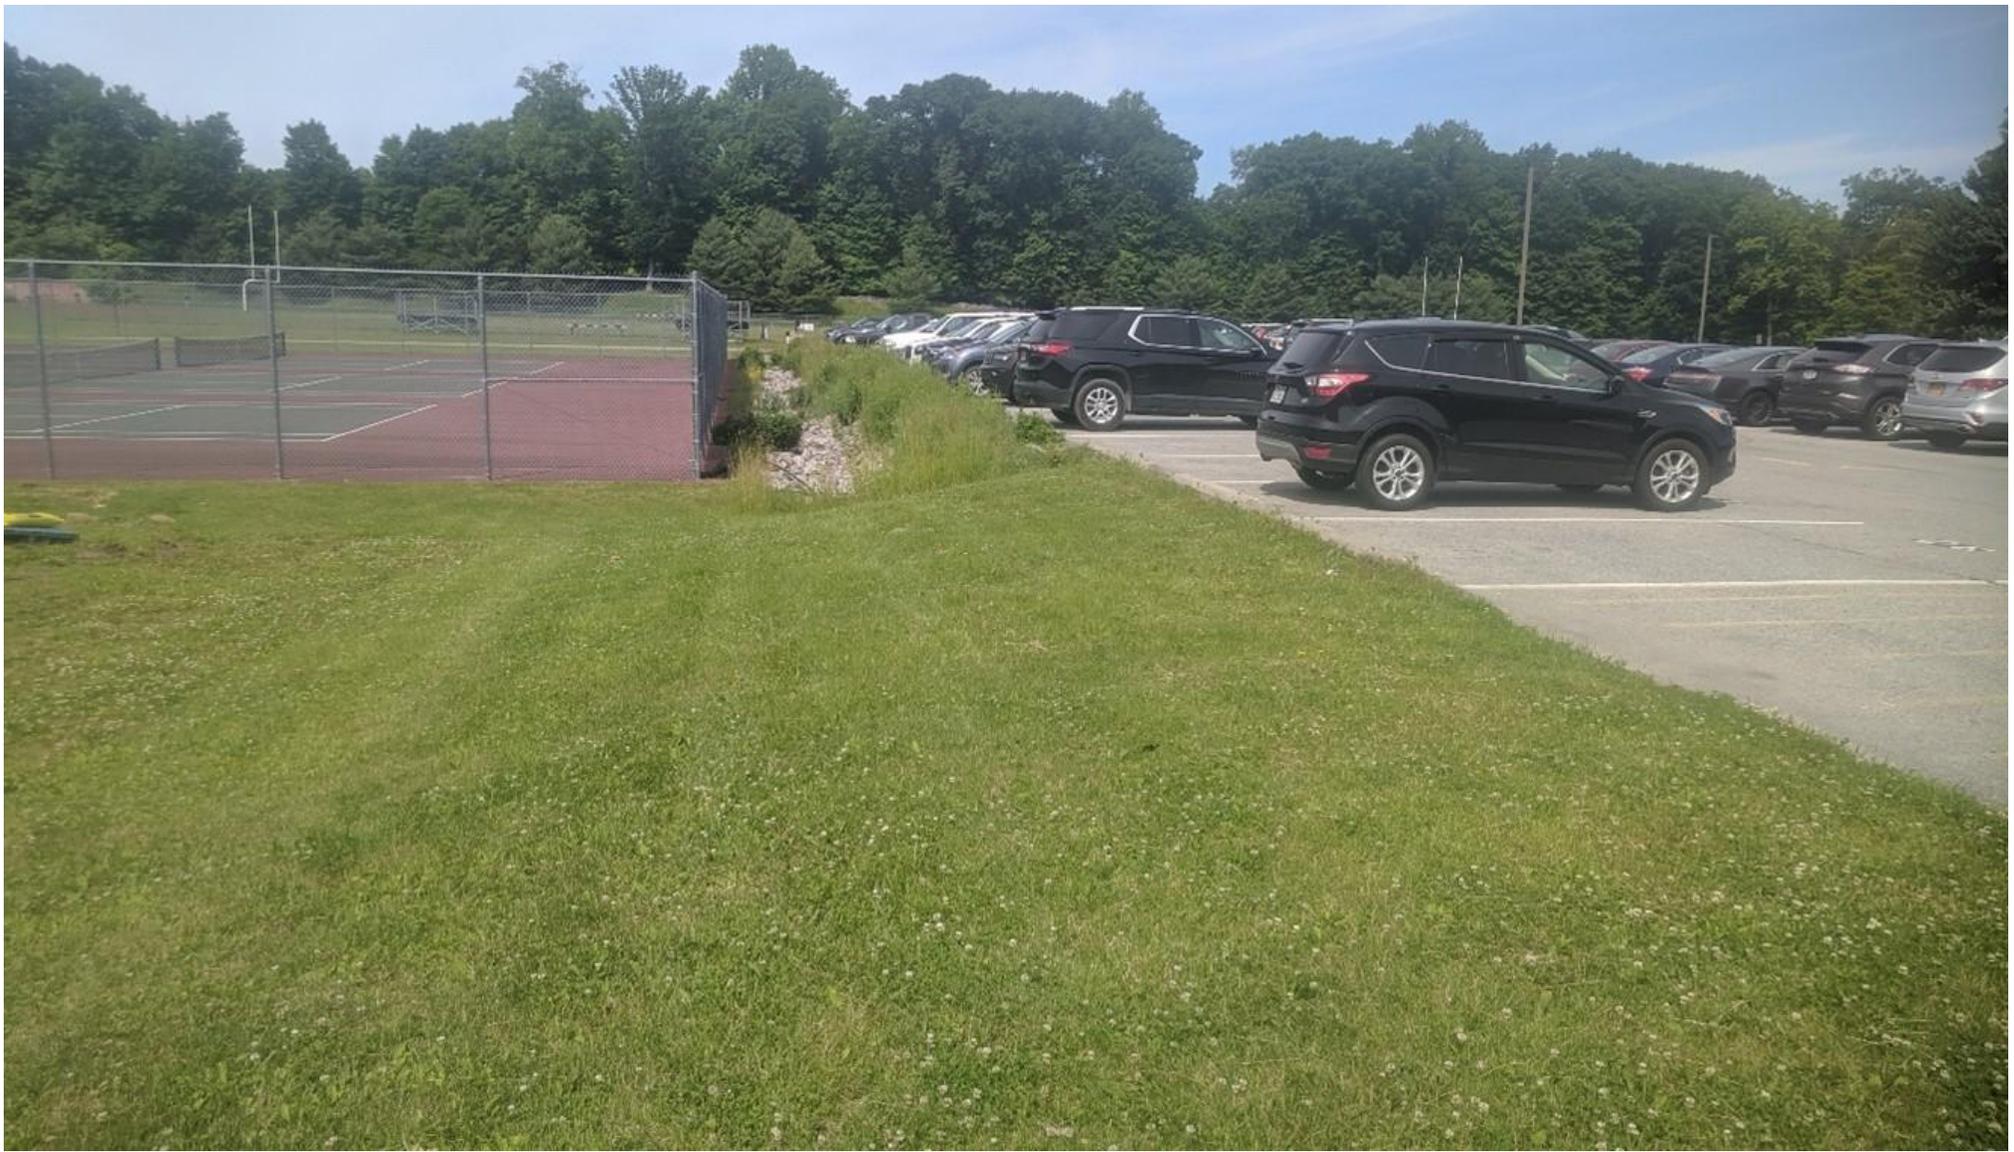
HS-01

**Category 44: Closed Drainage Pipe Stormwater Management System**  
Tennis Court/Parking Lot Swale: Eroding and needs repair/replacement.

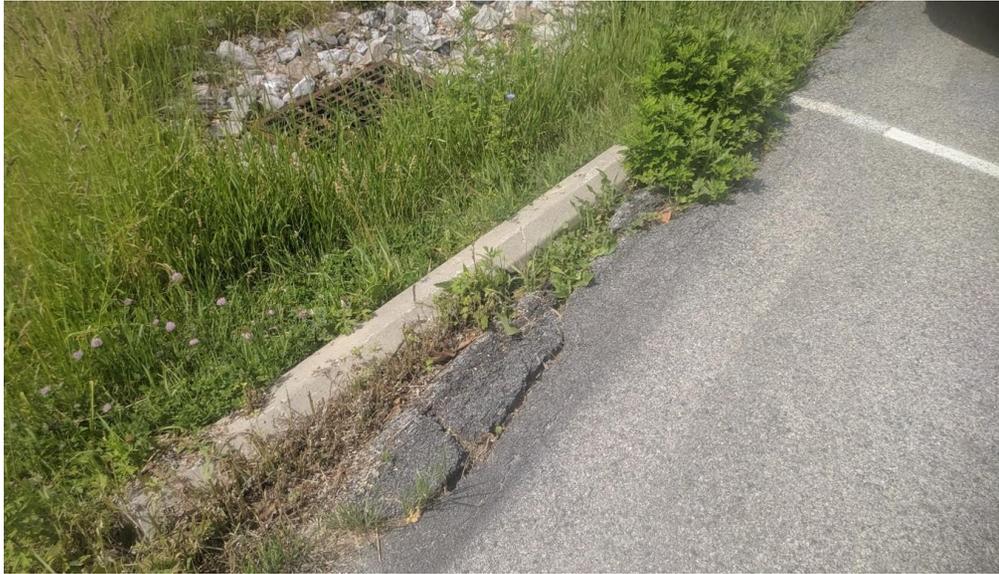
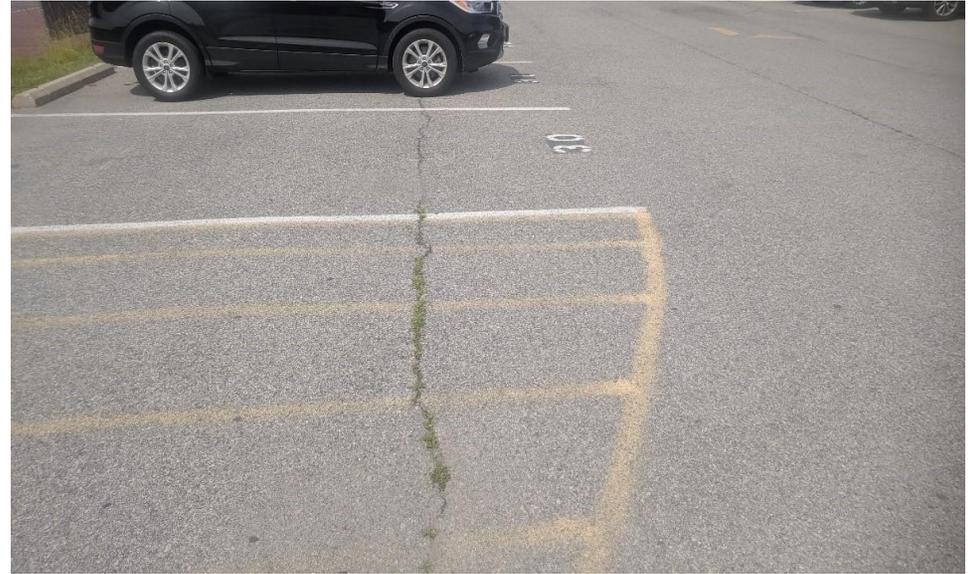
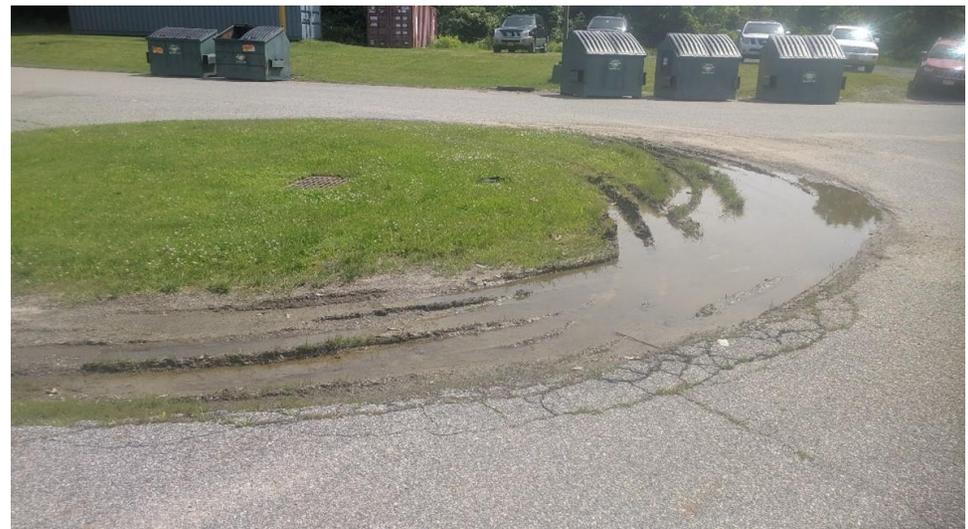
Tennis Court/Parking Lot Swale: Eroding and needs repair/replacement. Repair wide cracks. Pavement in fair condition aside from large cracks and settlement in some areas. Repair drainage at loading dock area.

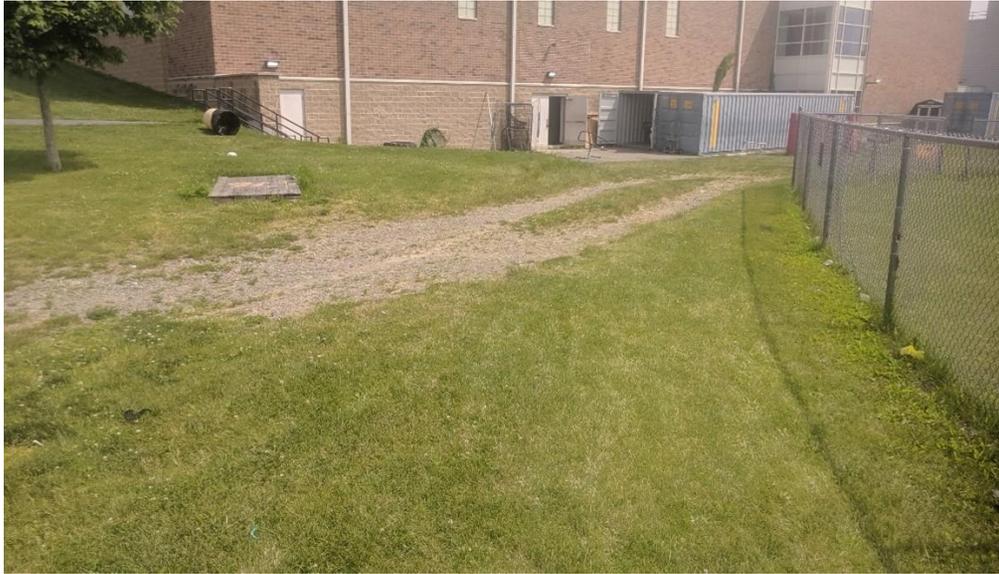
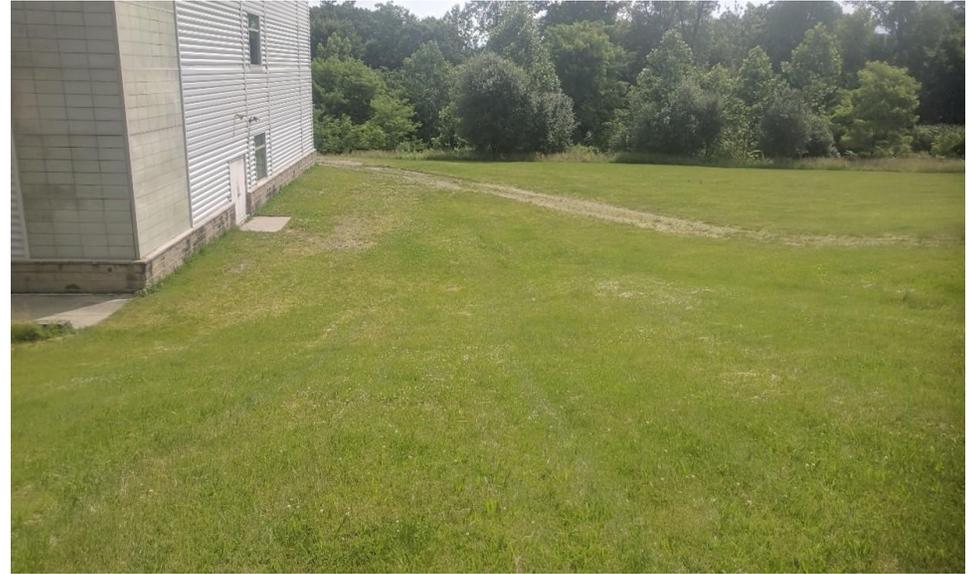
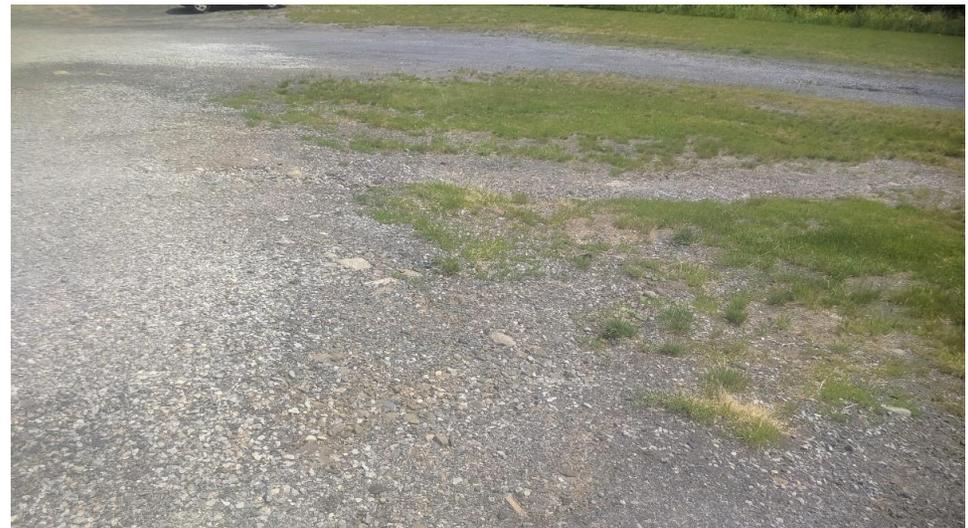
Consider pavement along emergency perimeter roadway. Repair/resurface gravel fire access drive at rear of building. Large potholes with ponding water on south end, and wide eroded channels on north end. Consider installing asphalt pavement instead. Replace gravel vehicle access drive to track/field. Gravel overgrown with grass. Surface needs to be stable and recognizable for emergency vehicles.

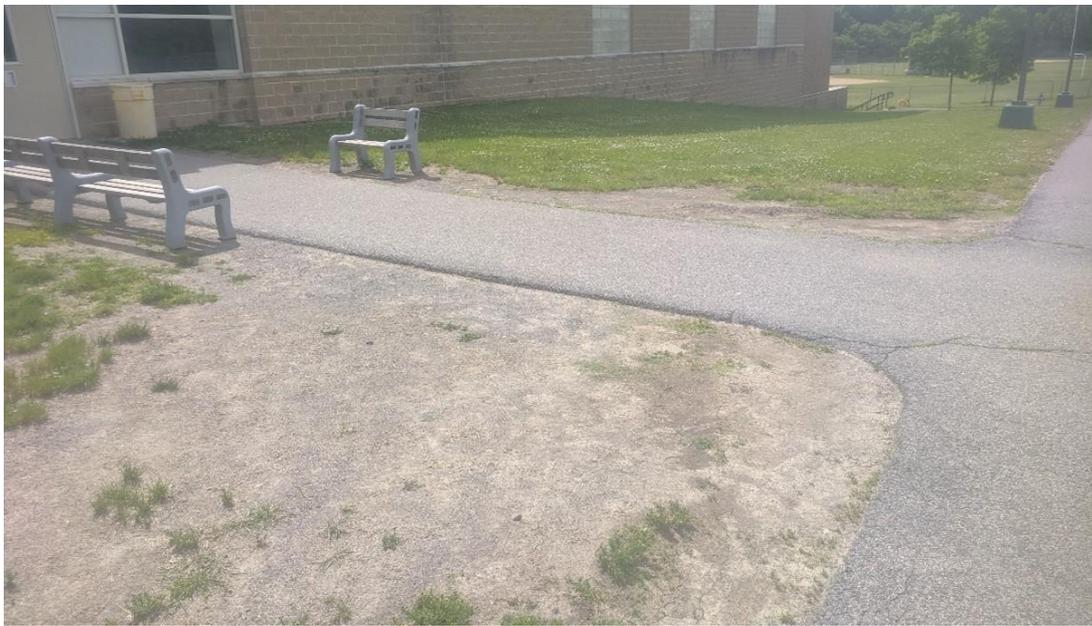
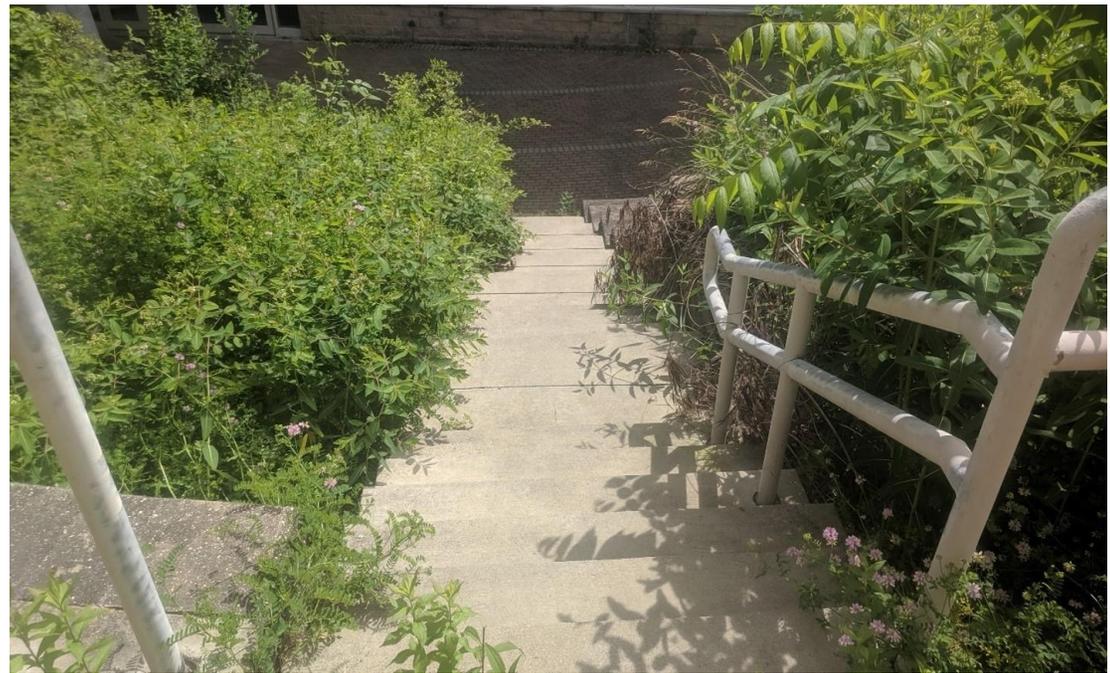
Replace asphalt sidewalk along building with concrete. Asphalt walk in poor condition at building entrance from athletic field parking lot. Replace courtyard stair between door B15 and A18. Stair at end of useful life due to treads spalling/surface crumbling.

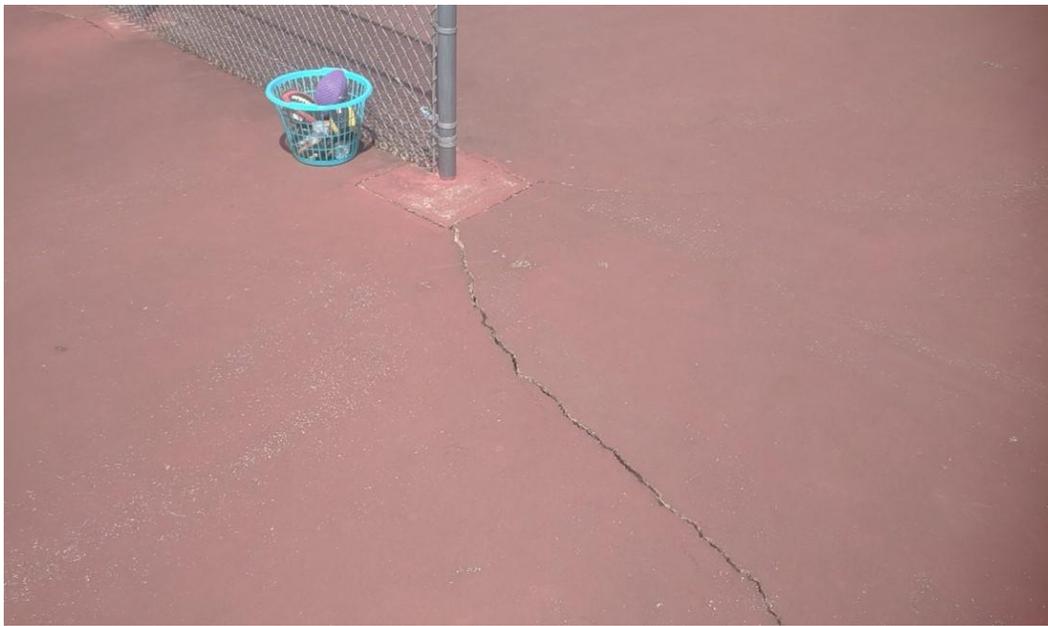
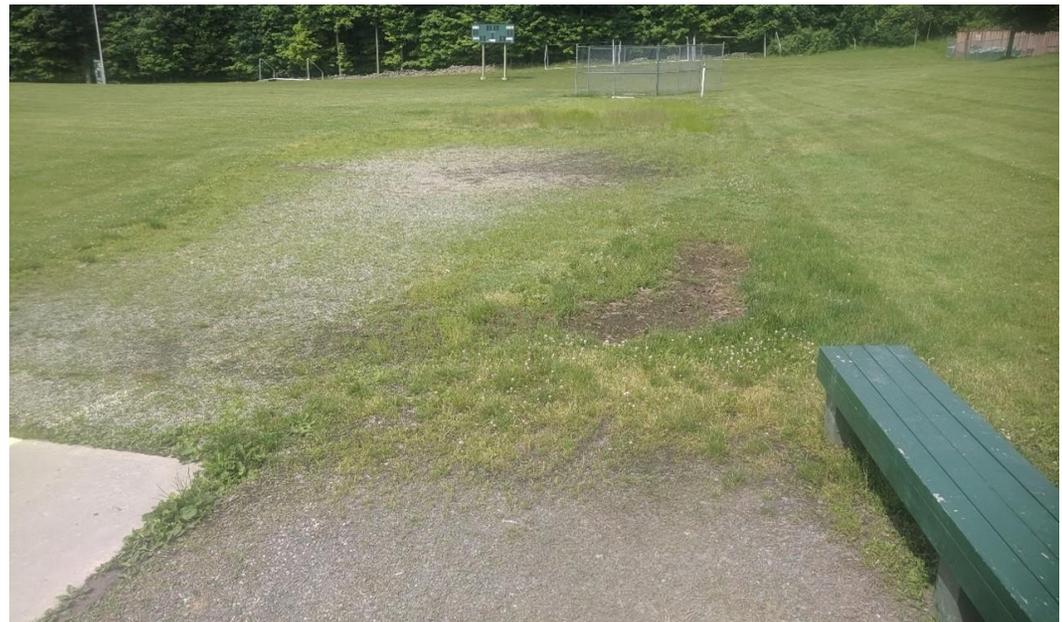
Improve parking lot drainage and tennis court drainage. Stone lines swale between parking lot and tennis courts needs to be repaired; poor condition resulting in ponding water/water infiltrating beneath tennis courts and causing wide cracks in tennis court surface. Improve drainage of soccer/baseball fields. Fields are flat/level which causes water to pond and fields to become soggy after storms. Generally poor drainage due to lack of pitch on fields for drainage. Existing field drainage undersized and backs up onto surface during heavy storm events. Rock void behind softball field indicates clogging/backup issue/failure.

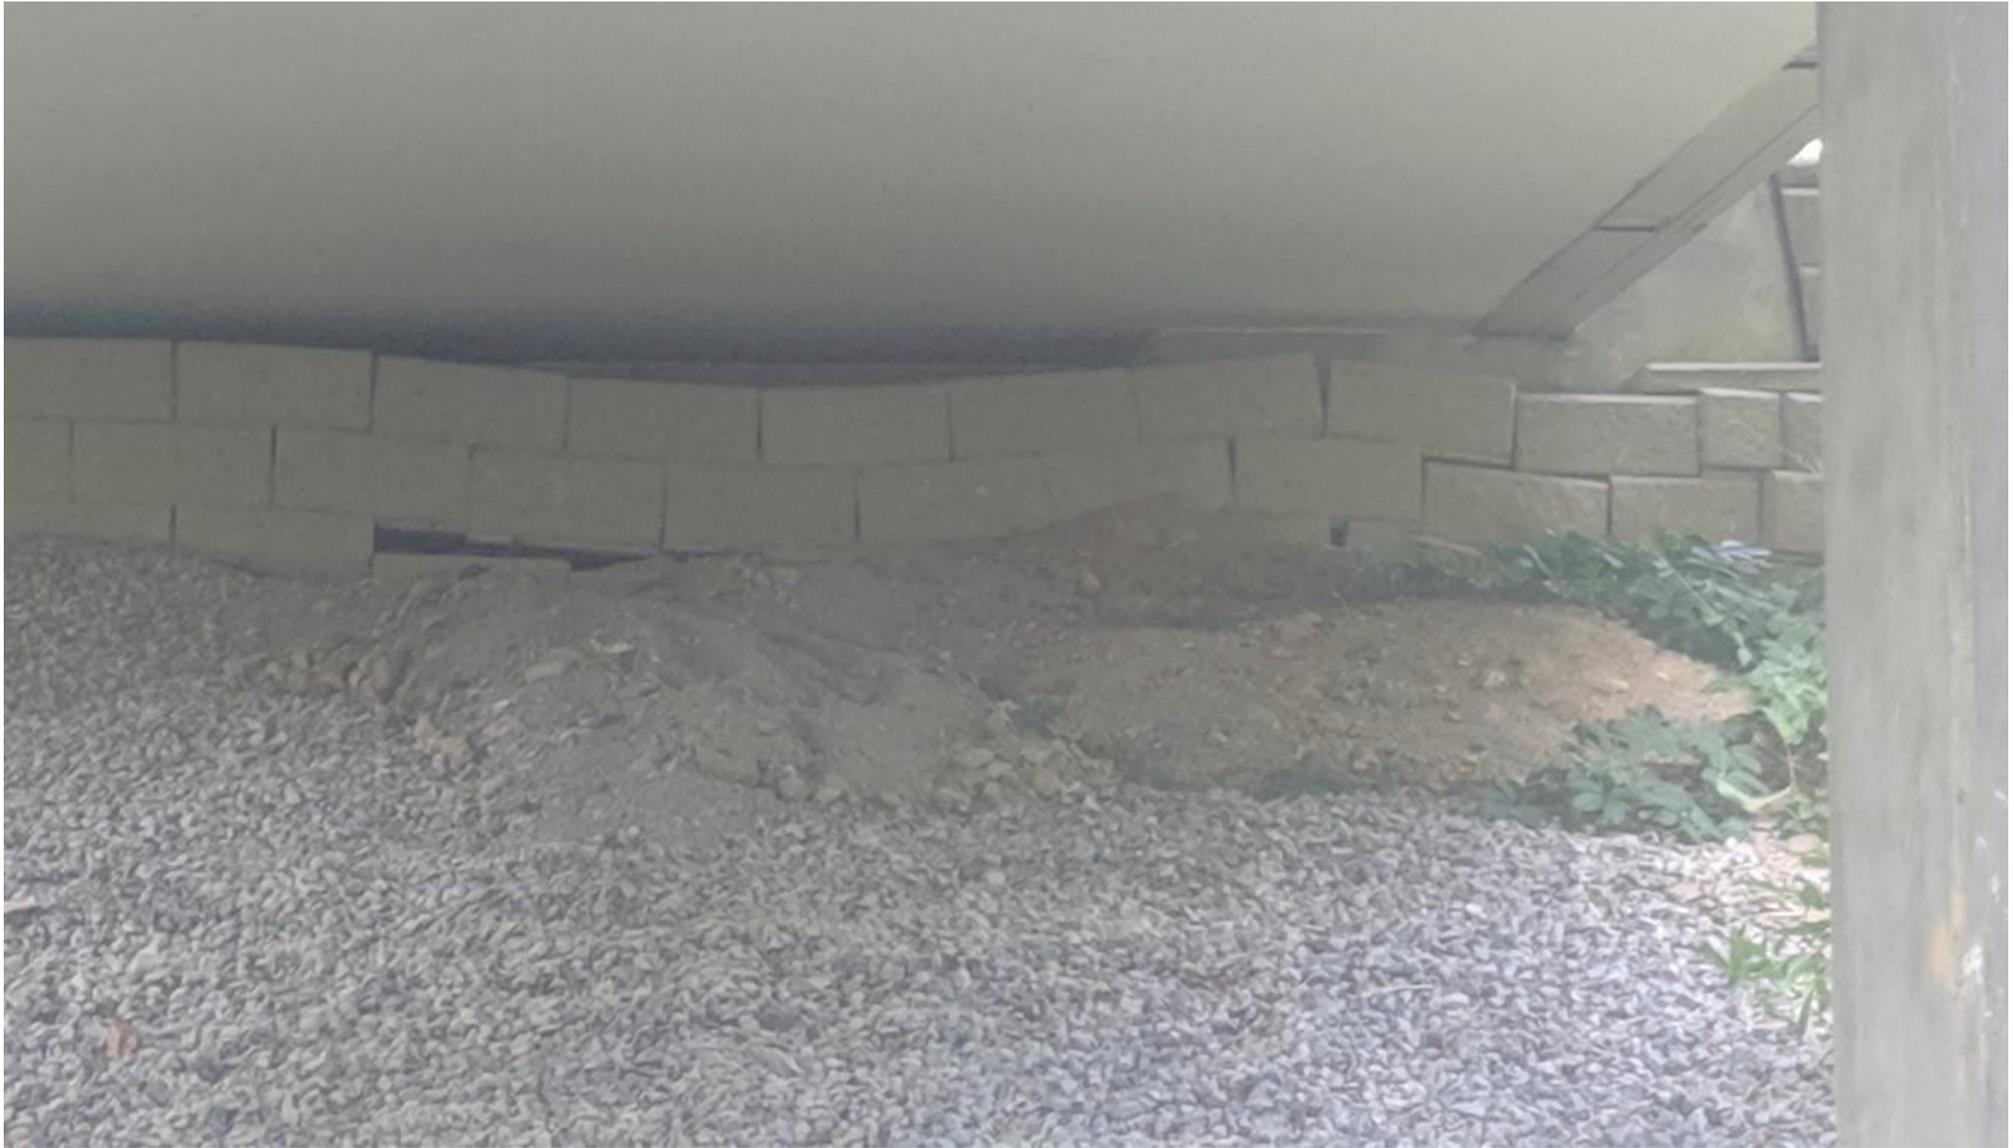
HS-12

Repair Retaining wall and drainage. – part of bridge system.

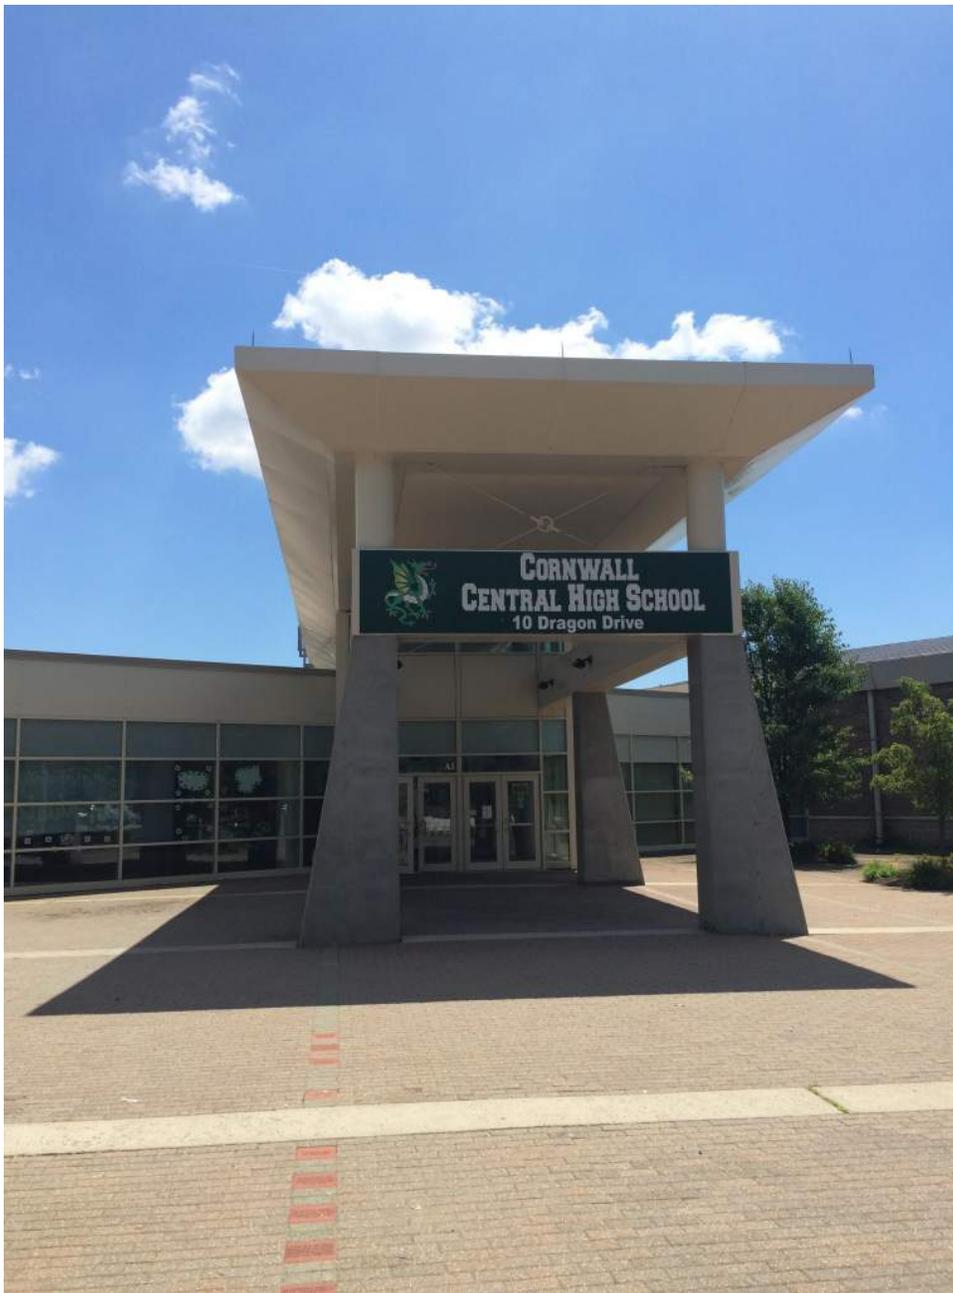
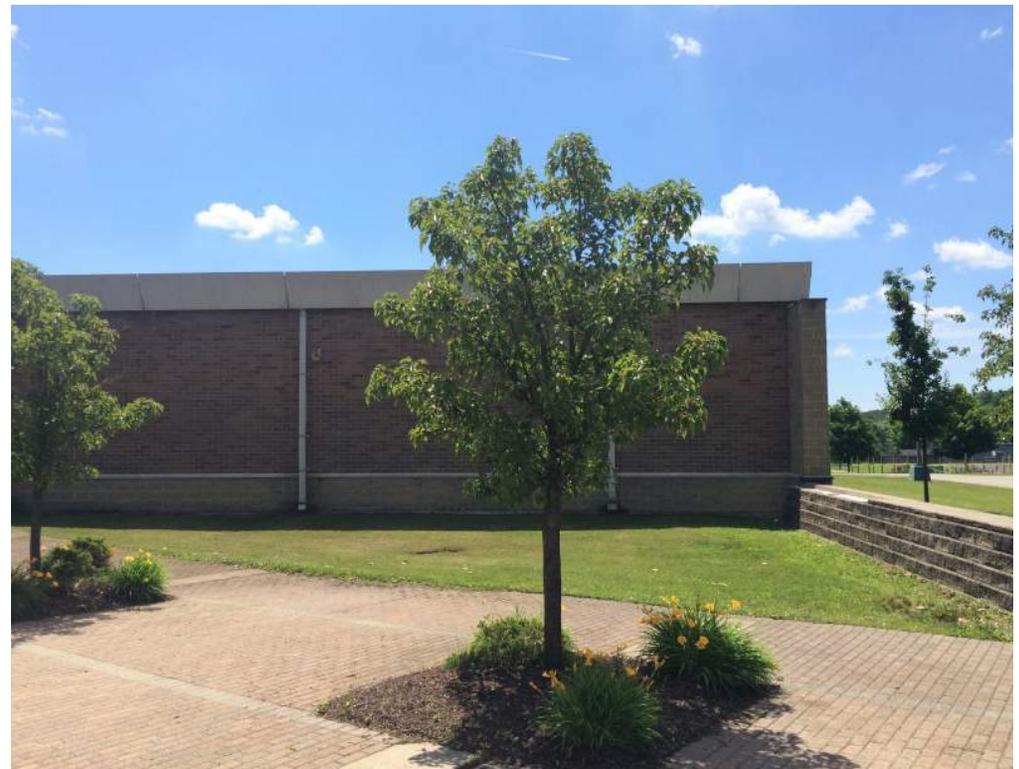
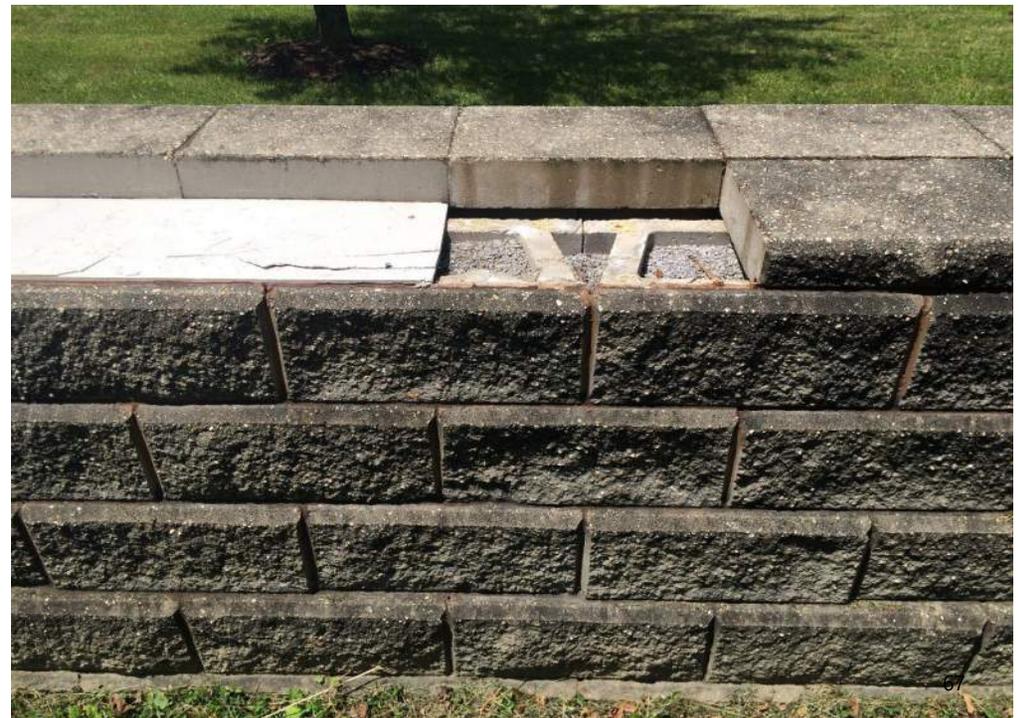
Replace courtyard pavers with concrete surface. Replace retaining wall at main entrance. Install section of sidewalk to connect sidewalk from NY Rt 94 to sidewalk at front of building.

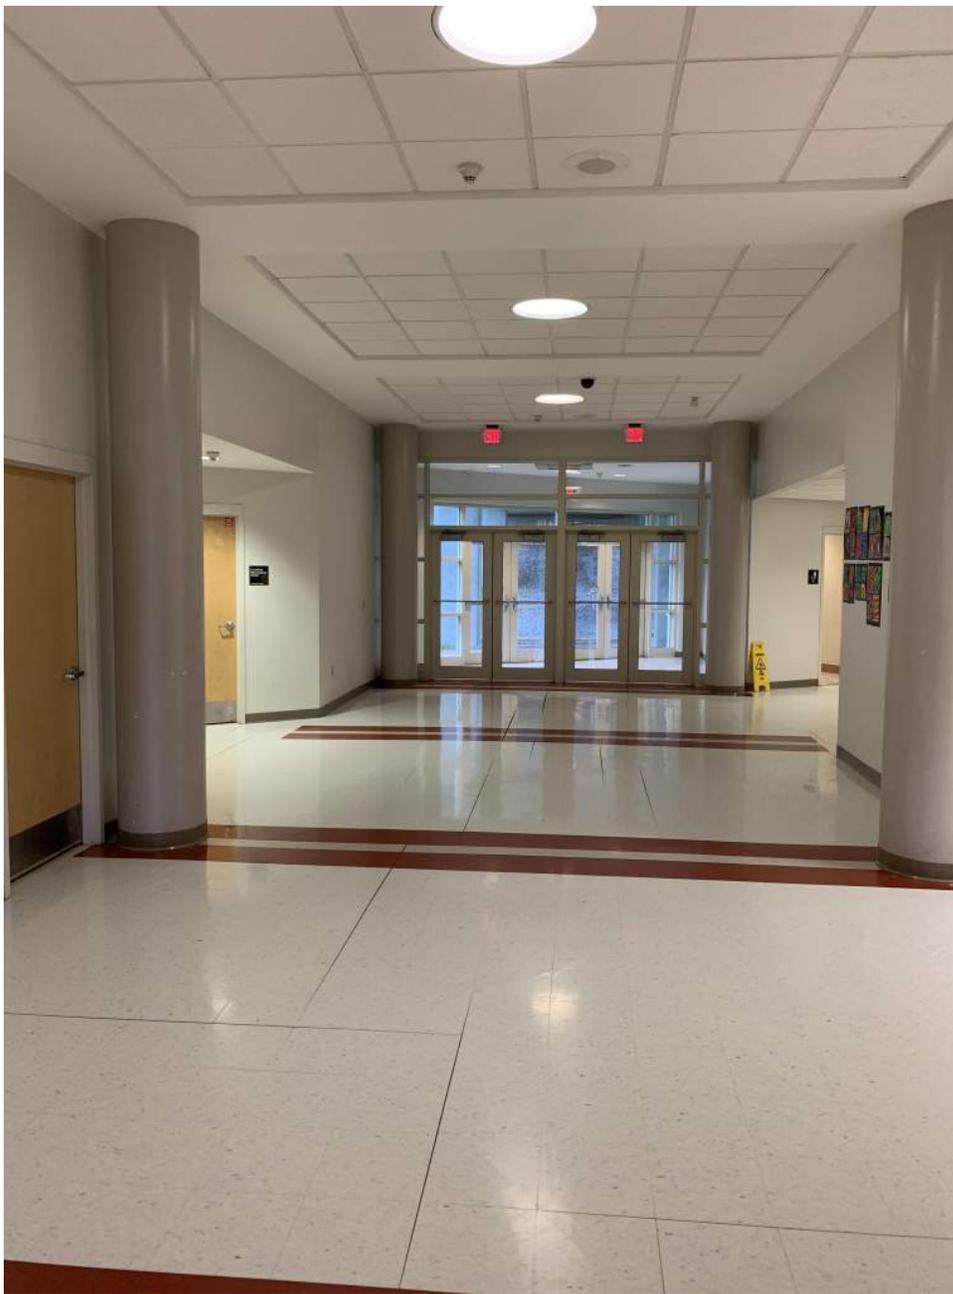
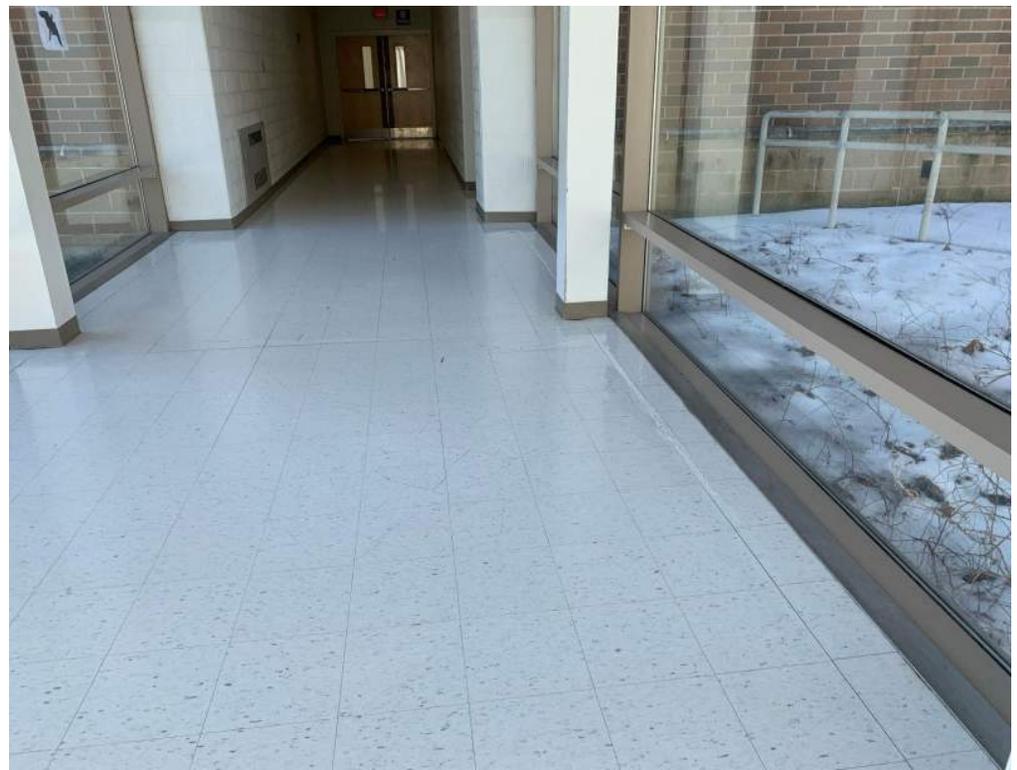
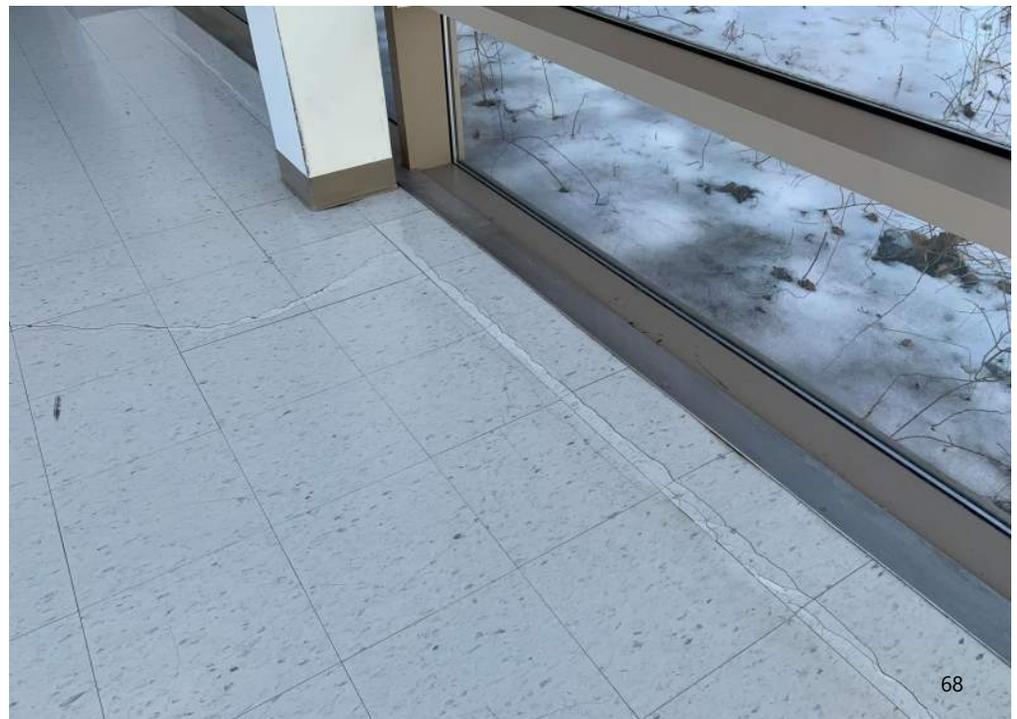
**Category 65: Structural Floors**  
Concrete repair in south bridge and lower entry vestibule (settlement).

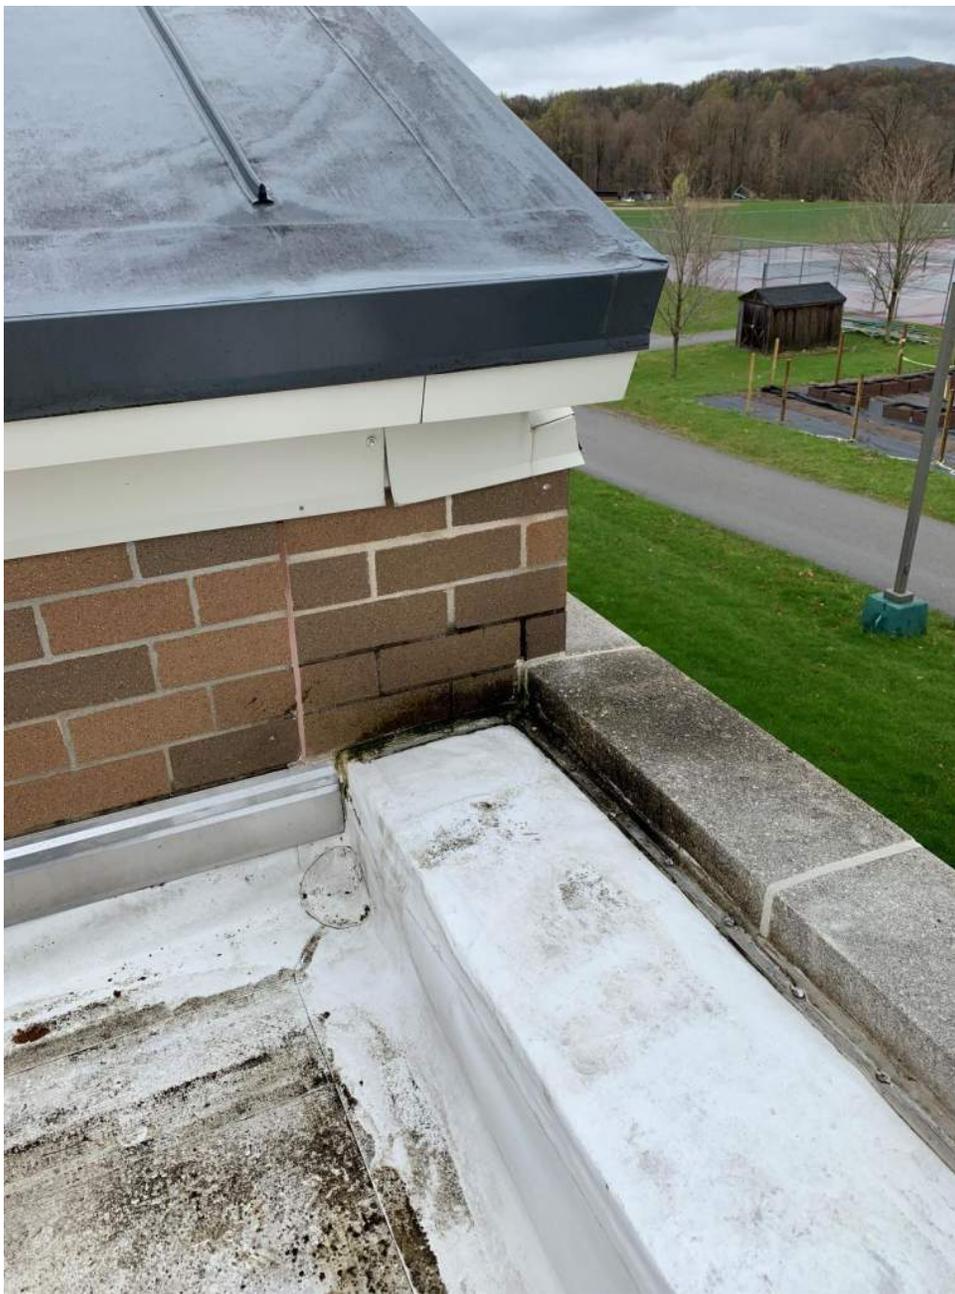
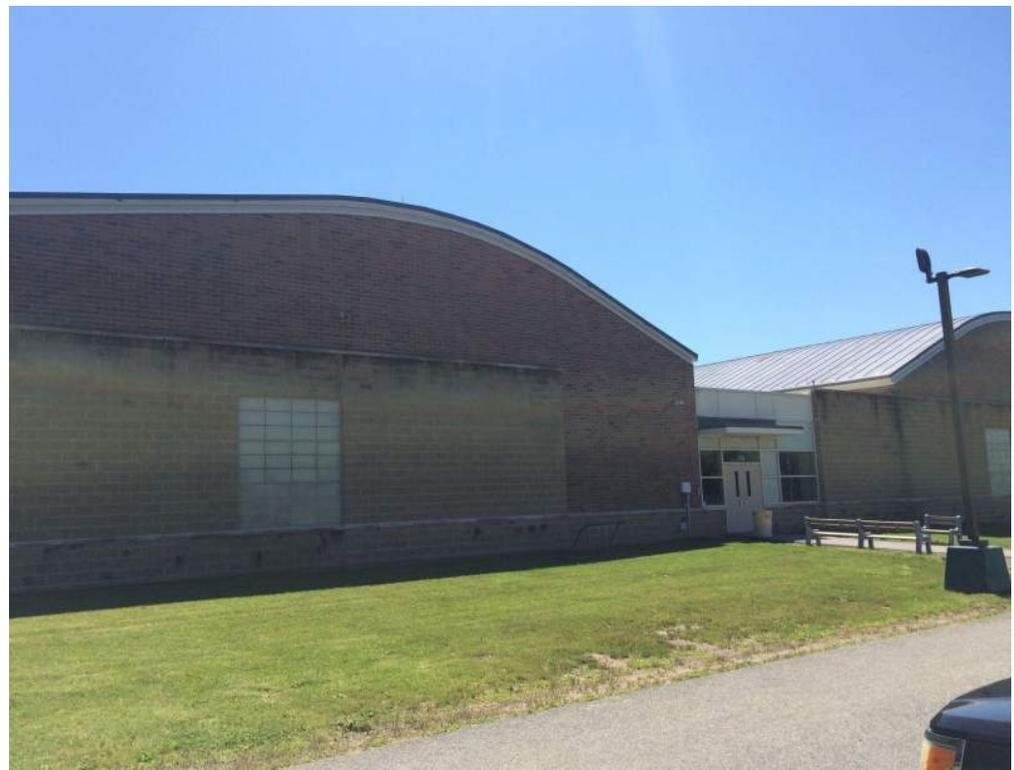
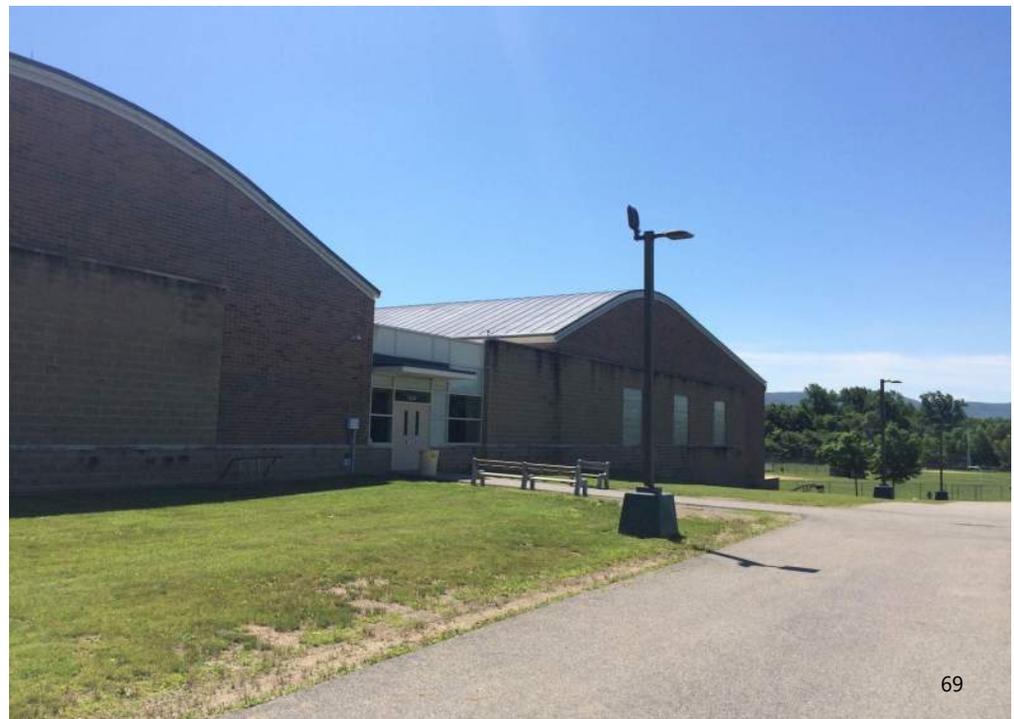
Masonry restoration identified; backer rod, sealants at parapets and masonry at roof level. Discoloration under cast band and low capstone along exterior walls at various locations.
