**2020 BUILDING  
CONDITION SURVEY  
REPORT**

CORNWALL CENTRAL  
SCHOOL DISTRICT

Central  
High School

CSArch Project #204-1901

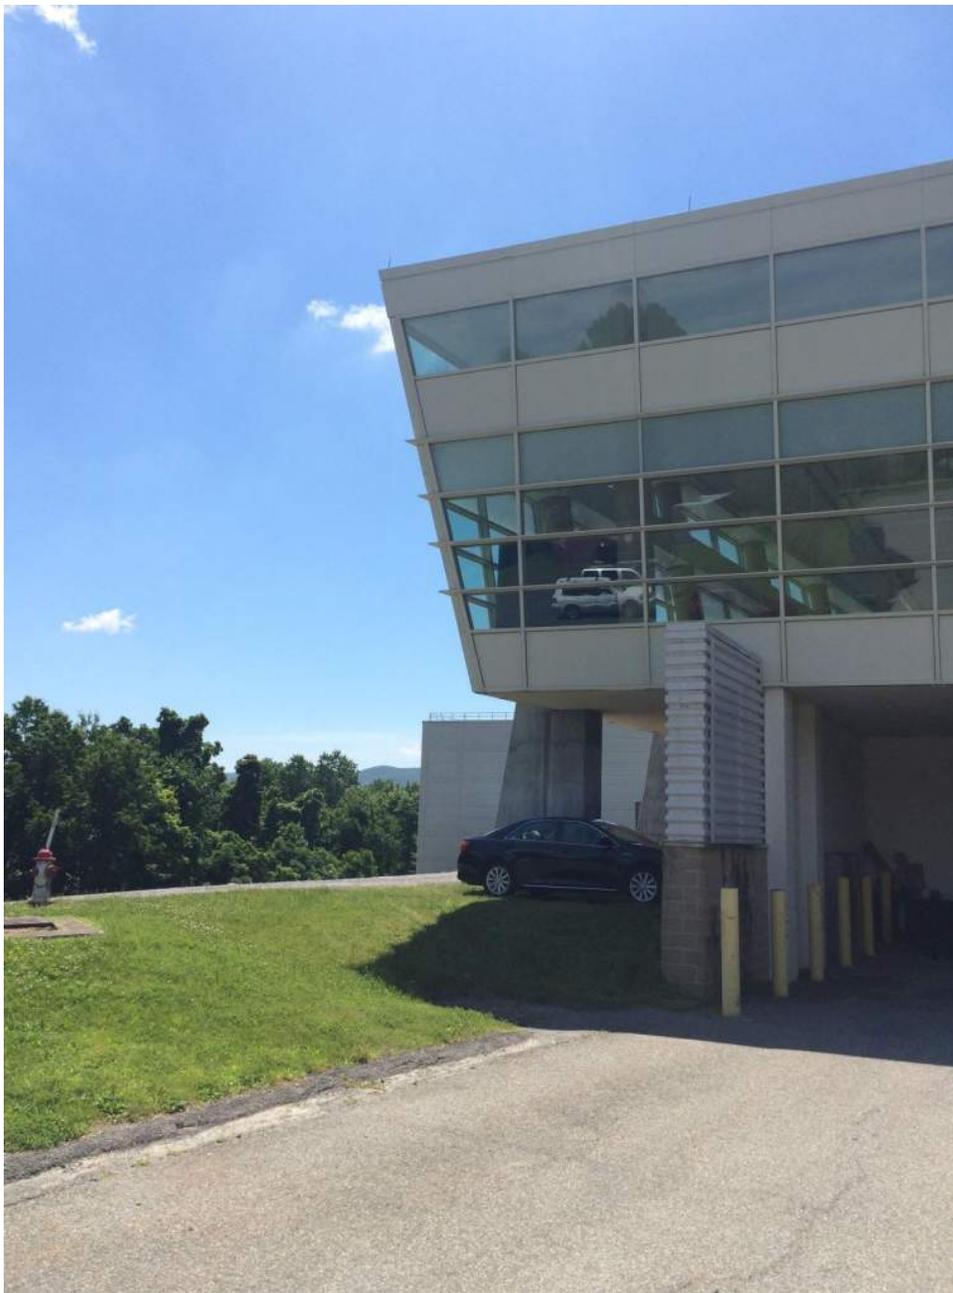
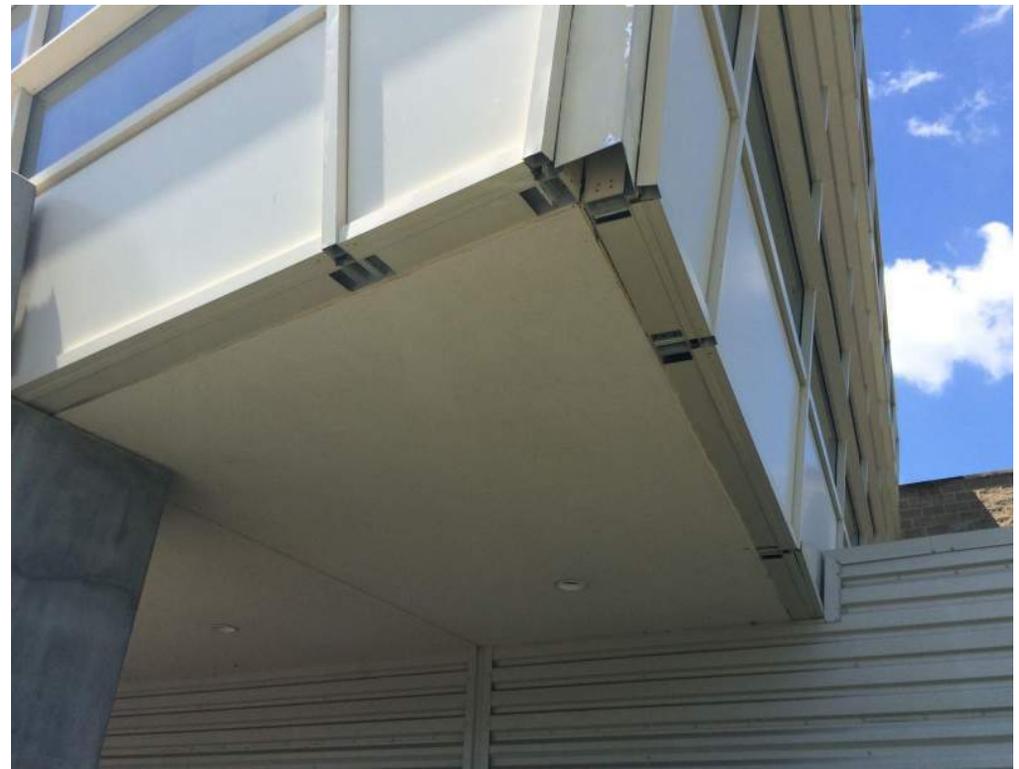
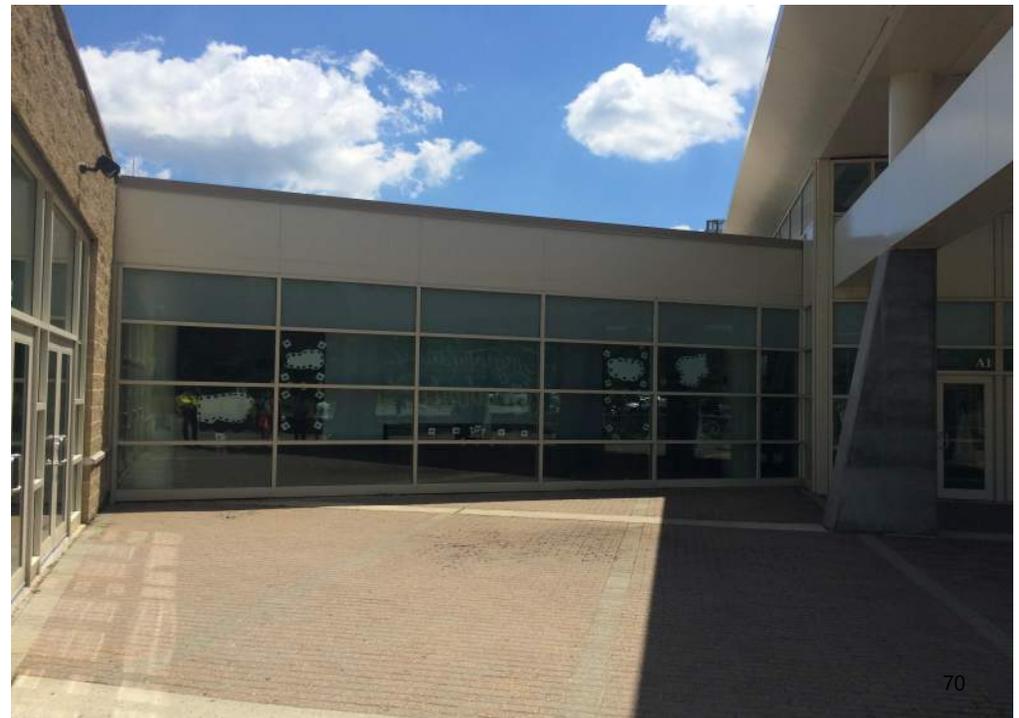
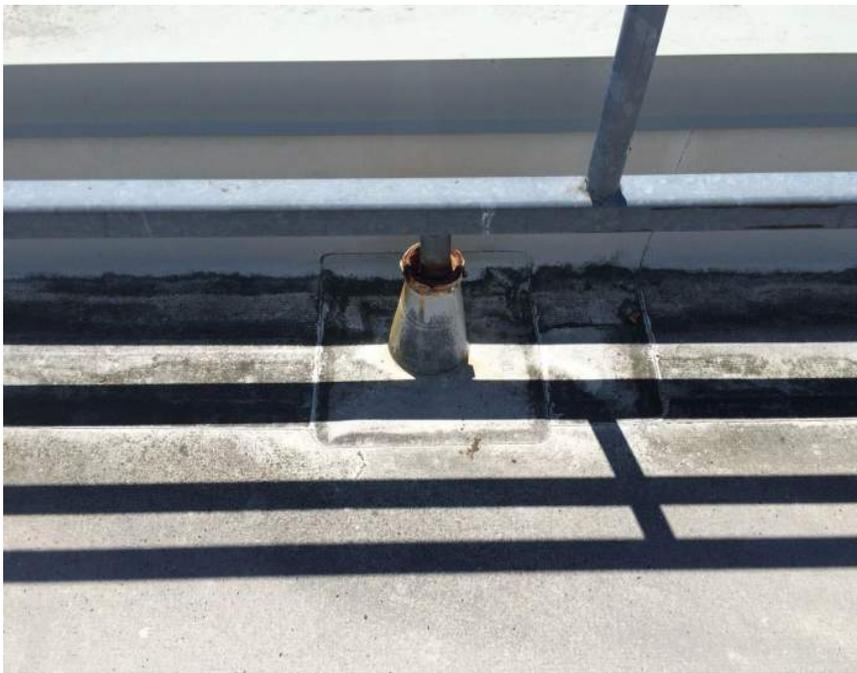
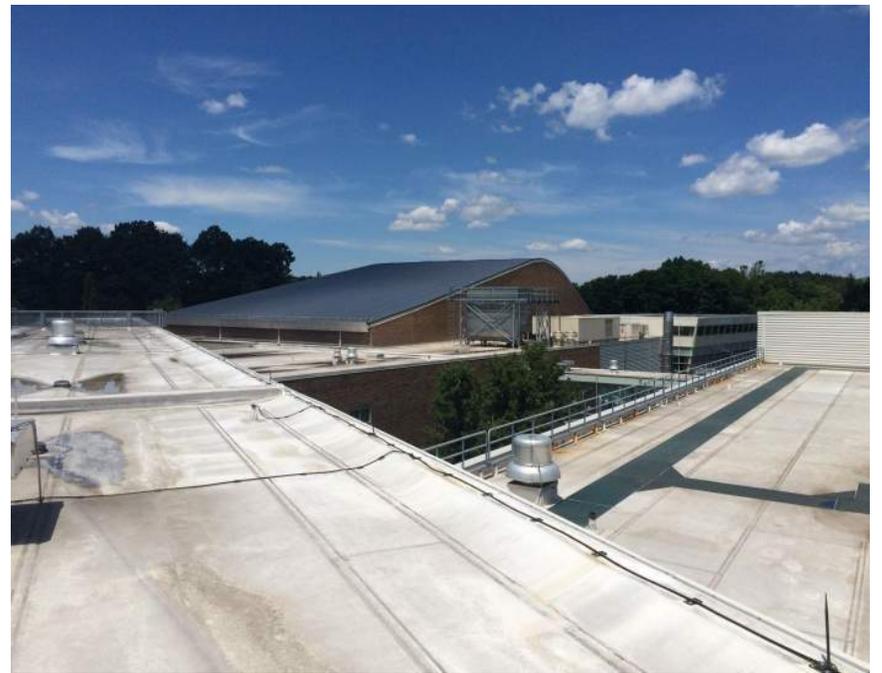
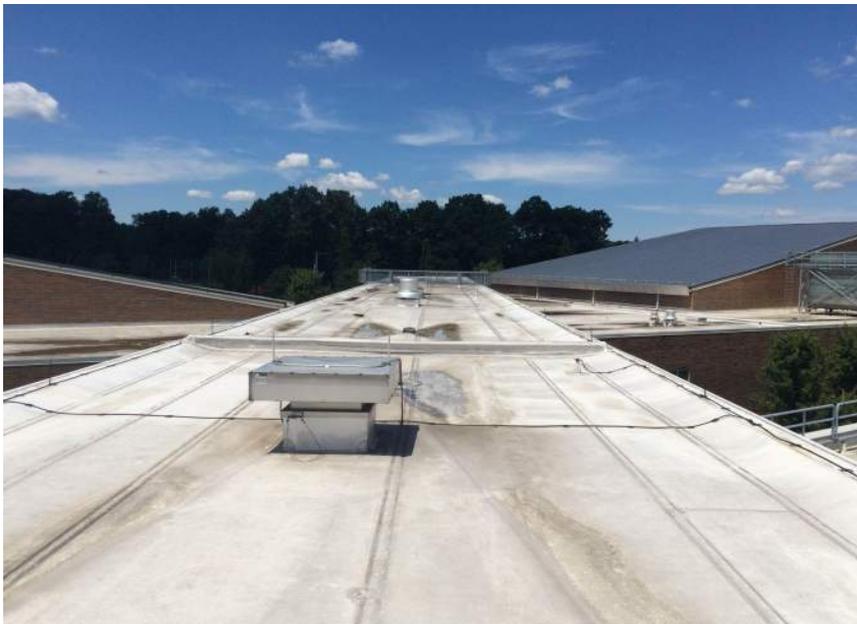
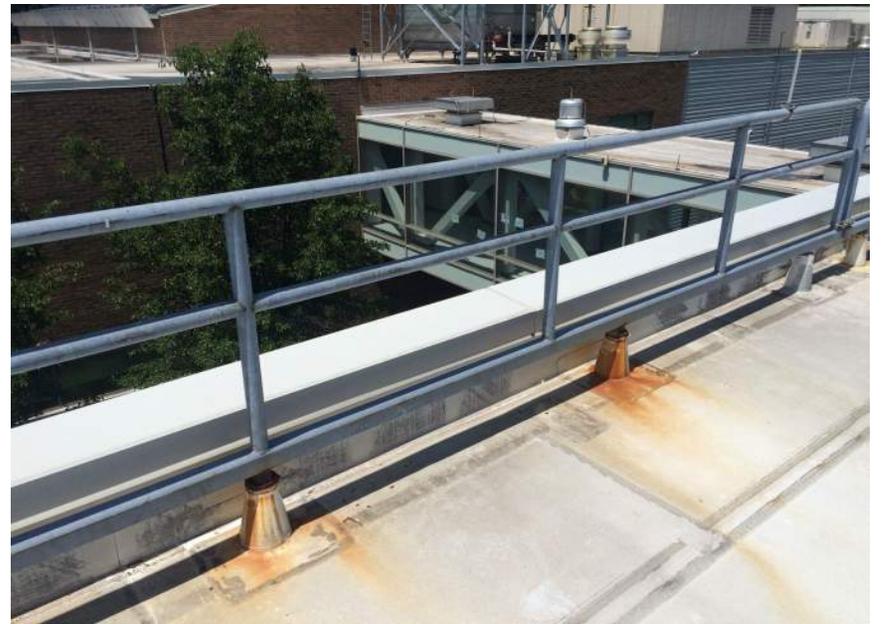
Window repairs and restorations. Seal off openings in curtain walls, fix sealants, and miscellaneous glazing repairs.

Correct failed sealant at roof safety rail & posts along perimeter. Replace roof areas and built-in cap flashings at identified areas. Include miscellaneous roof repairs. Waterproof existing rooftop ductwork.

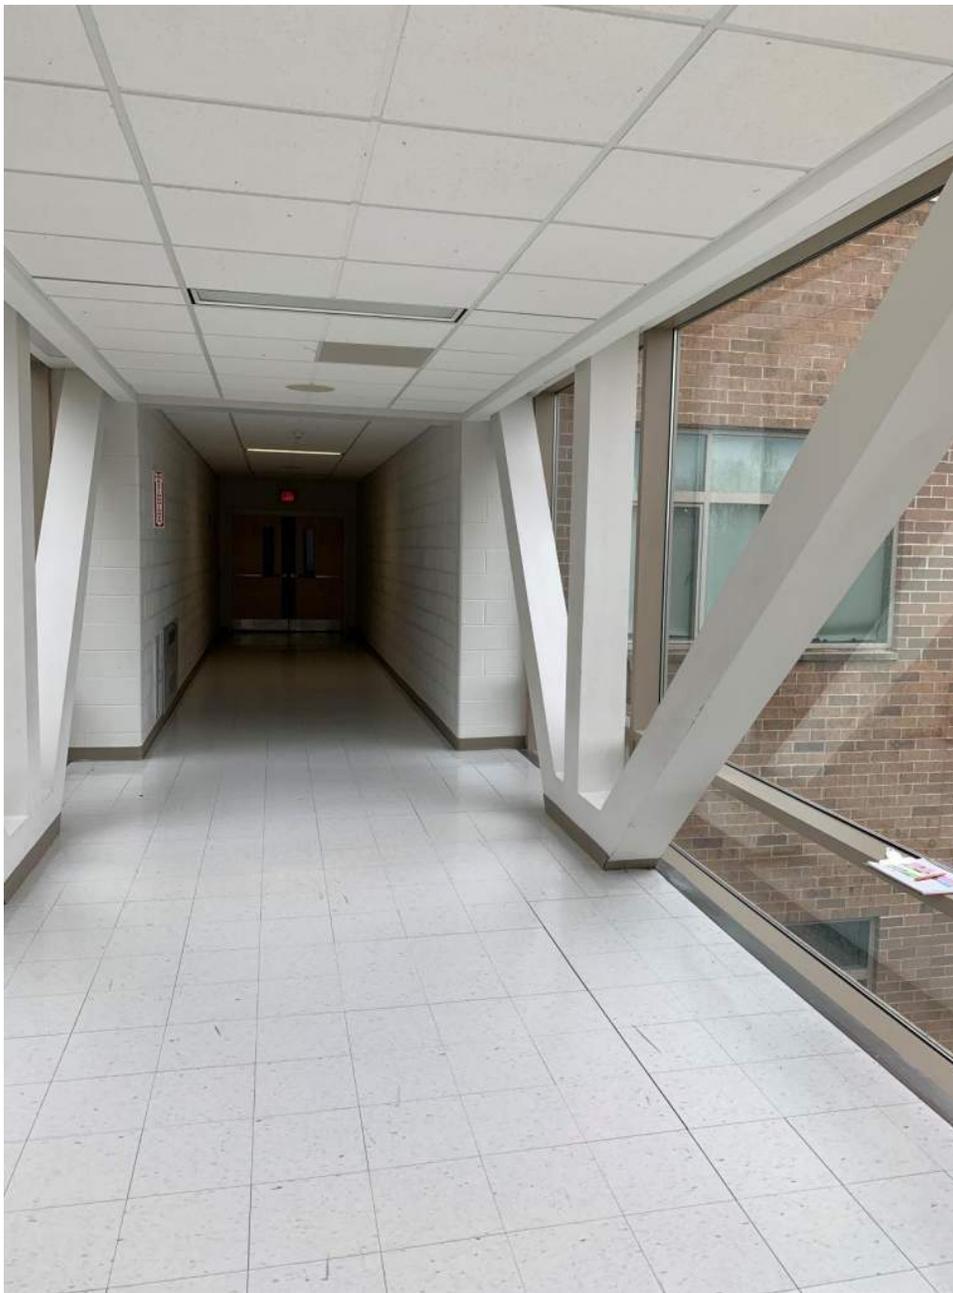
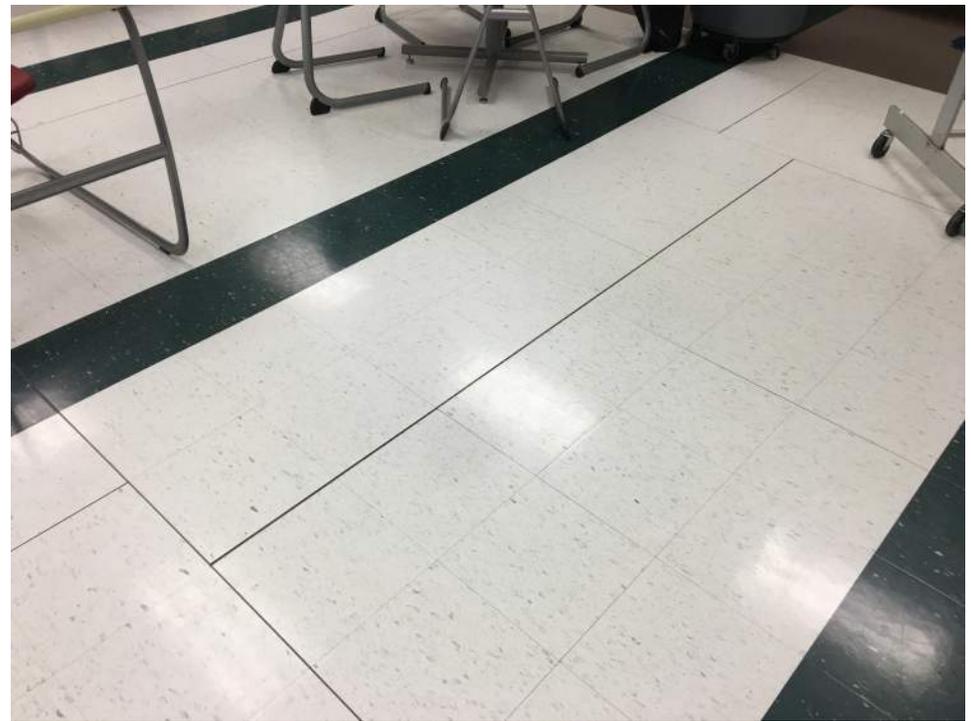
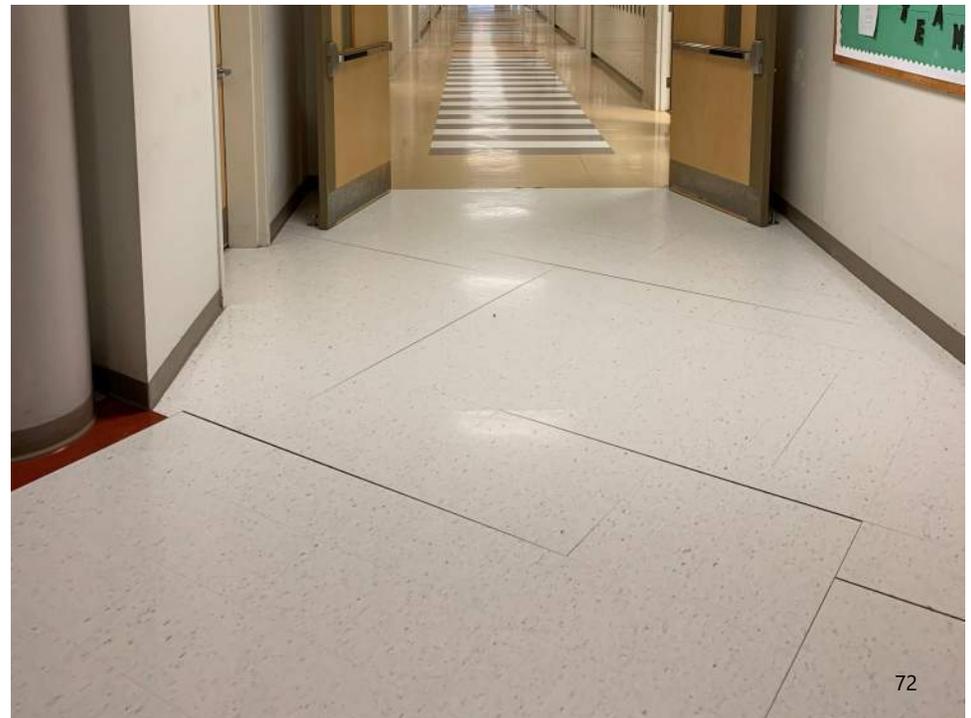
**Category 77: Resilient Tiles and Sheet Flooring**  
Replace existing vinyl composition tile flooring in select areas.

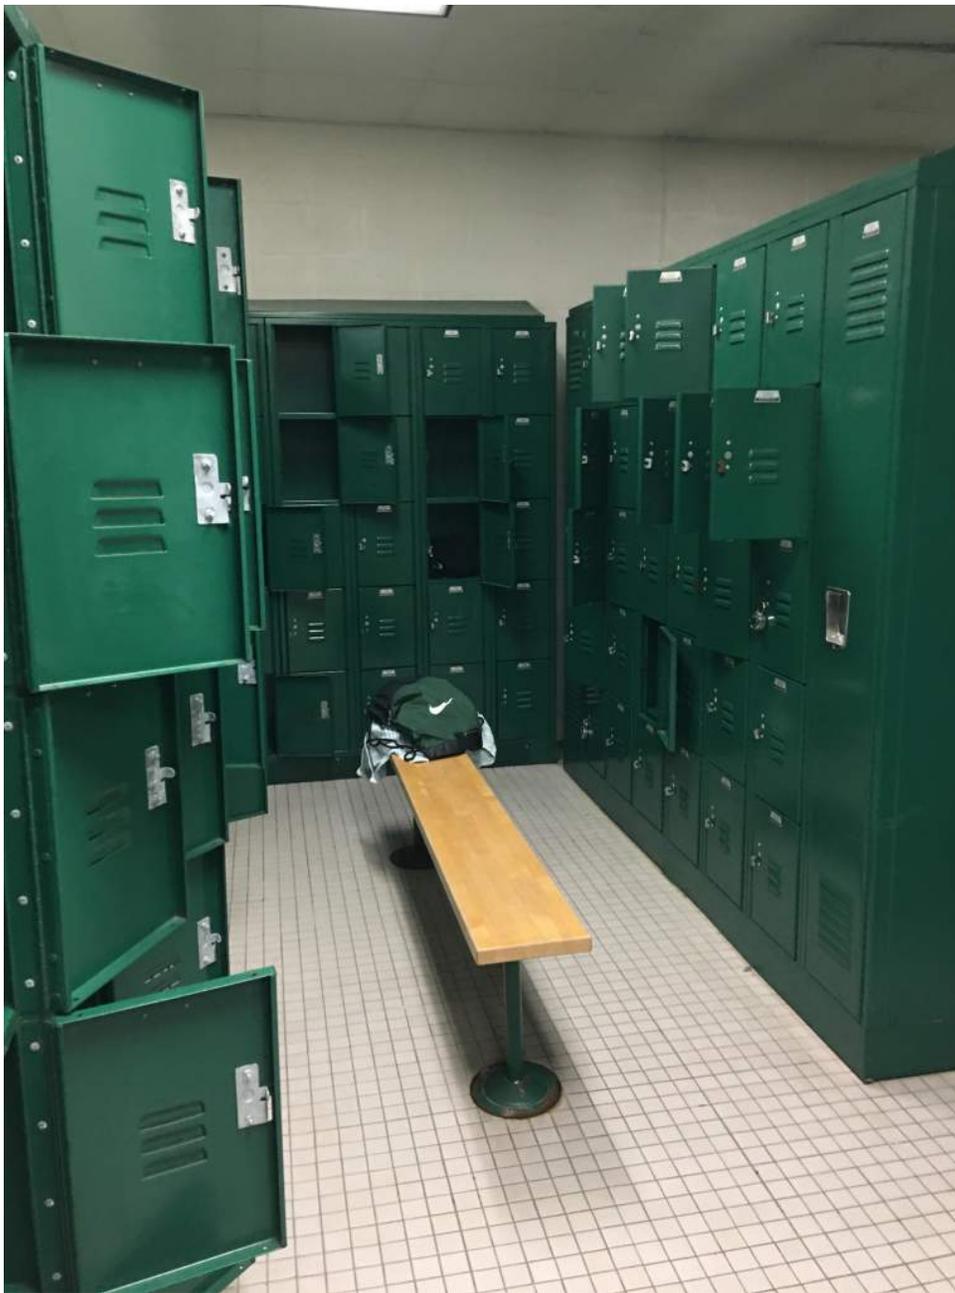
Replace lockers in male and female locker rooms.

- It is recommended to replace the metal locker systems in the male and female locker rooms.
- Wired glass was observed in various interior doors, replace as required. Consider adding magnetic door hold opens at the interior doors to the cafeteria.
- It is recommended that the VCT be replaced throughout the building where the tiles are separating from one another.
- It is recommended to repair cracks on the concrete filled stair treads, most stair treads are cracked.
- Gypsum board ceilings are in good condition as are all exposed ceilings.

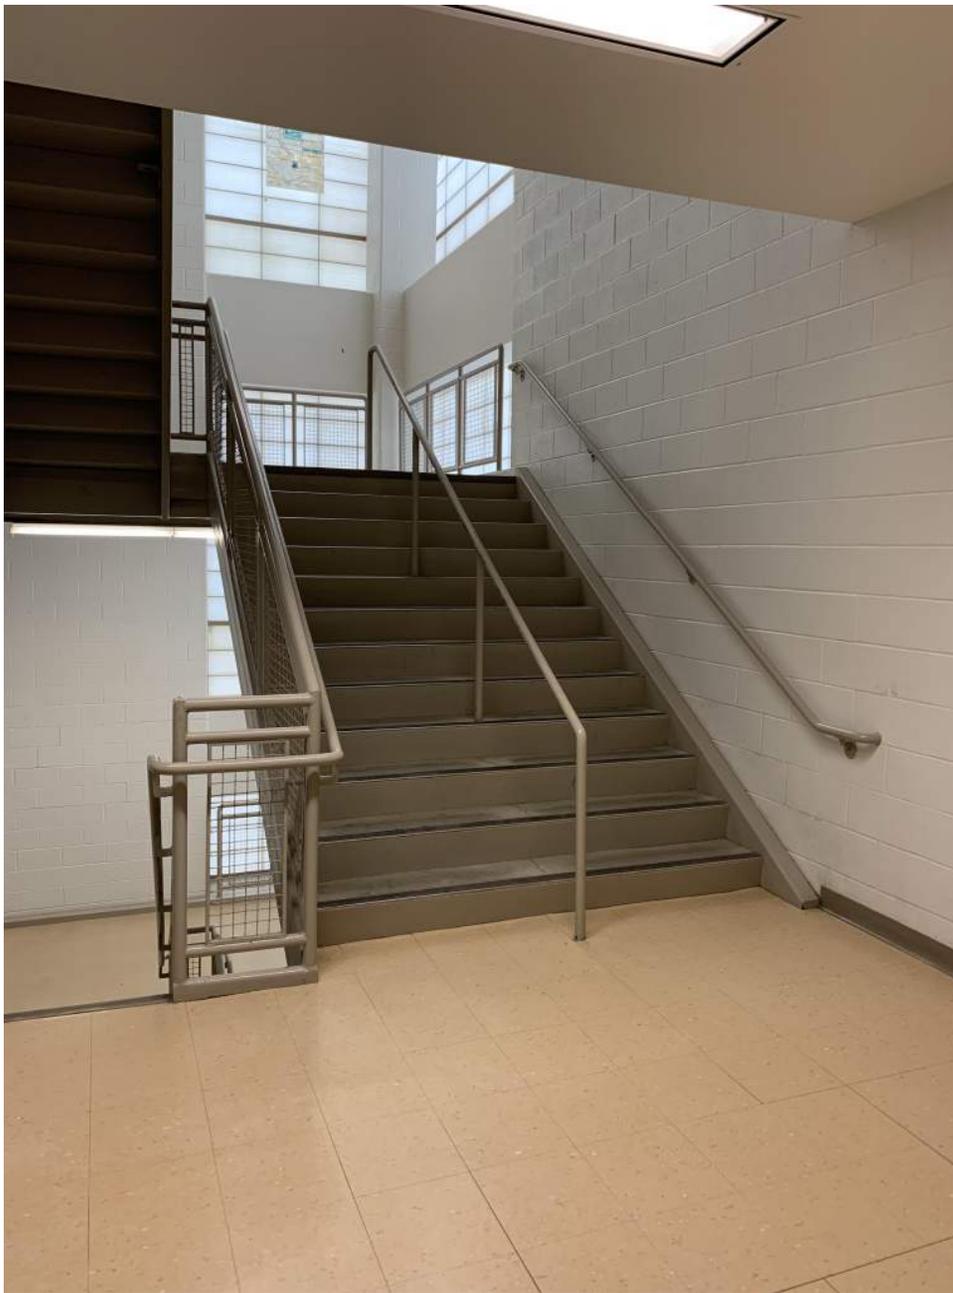
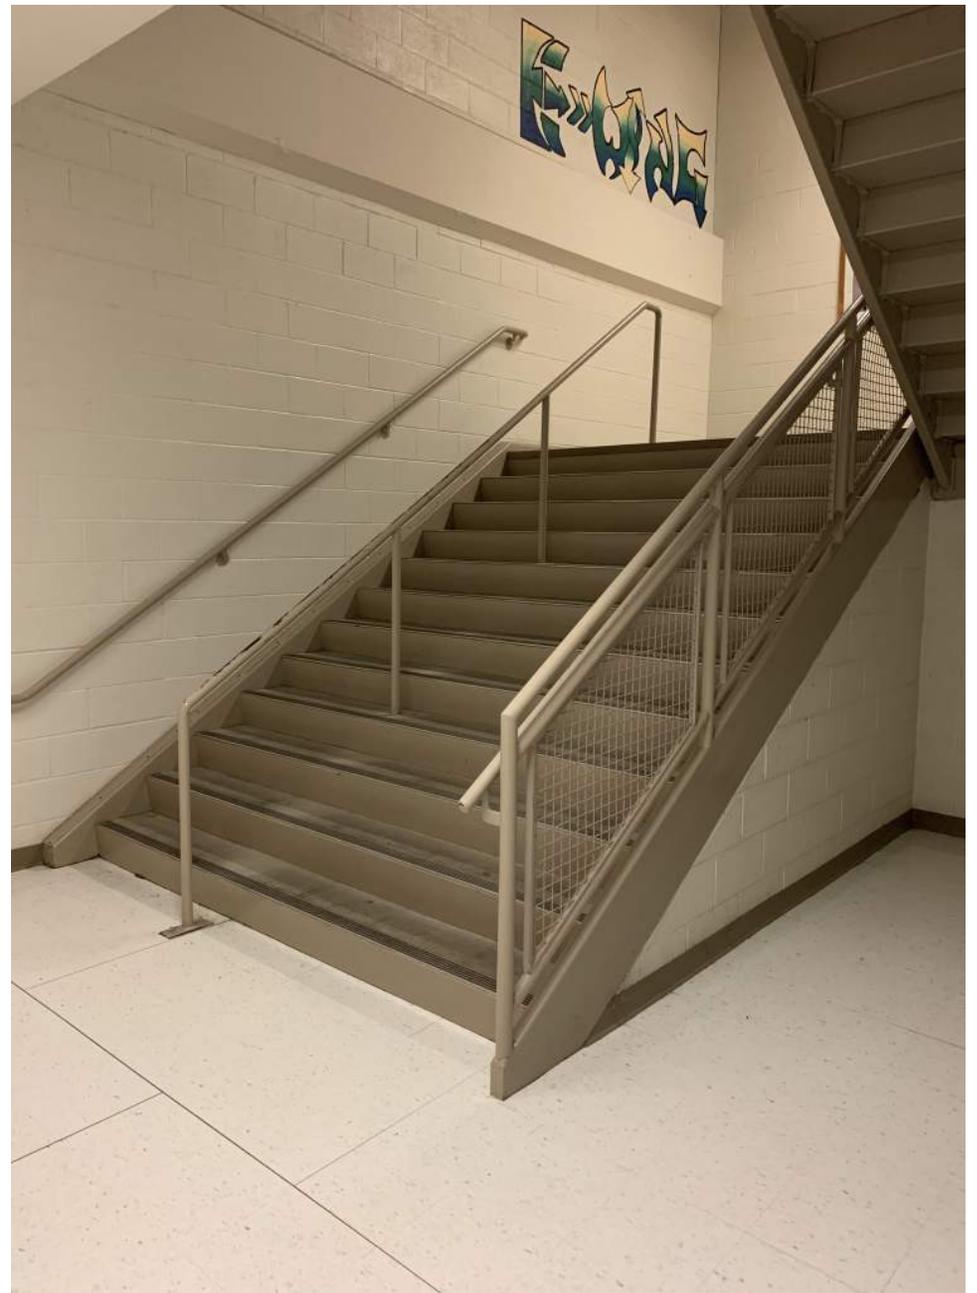
**Category 83: Interior Stairs**  
Concrete repair on concrete-filled stair treads.

The interior stairs are metal with concrete filled treads. Most are in generally good condition, but there are locations where the concrete treads are showing signs of settling and wear and tear. The building elevators are operational and in good working condition.

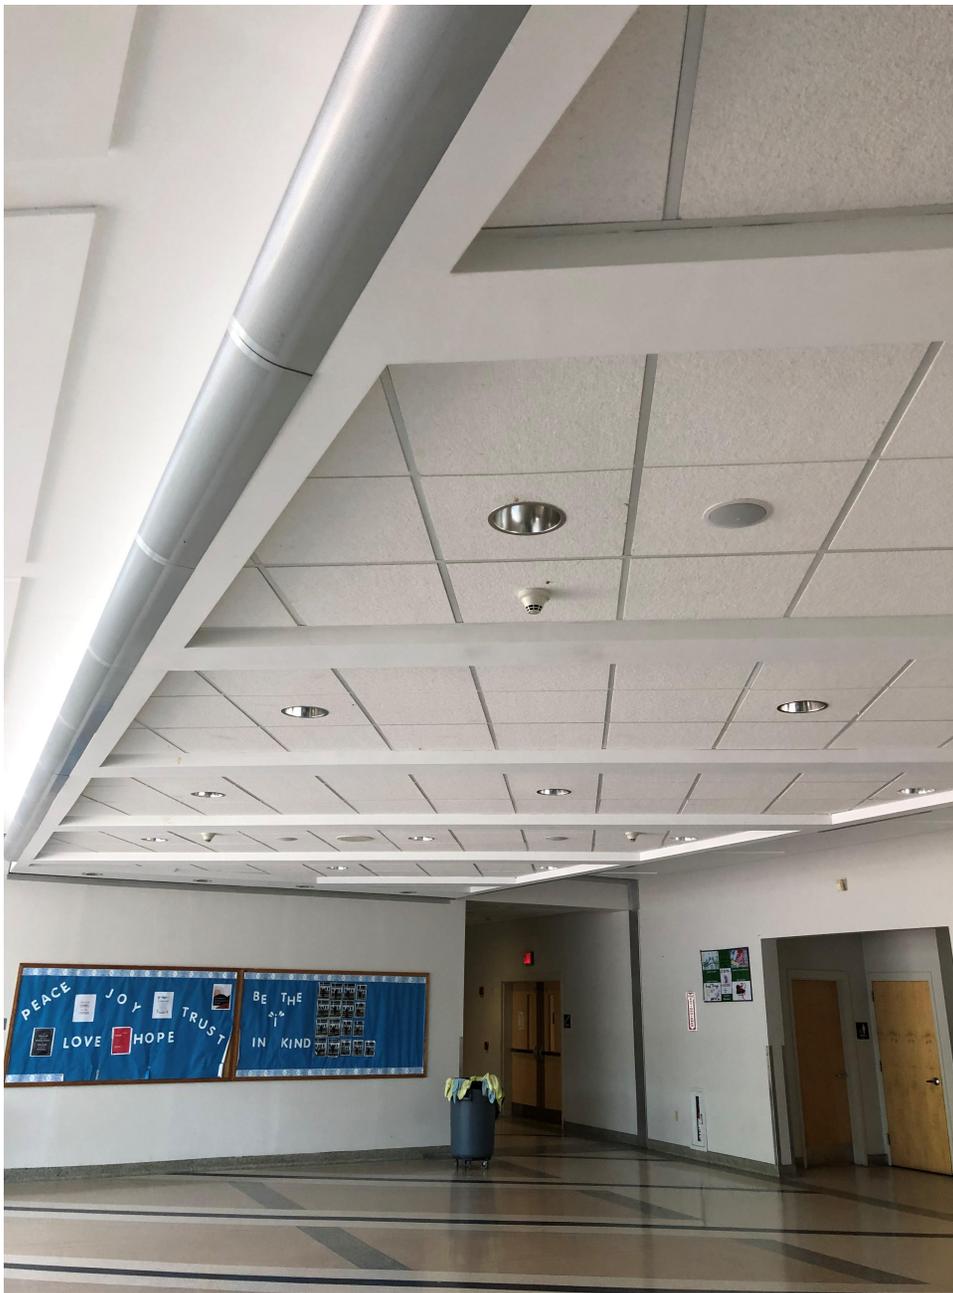
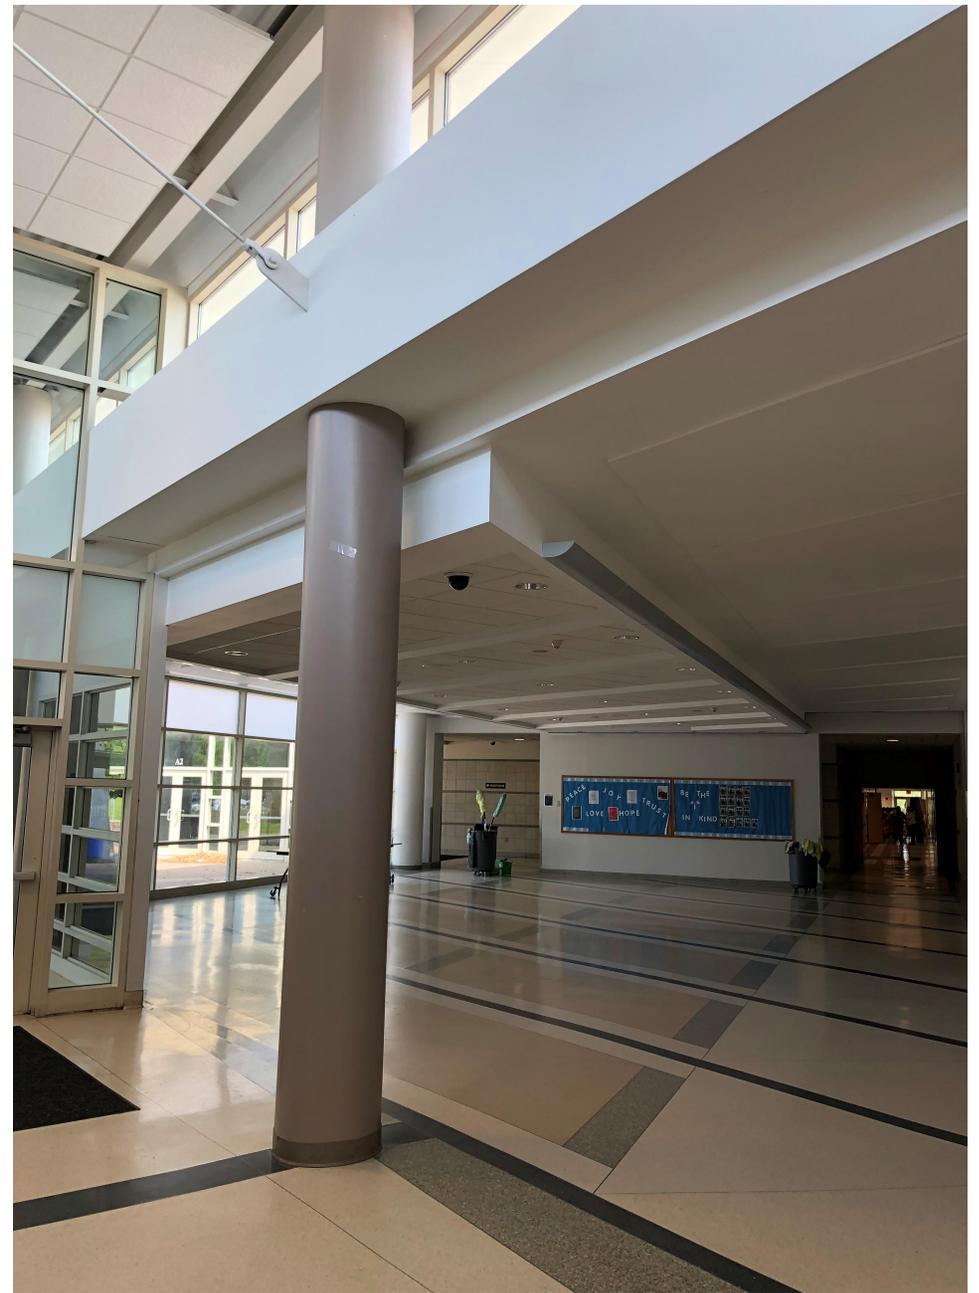
There is no direct supply air in the corridor and lobby to effectively heat the space and wash the window to avoid any potential condensation.

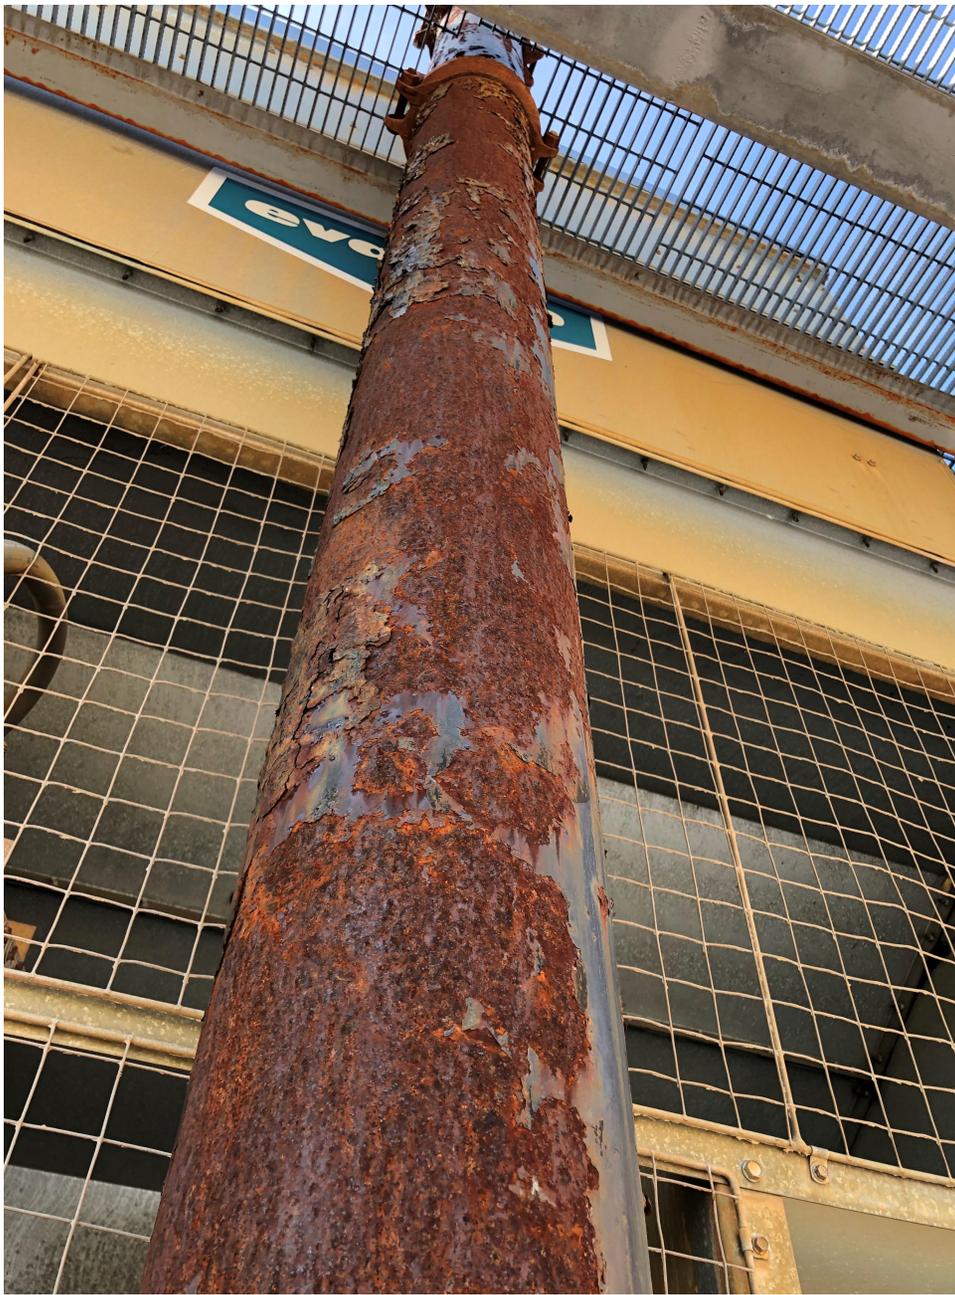
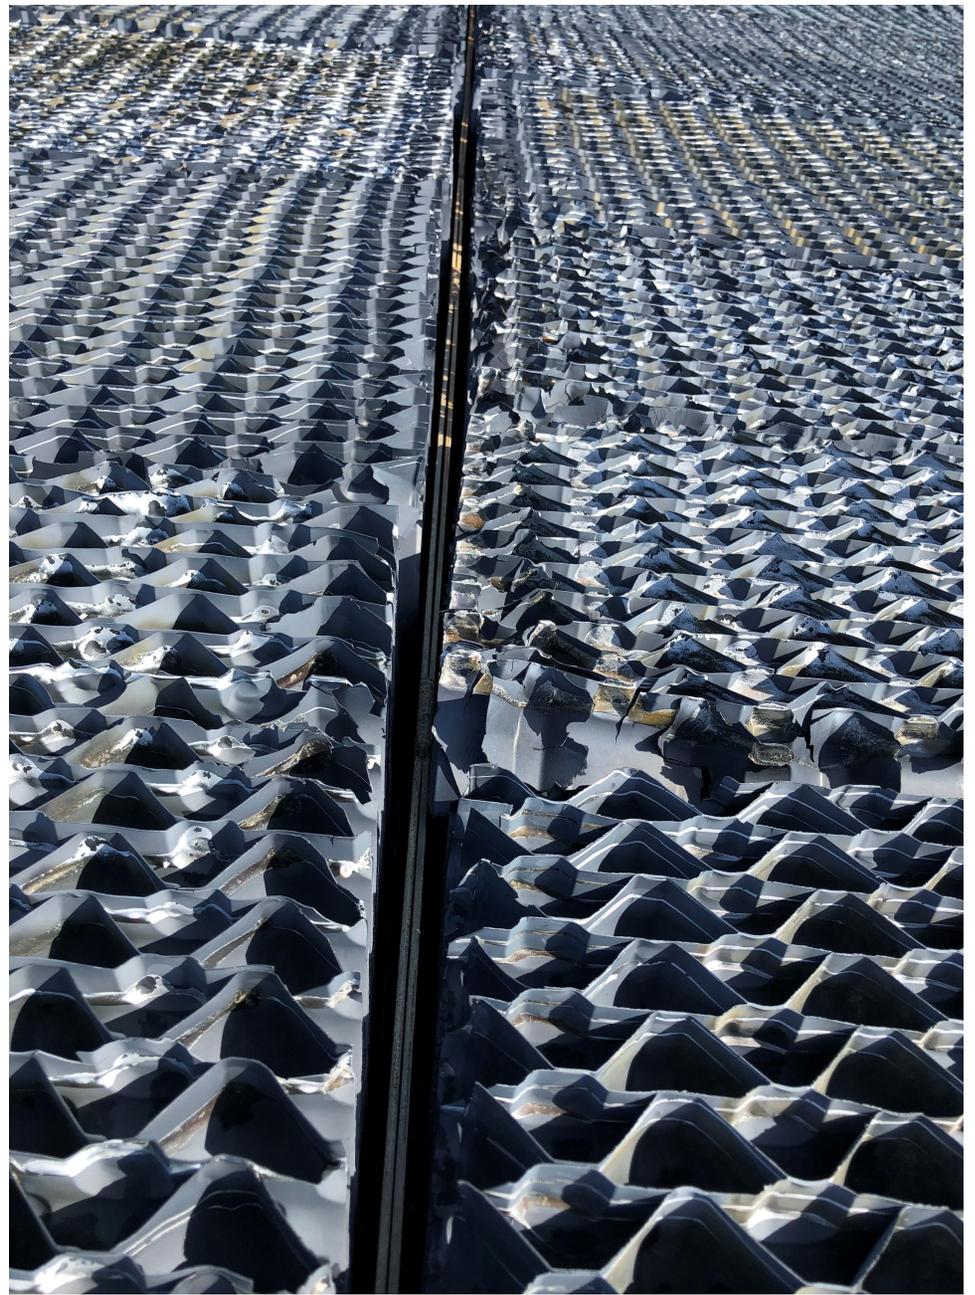
The cooling tower fan is rotting, corrosion on condenser water pipes, and honey comb starting to fail.

- Comfort and efficiency for the air handlers are good.
- The HVAC controls are in good condition.
- The 2003 boilers are in good condition.
- The Cooling Tower starts to show some corrossions, honeycomb starts to fail, and stainless fans start deteriorating. The Cooling Tower will require replacement within the next three years.
- It is recommended to provide additional heat to Band Room, Chorus Room, bridges, and lobby.

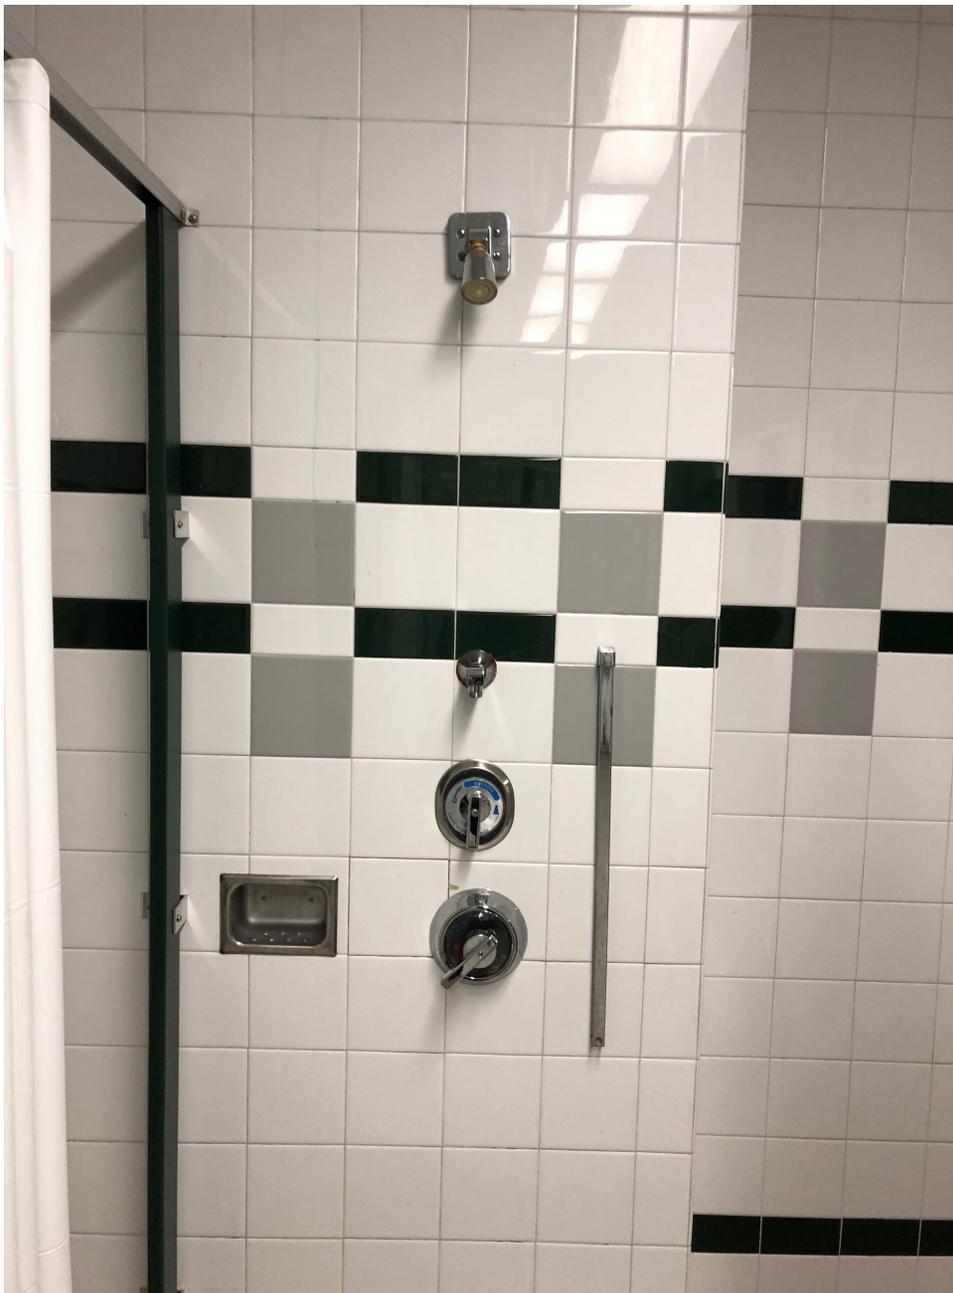
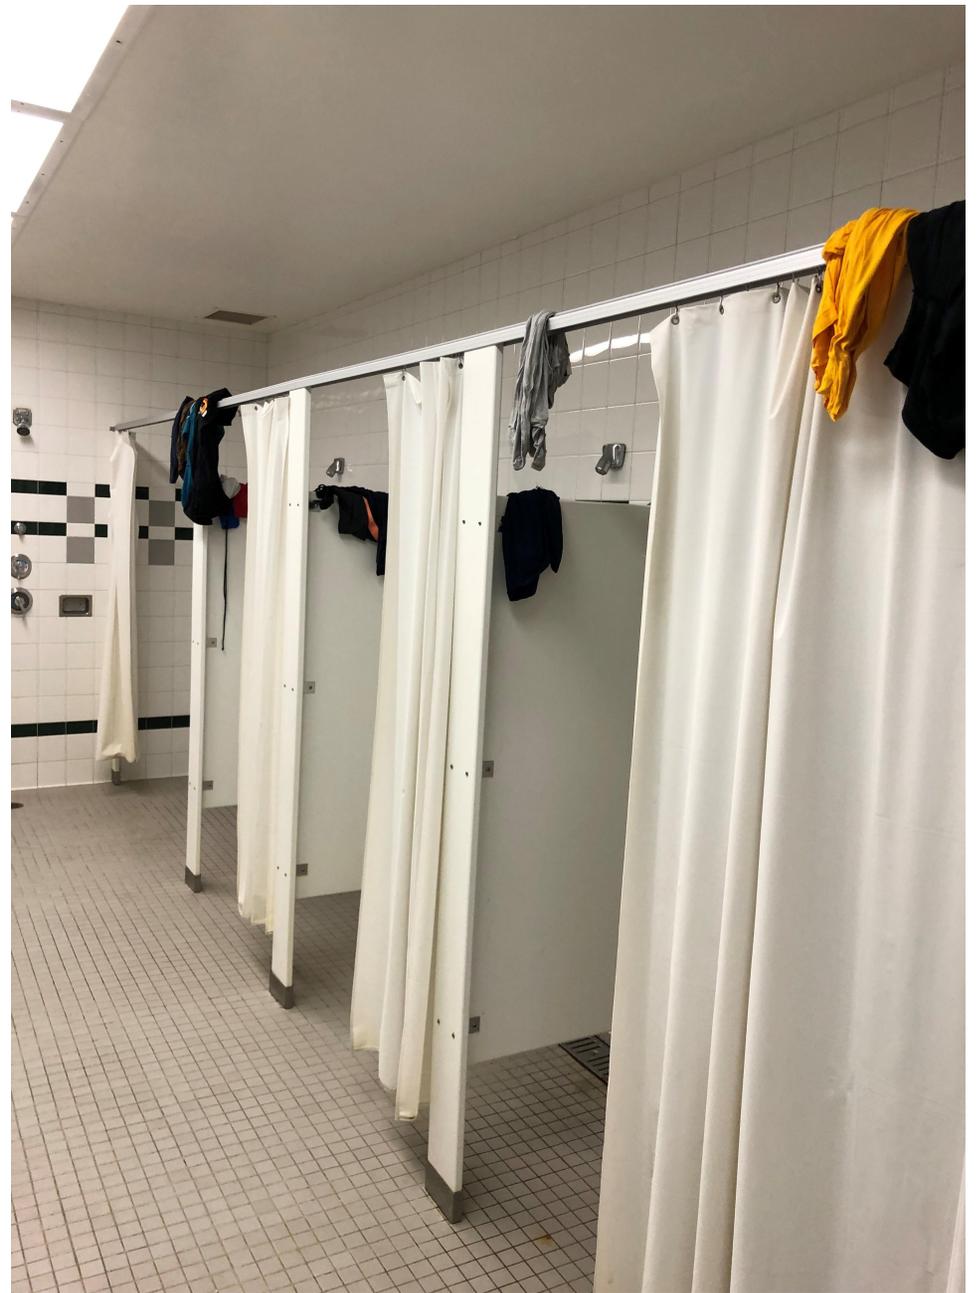
Shower heads are corroded and creating water leaks. Complete replacement of shower heads and provide maintenance access for each shower head. Remove the tile walls, replace the piping, and rebuild the wall.

- The girls and boy's locker rooms require some attention due to shower heads start to corrode, leak, and accessing the valve is an issue.
- District will replace sump pumps (In Kind) with 1/2 HP motor. Currently, only one pump is running.
- The present preventive maintenance policy should continue.

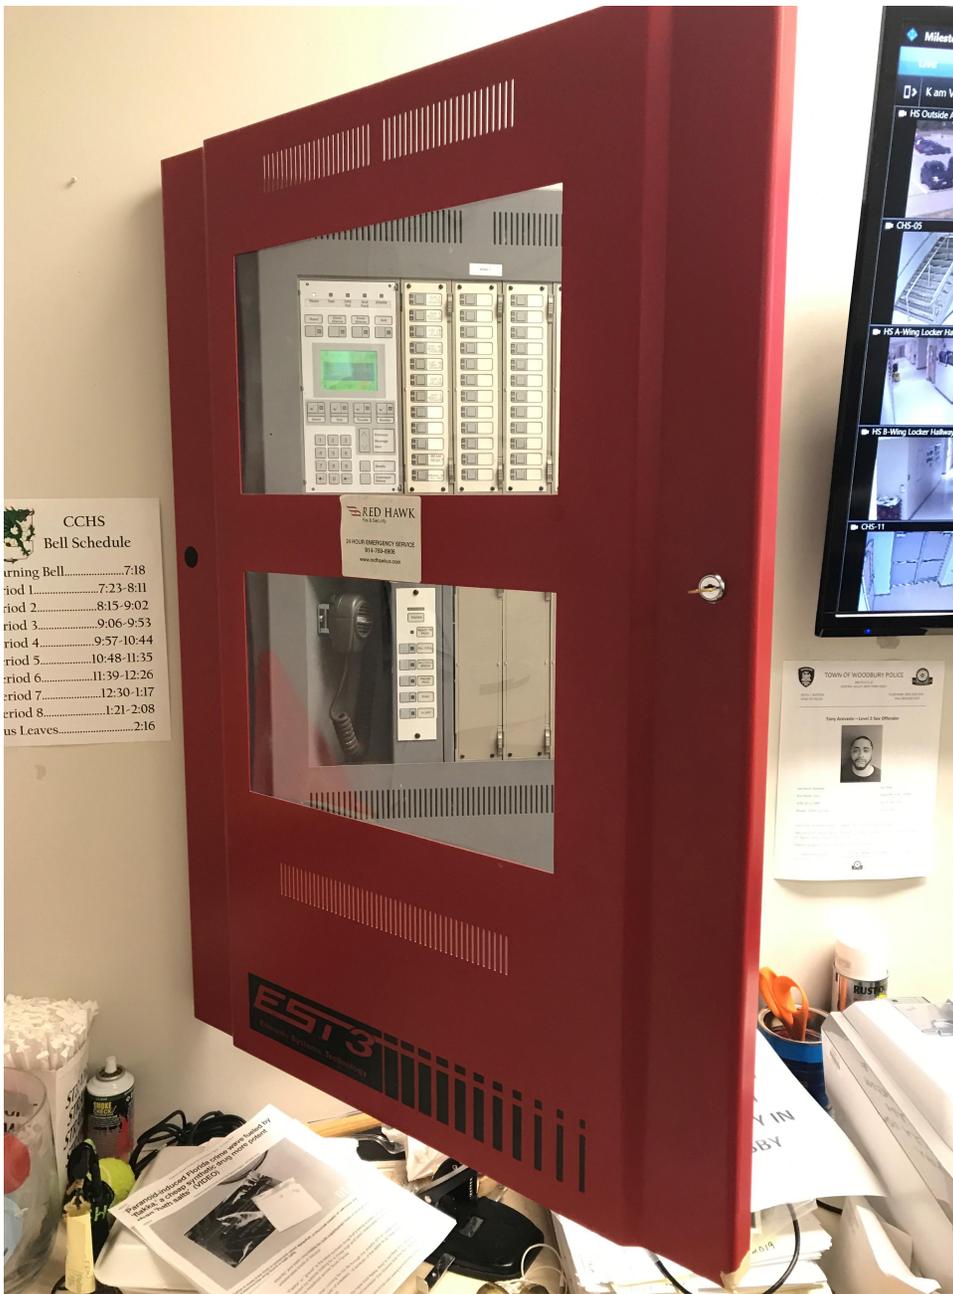
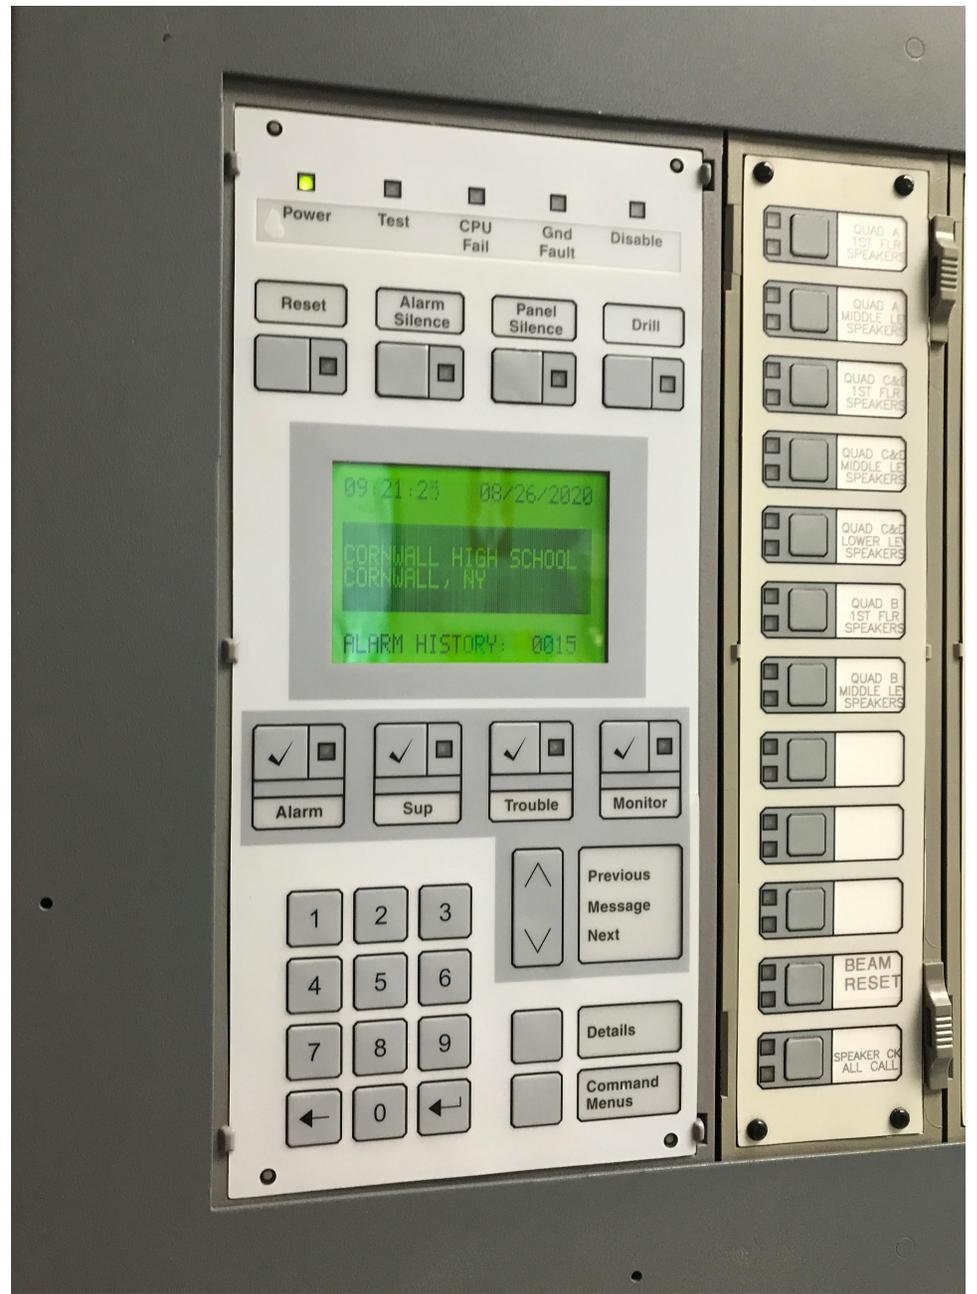
System ground loop issues and ground fault occurrences require diagnosis to repair.
