**2020 BUILDING  
CONDITION SURVEY  
REPORT**

CORNWALL CENTRAL  
SCHOOL DISTRICT

Buildings and  
Grounds

CSArch Project #204-1901

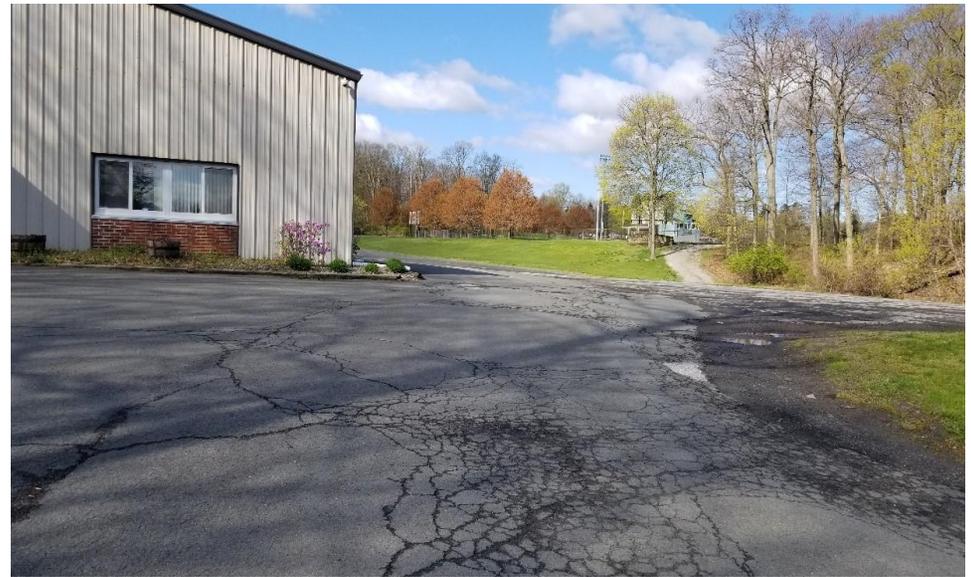
BG-03

- The asphalt parking lot and driveways are unsatisfactory.
- The parking lot and driveways are at the end of their useful life and need to be replaced.
- The storage yard pavement is in fair condition.
- The storage garage at the rear of the building appears to be in good condition.

**Category 55: Pavement**
