**2020 BUILDING
CONDITION SURVEY
REPORT**

CORNWALL CENTRAL
SCHOOL DISTRICT

Cornwall-on-Hudson
Elementary School

January 2021

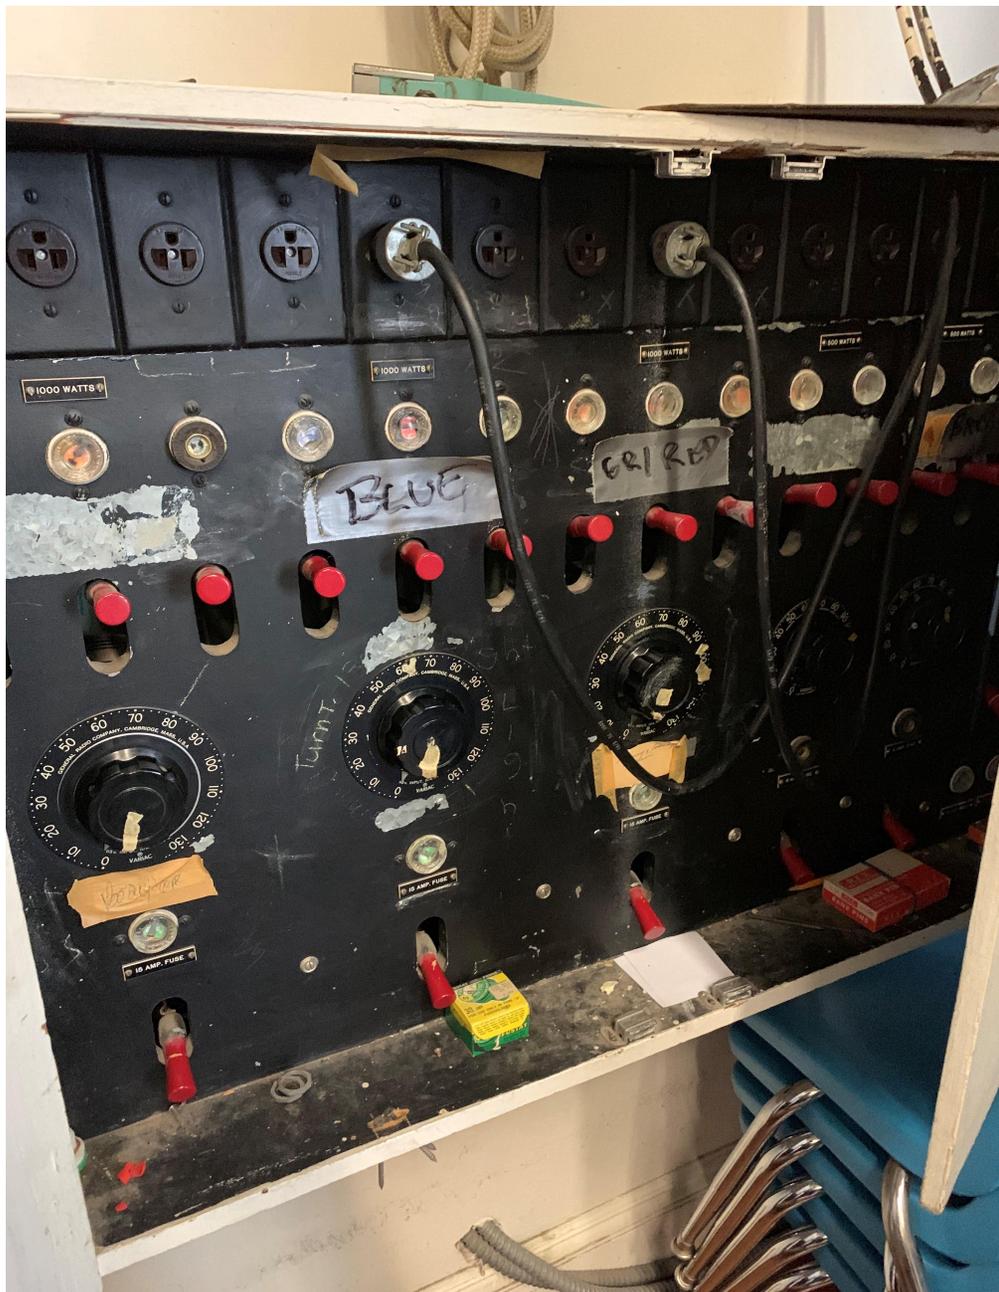
COH-27

Category 101: Electrical Power Distribution

Existing panel boards are approximately 50 years old and require replacement.
