**2020 BUILDING  
CONDITION SURVEY  
REPORT**

CORNWALL CENTRAL  
SCHOOL DISTRICT

Willow Avenue  
Elementary School

January 2021

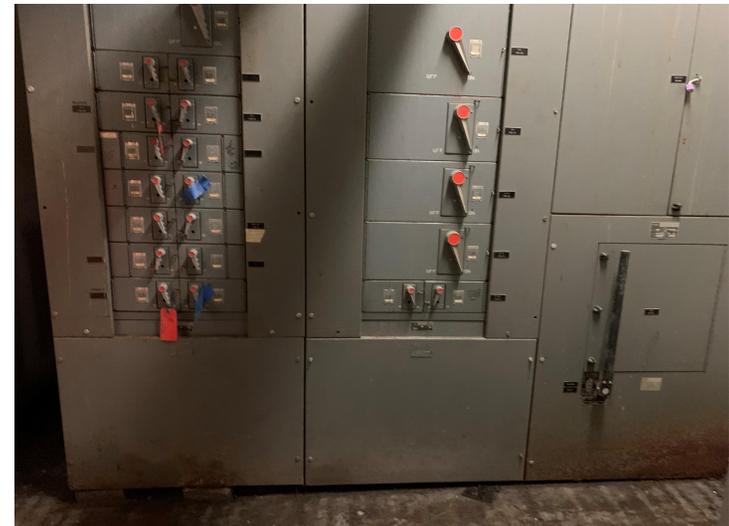
WA-55

Existing switchboard assembly is past its useful life with possible water damage from previous flooding. Existing panels are approximately 50 years old and require replacement.

- Main switchgear has water damage, replace
- Replace building distribution panels
